## SEISMIC PERFORMANCE OF ROCK BLOCK STRUCTURES WITH OBSERVATIONS FROM THE OCTOBER 2006 HAWAII EARTHQUAKE

Edmund MEDLEY<sup>1</sup>, Dimitrios ZEKOS<sup>2</sup>

Keywords: rock block structures, Hawaii earthquakes, earthquake observations, geomechanical failures

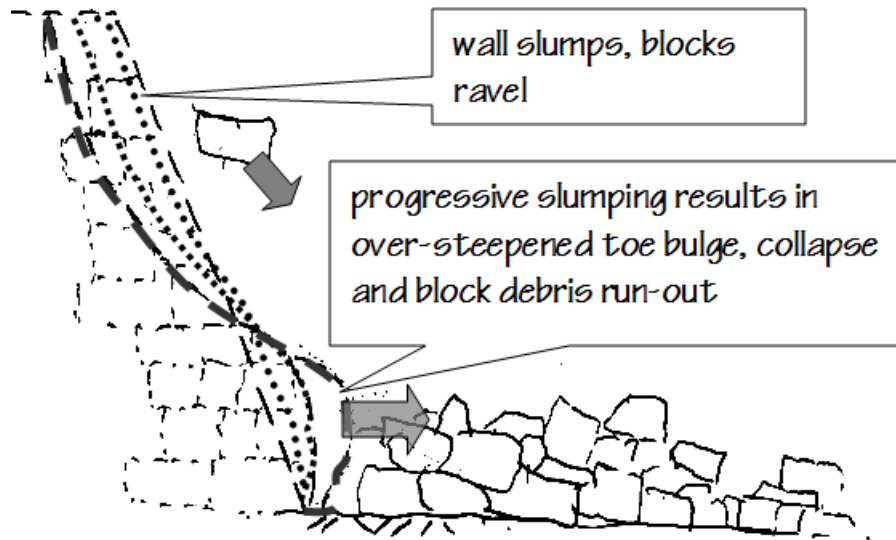
- J) Raveling, bulging and slumping failures of the outer faces of a rock block edifice, such as those observed at the Hawaiian heiaus described subsequently. Face failure may be progressive: the inclination of the bulges increase until they become over-steepened and collapse, thereby inducing collapse of the face above.

**Figure 10J. Raveling, bulging and slumping of the face of a rock block edifice.**

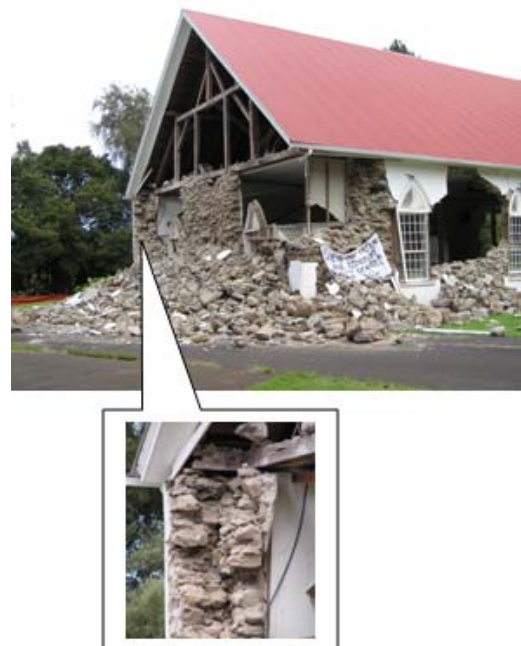
Figure 12. Kalāhikiola Church, Hawaii. Weakly cemented rock block walls failed dramatically (Medley, 2006).

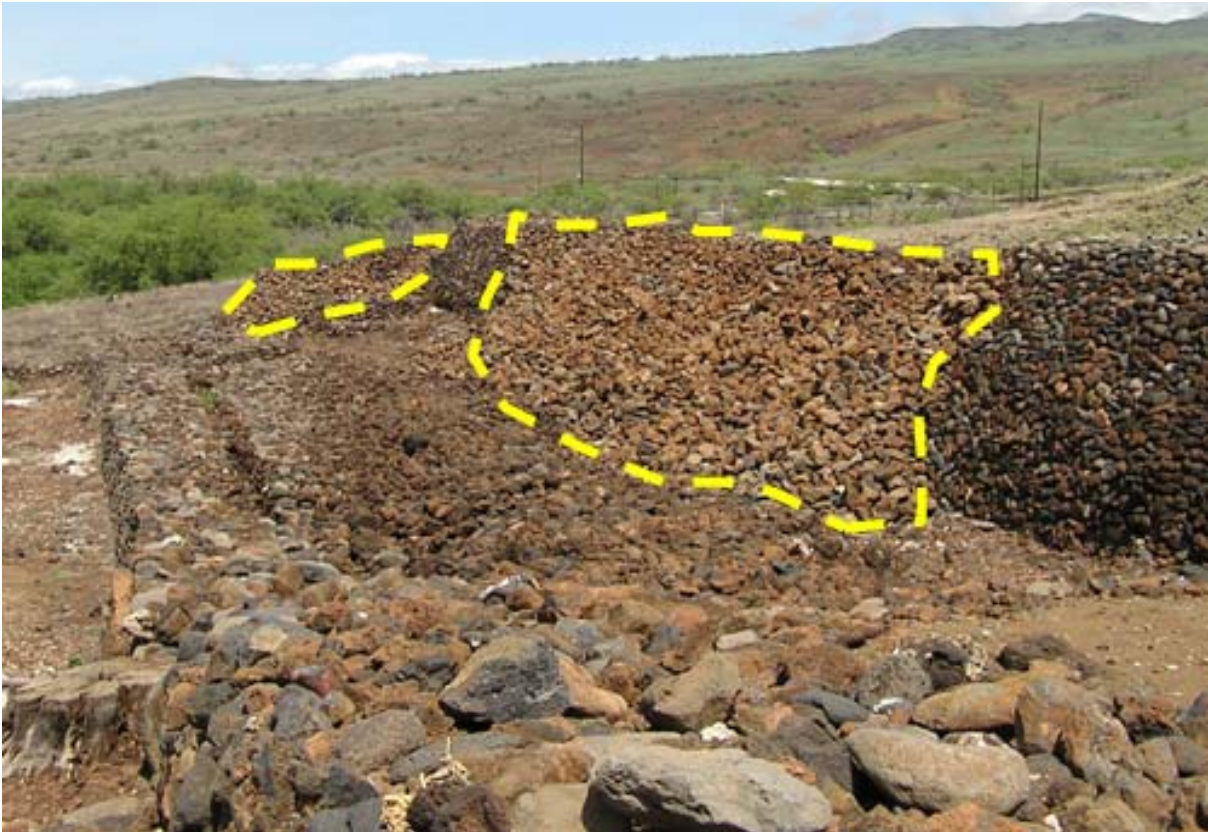
Figure 14. Raveling and slumping of eastern wall of Mailekini Heiau, after earthquake.

The Pu'ukoholā and Mailekini Heiaus were both severely damaged by the October 15 2006 earthquakes, the epicenters of which were less than 50 km away (Figure 11). At the Mailekini heiau, much of the interior face of the east wall slumped and raveled (Figure 13 and Figure 14). The worst damage at the Pu'ukoholā Heiau was to high retaining walls bounding the sole access passage (Figure 15 and Figure 16). Many wall bulges were observed at originally steep wall faces (40 to 50 degrees) resulting in further steepening of the wall faces near the bottom of the edifice (Figure 17 and Figure 18), although it is likely that some bulging had occurred before the earthquakes. The bulging suggests that there are future vulnerabilities to increased rock face instability and possible eventual collapses from future earthquakes or creep deformation (Medley, 2006). Some slumps and ravel of the wall faces occurred where the bulges over-steepened and collapsed (Figure 19) apparently in much the same fashion as sketched in Figure 10J. The angle of repose for the slumps was about 30 degrees, with run-outs extending to more than 5 m from the original toe of the walls.

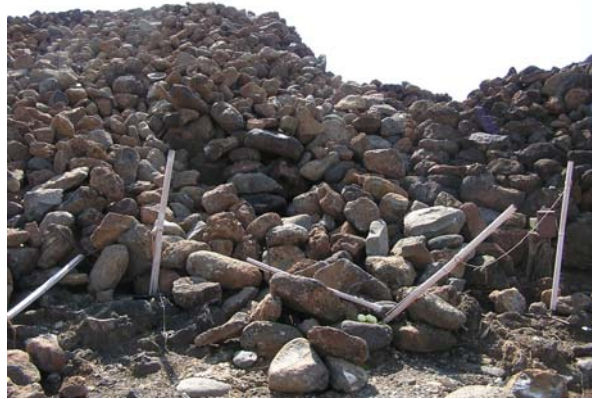
**Figure 16. Post-earthquake view of collapsed entrance.**

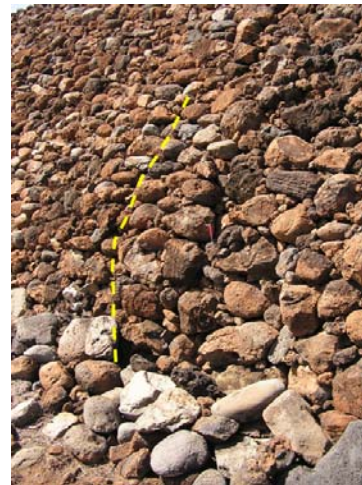
**Figure 18. Post-earthquake photo near NE corner of Pu'ukoholā shows bulging of face of wall (indicated by yellow line).**

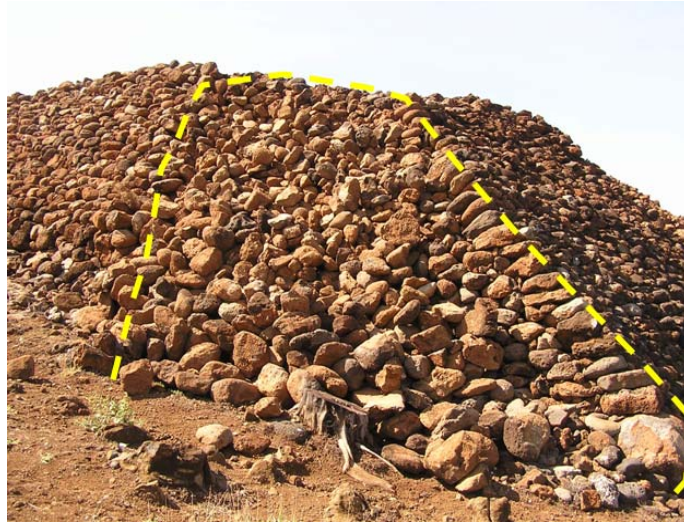
The location of the Heiau on the brow of a hill may have focused seismic shaking, although no details about site response are available. The pre-earthquake geometry of the Pu'ukohola Heiau was apparently surveyed a few years ago with terrestrial LiDAR (Light Detection and Ranging) before the earthquake (personal communication with National Park Service staff). As shown in Figure 17, there was apparent wall bulging or steepening of the Heiau walls before the earthquake, but it is unknown how much of this occurred because of, or since, wall renovations in the 1970's. A repeat LiDAR survey could form the basis for quantifying earthquake-related deformation, back-analysis and identification of those portions of the edifices vulnerable to further damage in future earthquakes, or due to creep (Medley, 2006).

**Figure 19. Pu'ukoholā Heiau. Slump failure due to earthquakes (between dashed lines).**

The Pu'ukoholā and Mailekini Heiaus suffered great damage in the  $M_w$  6.7 and 6.0 earthquakes that shook the island of Hawaii on October 15, 2006. The causes of the damage have not been adequately studied, but further analyses should ideally research: ground and structure responses; understanding of the effects of topographic focusing; consideration of the quality of the interior core; review of the nature and quality of previous repairs in the last 200 years; and estimation of the occurrence of prior permanent wall deformations. Since portions of the Heiaus now have potentially hazardous wall geometries, these should be analyzed to assess future potential performance under static and dynamic loading.
