## SEISMIC PERFORMANCE OF ROCK BLOCK STRUCTURES WITH OBSERVATIONS FROM THE OCTOBER 2006 HAWAII EARTHQUAKE

Edmund MEDLEY<sup>1</sup>, Dimitrios ZEKOS<sup>2</sup>

Keywords: rock block structures, Hawaii earthquakes, earthquake observations, geomechanical failures

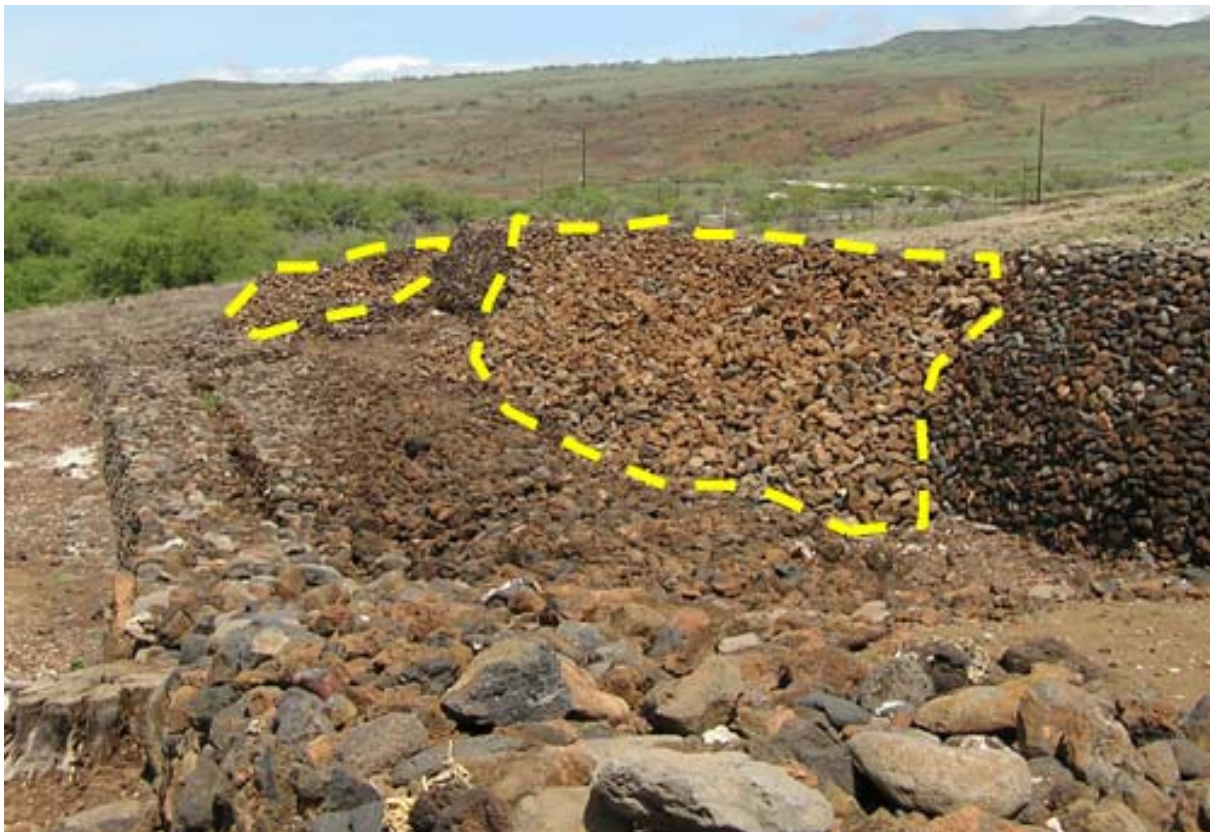
Figure 14. Raveling and slumping of eastern wall of Mailekini Heiau, after earthquake.

The Pu'ukoholā and Mailekini Heiaus were both severely damaged by the October 15 2006 earthquakes, the epicenters of which were less than 50 km away (Figure 11). At the Mailekini heiau, much of the interior face of the east wall slumped and raveled (Figure 13 and Figure 14). The worst damage at the Pu'ukoholā Heiau was to high retaining walls bounding the sole access passage (Figure 15 and Figure 16). Many wall bulges were observed at originally steep wall faces (40 to 50 degrees) resulting in further steepening of the wall faces near the bottom of the edifice (Figure 17 and Figure 18), although it is likely that some bulging had occurred before the earthquakes. The bulging suggests that there are future vulnerabilities to increased rock face instability and possible eventual collapses from future earthquakes or creep deformation (Medley, 2006). Some slumps and ravel of the wall faces occurred where the bulges over-steepened and collapsed (Figure 19) apparently in much the same fashion as sketched in Figure 10J. The angle of repose for the slumps was about 30 degrees, with run-outs extending to more than 5 m from the original toe of the walls.

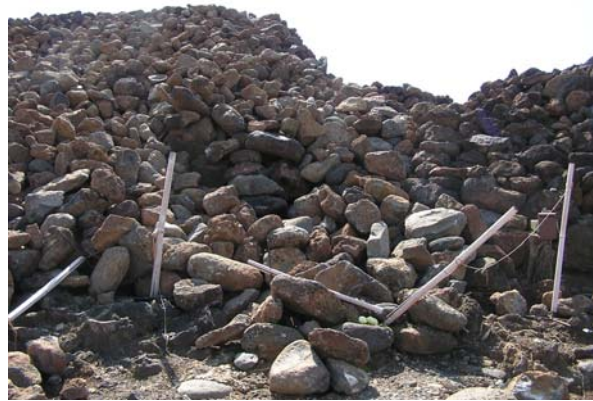
**Figure 16. Post-earthquake view of collapsed entrance.**

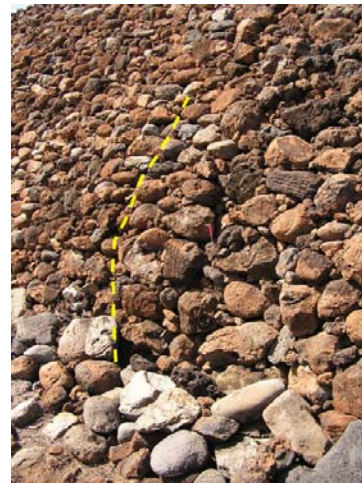
**Figure 18. Post-earthquake photo near NE corner of Pu'ukoholā shows bulging of face of wall (indicated by yellow line).**

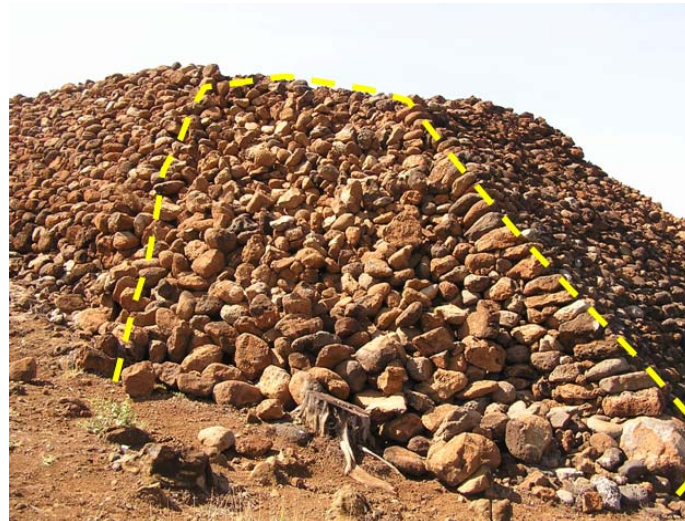
The location of the Heiau on the brow of a hill may have focused seismic shaking, although no details about site response are available. The pre-earthquake geometry of the Pu'ukohola Heiau was apparently surveyed a few years ago with terrestrial LiDAR (Light Detection and Ranging) before the earthquake (personal communication with National Park Service staff). As shown in Figure 17, there was apparent wall bulging or steepening of the Heiau walls before the earthquake, but it is unknown how much of this occurred because of, or since, wall renovations in the 1970's. A repeat LiDAR survey could form the basis for quantifying earthquake-related deformation, back-analysis and identification of those portions of the edifices vulnerable to further damage in future earthquakes, or due to creep (Medley, 2006).

**Figure 19. Pu'ukoholā Heiau. Slump failure due to earthquakes (between dashed lines).**
