**FORENSIC INVESTIGATION OF THE FAILURE OF AN
INTERCEPTOR SEWER, SEA CLIFF AREA, SAN FRANCISCO,
CALIFORNIA**

Dr. Edmund W. Medley, P.E., C.E.G.

**Proceedings of WEFTEC 2000
Water Environment Federation
Anaheim, CA October 2000**

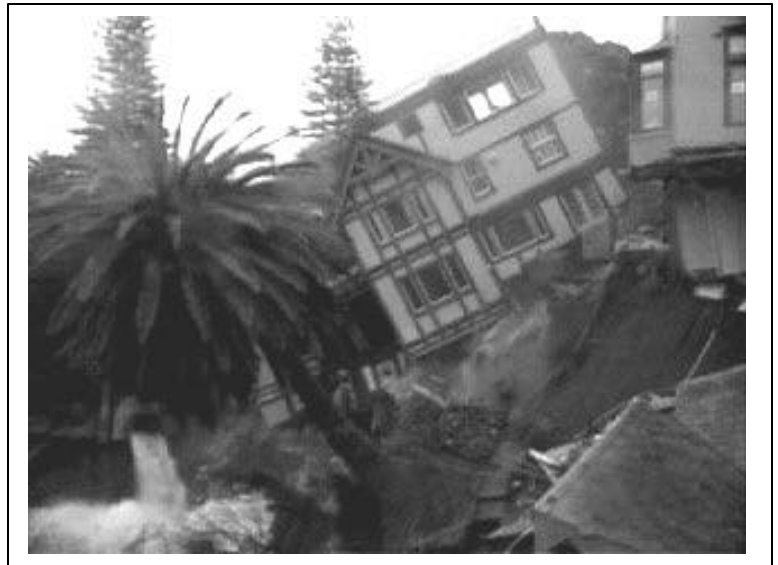
Sewage discharge from the Overflow Structure manholes and residential drains stopped about 0245. By this time San Francisco Fire Department staff were on the scene and the documented record improved significantly. At about the same time, parts of El Camino del Mar began to collapse into a large pit, and the sewer was seen to be severed. At about 0305 to 0315, surveyors in the Richmond Transport, approximately 9000 feet west of the incident site, were chased out of the West Portal by a two-foot high wave of water. Shortly after they escaped, the West Portal shaft filled with water. Sometime before dawn, the attached garage of the Yee residence fell into the pit ([Figure 2](#)). The pit caused by the ruptured sewer grew until about 0730, when the historic Billman home fell into the void ([Figure 9](#)). Several families were evacuated from the neighborhood as the pit undermined the sand underlying their homes.

Figure 2 – Aftermath of the Sea Cliff Incident: a 200 foot diameter and 40 foot deep pit containing the debris from the collapsed Billman residence. Yee residence in background.

Discharge from the ruptured sewer was eventually halted by the placement of a plug of approximately 100 cubic yards of concrete in the sewer upstream of the incident site. About 30,000 cubic yards of emergency fill was then placed in the void to stabilize the steep slopes and prevent further property loss.

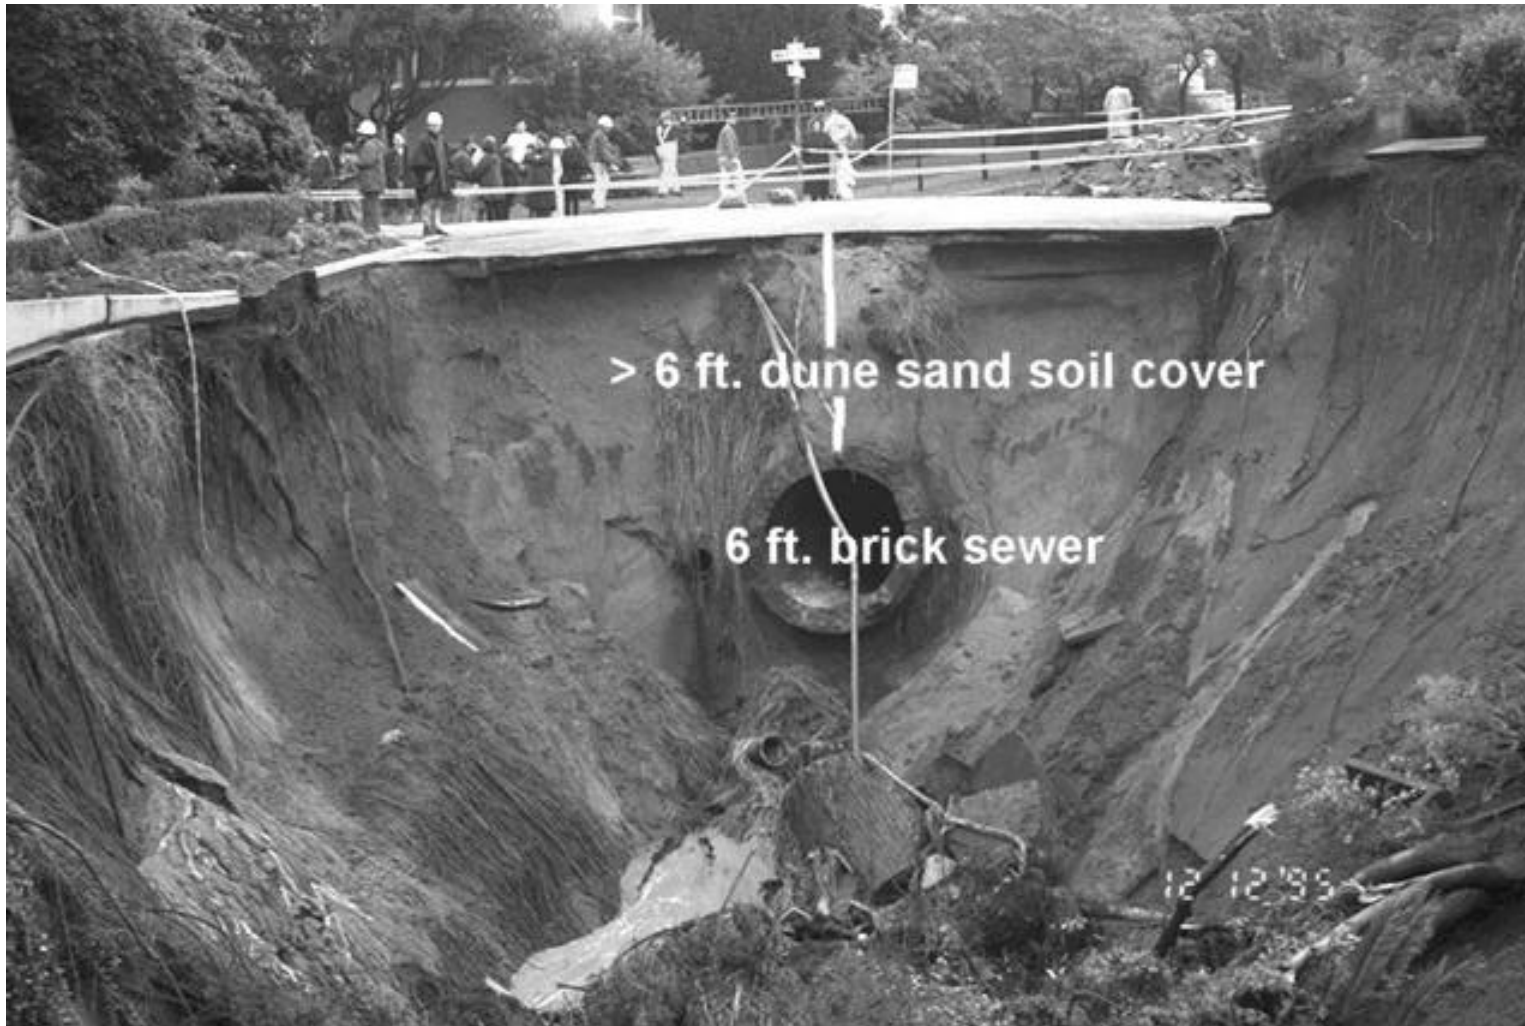
During mining in August 1994, two small sinkholes were observed on the ground surface near the end of the adit. The small depressions eventually coalesced between August 1994 and late 1995 to form one depression (sinkhole) about 10 feet in diameter and 7 feet deep, centered about 8 feet from the end of the adit ([Figure 4](#) and [Figure 5](#)). The sinkhole was located adjacent to the brick sewer ([Figure 4](#)). Relative to the topography as surveyed in February 1995, the distance between the sewer and the bottom of the sinkhole was about 2 feet ([Figure 5](#)). The top of the adit terminated 5.5 feet beneath the brick sewer east of the Billman property driveway.

Figure 4 – Location of the initiation of sewer failure. Section AA' is shown in Figure 12.
