Forensic evaluation of an embankment on soft ground using CPT

W. M. Camp, III, & A. D. Goldberg,
S&ME, Inc., Mount Pleasant, SC, USA

D. L. Bellamy
South Carolina State Ports Authority, Charleston, SC, USA

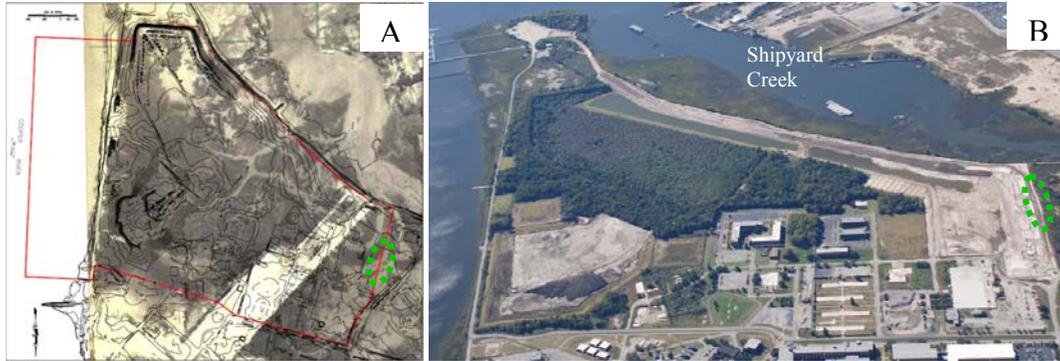
A new container terminal, known as the Charleston Naval Base Container Terminal or CNBCT, is currently under construction in North Charleston, South Carolina, USA. As shown in Figure 1A, the site consisted of salt marsh and tidal creeks as recently as 1939. Over the next 20 to 30 years, much of the site was filled for land reclamation and a significant portion of it was used as a dredge spoil disposal area. The original marsh deposits and the more recently placed dredge spoil consist of predominantly fine-grained, very soft, high plasticity, soils. The low strengths and high compressibility of the soils were considered in the design of the new roadway embankment but approximately 0.2 km of the 1.5 km long embankment experienced large lateral movement during construction. The area of movement or embankment failure is indicated in Figure 1 by the dotted blue line.

Figure 1. Aerial photos of the project site from 1939 (A) and 2009 (B). The red line in (A) indicates the area of the proposed container terminal and the dotted green line indicates the area of movement that is the focus of this paper. The embankment runs along the western edge of the property (North is down), turns to the east, and then parallels Shipyard Creek.

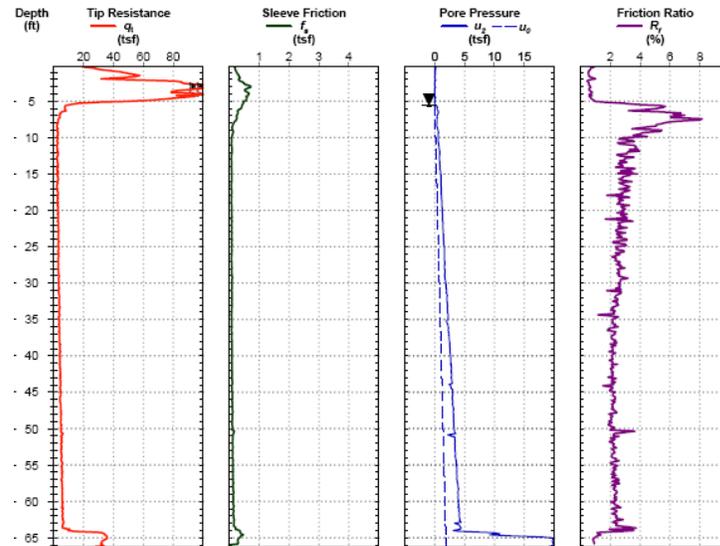
conditions were used to develop base case profiles for representative portions of the site. The exploration locations were arranged in a grid pattern with a spacing of about 90 m to 120 m between soundings/borings. The data from a typical CPT sounding is presented in Figure 2. For design-phase analyses in the area of the new roadway embankment, we assumed the shear strength at the top of the soft clay stratum was equal to 11 kPa (230 psf) and increased linearly with depth at a rate of 1 kPa per m of depth (7 psf per ft of depth). This strength profile was generally confirmed in the field during the construction and monitoring of two design-phase test embankments (Goldberg et al., 2007).

Figure 2. Typical CPT data from the general area of the embankment.

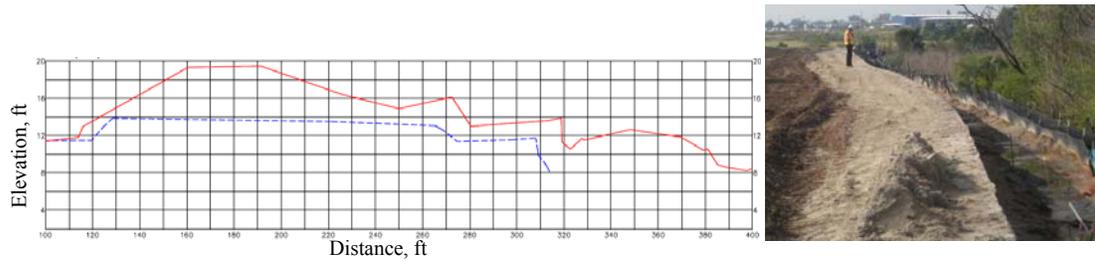
continued fill placement and grading as the failure was occurring. A large bulge was apparent beyond the western toe of the embankment. The last surveyed cross section prior to the movement and the post-failure survey are shown in Figure 3A and a picture showing the lateral displacement of the MSE wall is shown in Figure 3B. An instrumentation cluster was located near the center of the failed segment at station 62. The data are presented in Figure 4.

Figure 3. A) Surveys made approximately 1 week before failure (blue line) and 1 week after failure (red line) and B) photo illustrating the lateral displacement of the MSE wall.

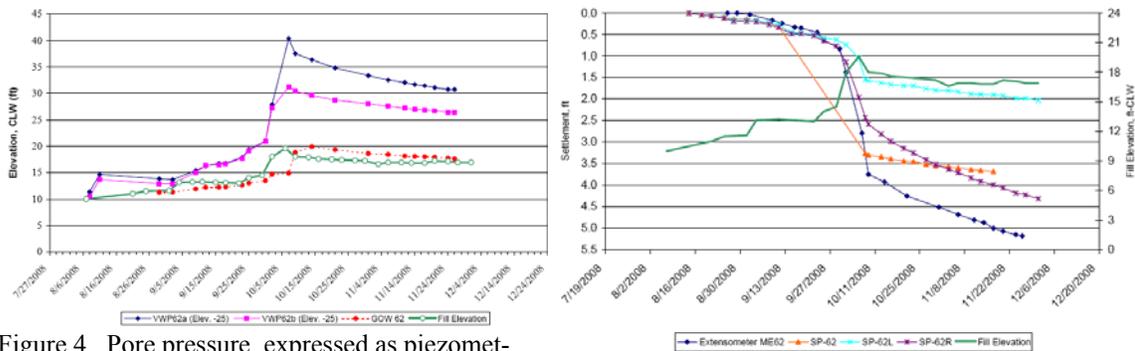
Figure 4. Pore pressure, expressed as piezometric elevation, and settlement data recorded near the midpoint of the embankment failure. The majority of the movement occurred on October 7.

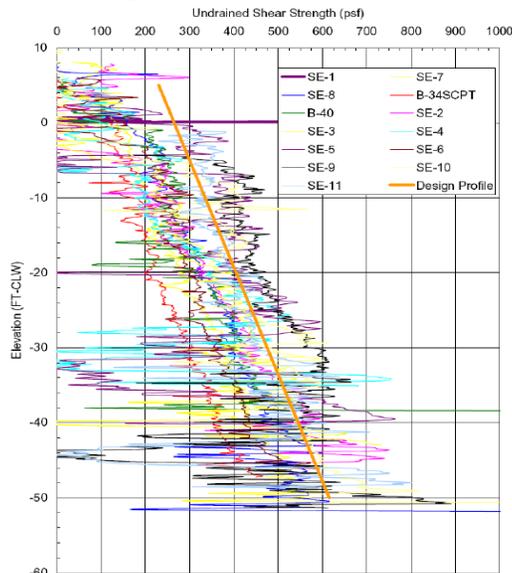
A summary plot of the estimated shear strength at 13 CPT locations is presented in Figure 5. A plot of the “base case” design profile is also included in Figure 5 for comparison. In general, the estimated strengths are considerably less than the design profile. In some cases, the estimated strengths from the supplemental soundings were only half of the strengths assumed in the design profile. The supplemental soundings were concentrated around the perimeter of the failure site and more than tripled the amount of subsurface data as compared to what was obtained during the original subsurface exploration.

Figure 5. Summary plot of estimated undrained shear strength using Mayne & Holtz 1988 with $N_u = 9$. Assumed strength profile used for design is shown for comparison.

The supplemental exploration data clearly indicated that the strength within the area of the movement was anomalously low as compared to the assumed design profile. These new estimated strength profiles were obviously useful in evaluating the embankment failure but additional information was still needed. More specifically, it was not clear if the embankment had experienced a conventional rotational/bearing capacity failure or if a lateral squeeze failure had occurred (Bonaparte & Christopher, 1987). Consolidation induced strength gain would gradually improve the bearing capacity thereby making it possible to eventually increase the fill height. However, since lateral squeeze failures are generally controlled by the conditions adjacent to the embankment and outside of its footprint (i.e., a zone that will generally not experience consolidation induced strengthening), such a failure would mean that fill could not be added without additional measures (e.g., structural retention, ground reinforcement along the embankment perimeter, etc.) regardless of the available waiting period. Additionally, the back-analyses were very sensitive to the assumed condition of the two geosynthetic layers. The location of much of the vertical movement coincided roughly with the back edge of the upper geosynthetic (i.e., the failure surface could have passed behind it rather than through it) but a rotational failure surface would have had to pass through the lower geosynthetic layer.

After concluding that the large horizontal and vertical movements were primarily due to bearing capacity/rotational failures, conventional limit-equilibrium stability analyses were used with the additional shear strength estimates from the forensic exploration to back-compute the strength profile at the time of the failure. In general, the back-computed strengths were in agreement with the strengths from the FVT and CPT correlations. Consolidation analyses and the results from CIU triaxial testing and the design-phase test embankments were used to estimate the consolidation-induced strength gain with time. Based on these findings, the embankment construction was modified to include two idle periods followed by two fill stages and then a final idle period before stripping to the design subgrade elevation. The modifications resulted in a total idle or surcharge period that was slightly longer than the originally anticipated period and a slightly lower final surcharge height. The large movements had damaged many of the instrumentation clusters and the revised plans included replacement instruments, additional monitoring (e.g., position surveys of the temporary MSE wall), and more frequent monitoring during fill placement.

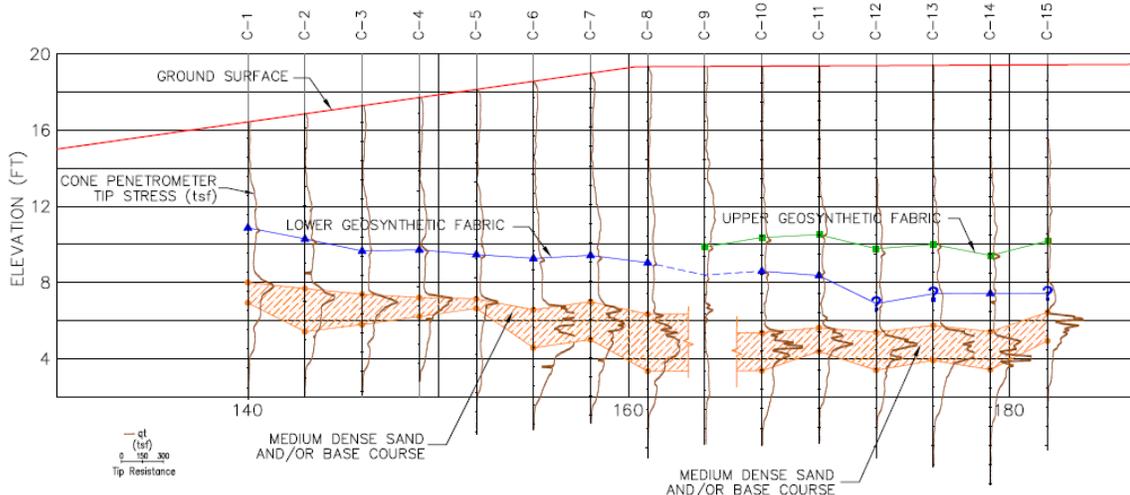
To address these remaining uncertainties, an array of 15 CPT soundings was performed perpendicular to the embankment alignment within the area of greatest observed movement. The first sounding was located on the eastern slope of the embankment and each successive sounding was performed approximately 1 m to the west of the previous sounding. A schematic depiction of the embankment cross-section, the CPT sounding locations and the interpreted subsurface conditions is shown in Figure 6.

Figure 6. Cross-section of embankment with 15 supplemental CPT sounding locations spaced at 1 m intervals. The interpreted position of geosynthetic layers and pre-construction base course is also shown as well as the tip stresses from each sounding.

by an immediate decrease in the tip stress, all occurring over a very short distance. Additionally, the CPT operator reported hearing/sensing a slight “pop” when the apparent geosynthetic “signature” occurred. The fabric was generally identifiable but it was not possible to conclusively determine if it had ruptured. The signature at the likely location of rupture (C-9) was not as obvious but it may still have been present. Additionally, a fabric signature was not observed in two locations where rupture was unlikely (i.e., upper fabric was apparent). However, an unanticipated component of the supplemental data was very beneficial.

The portion of the embankment that failed was located over a previously paved parking area, where the pavement was stripped but the relatively thin base course of sand and coarse aggregate was not removed prior the embankment construction. This “crust” material was readily apparent in all but one of the CPT soundings. The base course was missing in sounding C-9, which was located just beyond the end of the upper geosynthetic layer and where the failure surface would have likely passed through the crust. Back analysis indicated that if a rotational failure (as opposed to the end of a lateral squeeze failure) were to have occurred, the slip surface should have passed beyond the upper geosynthetic layer and through the base course near the location of CPT C-9. It was therefore concluded that a shear displacement had occurred at the location of C-9 thereby indicating that a bearing capacity/rotational displacement was the primary mode of failure.
