**January 24, 2020 Elazığ-Sivrice Earthquake ($M_w=6.8$)
Reconnaissance Study Report**

**MIDDLE EAST TECHNICAL UNIVERSITY
EARTHQUAKE ENGINEERING RESEARCH CENTER**

REPORT NO: METU/EERC 2020-01

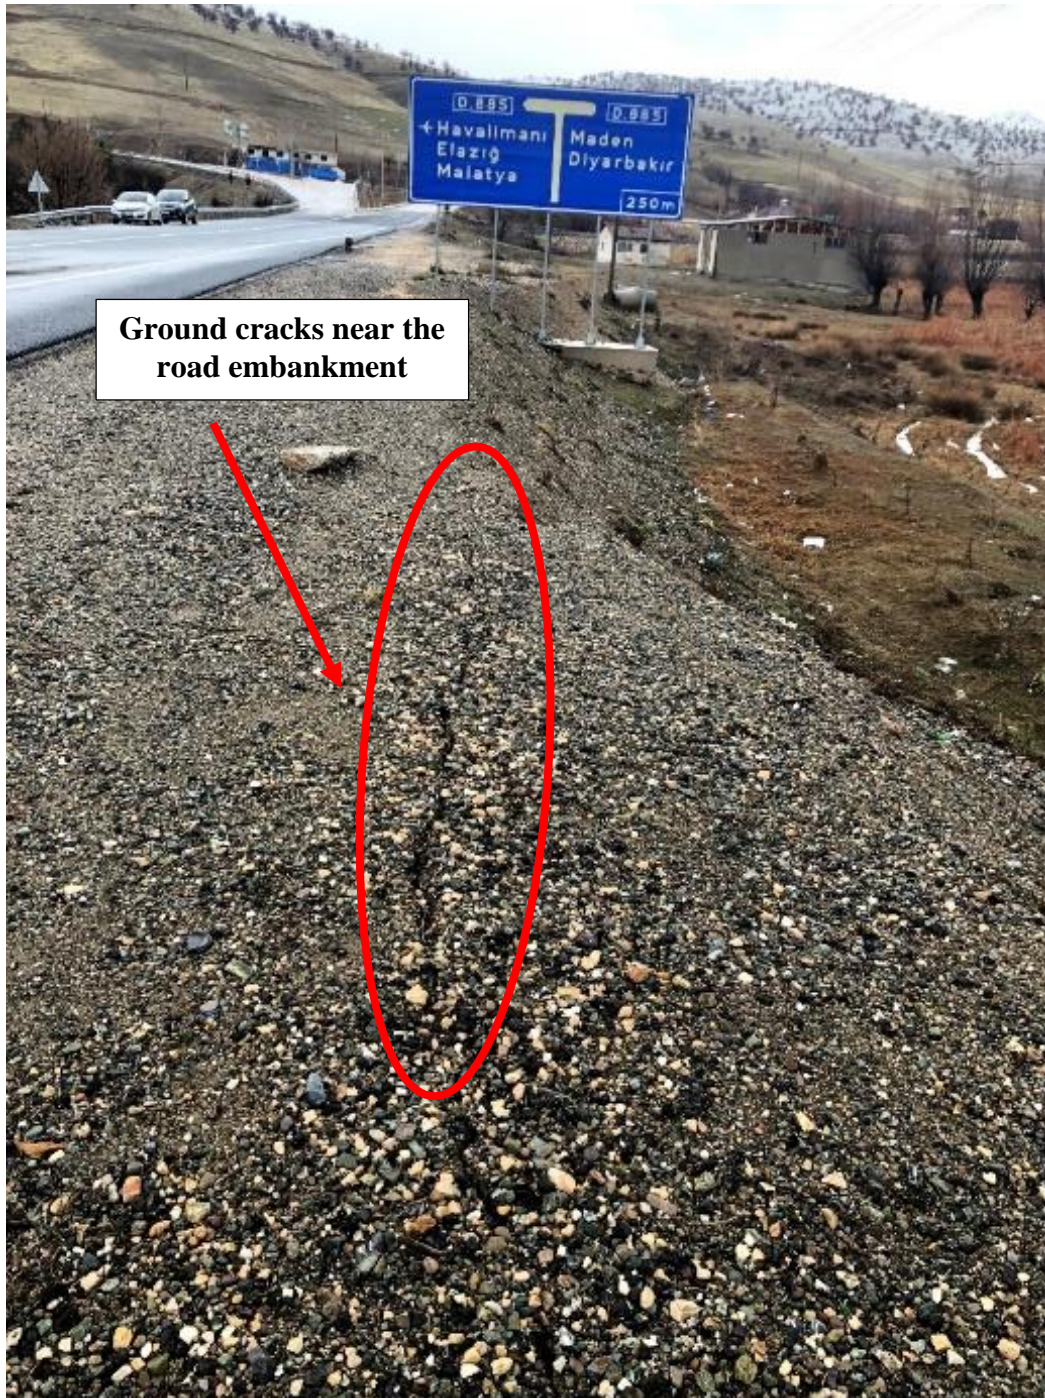
A small crack indicating a local bench failure was observed near the Sivrice road embankment, as shown in Figure 4.9. The crack is examined and presumed as a sign of a local small-scale slope instability problem.

Figure 4.9. A small crack observed near the highway embankment
(38°28'08.0"N 39°16'38.7"E / 31.01.2020 / 11:50)

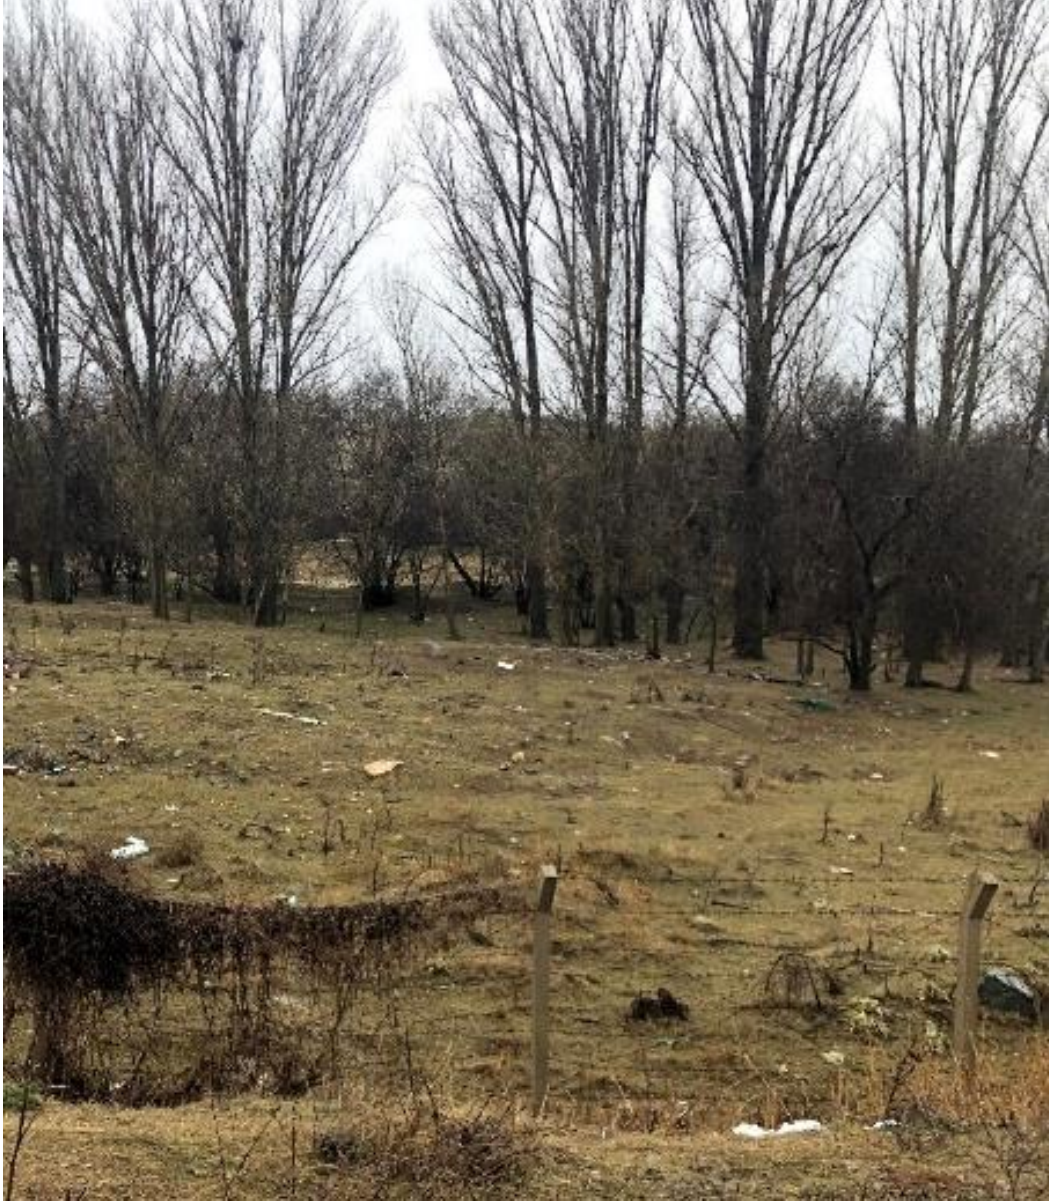
On the first stop just down the road embankment, a neighboring site was also visited, as shown in Figure 4.10. The site is composed of surficial clayey soils based on field observations. No damage and surface manifestation of ground deformations were observed.

Figure 4.10. Clayey site and no signs of ground failure
(38°28'09.0"N 39°16'46.8"E / 31.01.2020 / 11:51)

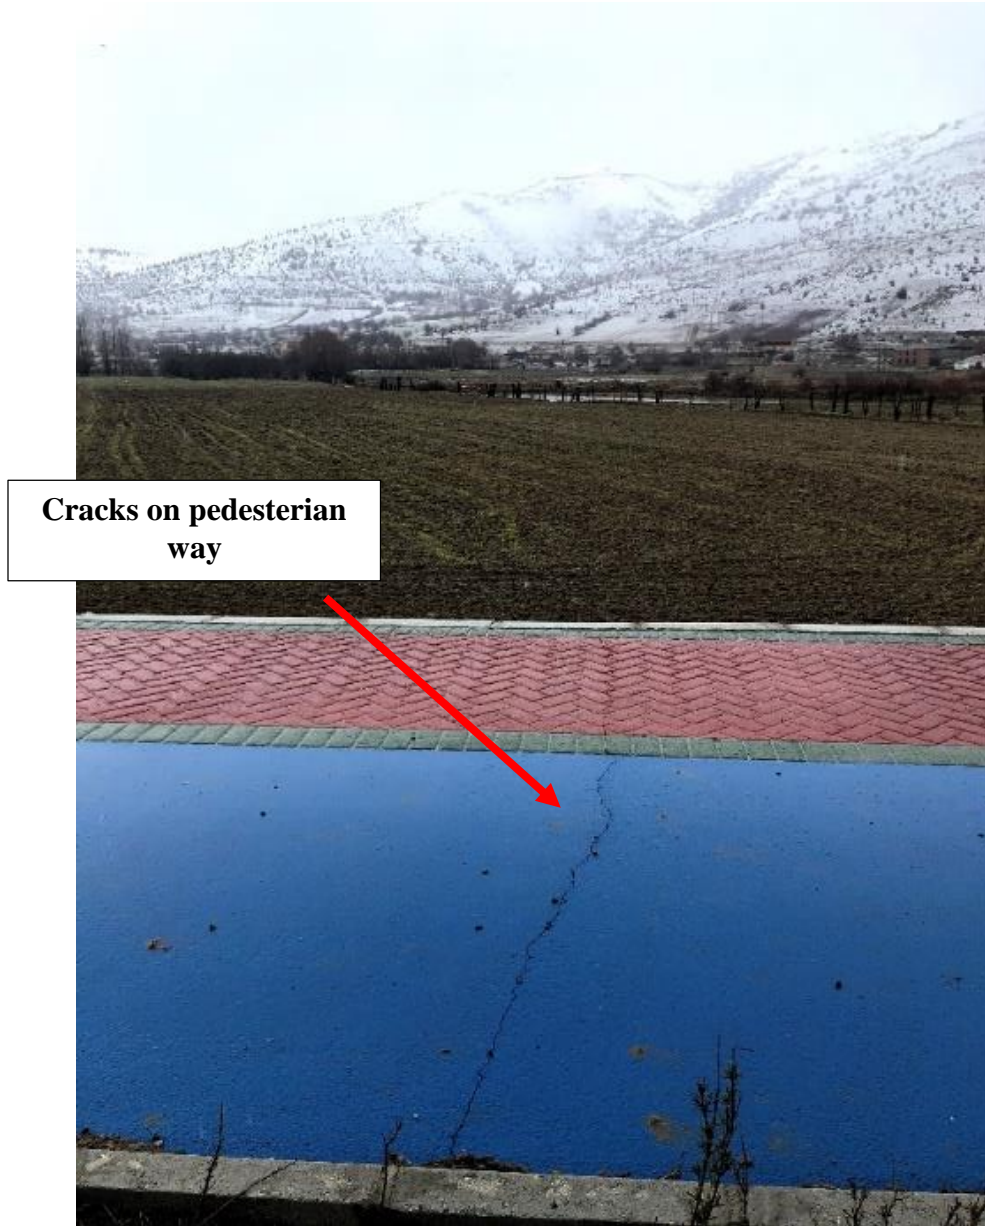
A crack was observed on the sidewalk near to Sivrice road as presented in Figure 4.11. The orientation of the cracking does not support a slope instability problem, which may be interpreted as an old crack existing before the earthquake.

Figure 4.11. Clayey site, no signs of failure
(38°28'10.0"N 39°17'03.6"E / 31.01.2020 / 11:56)

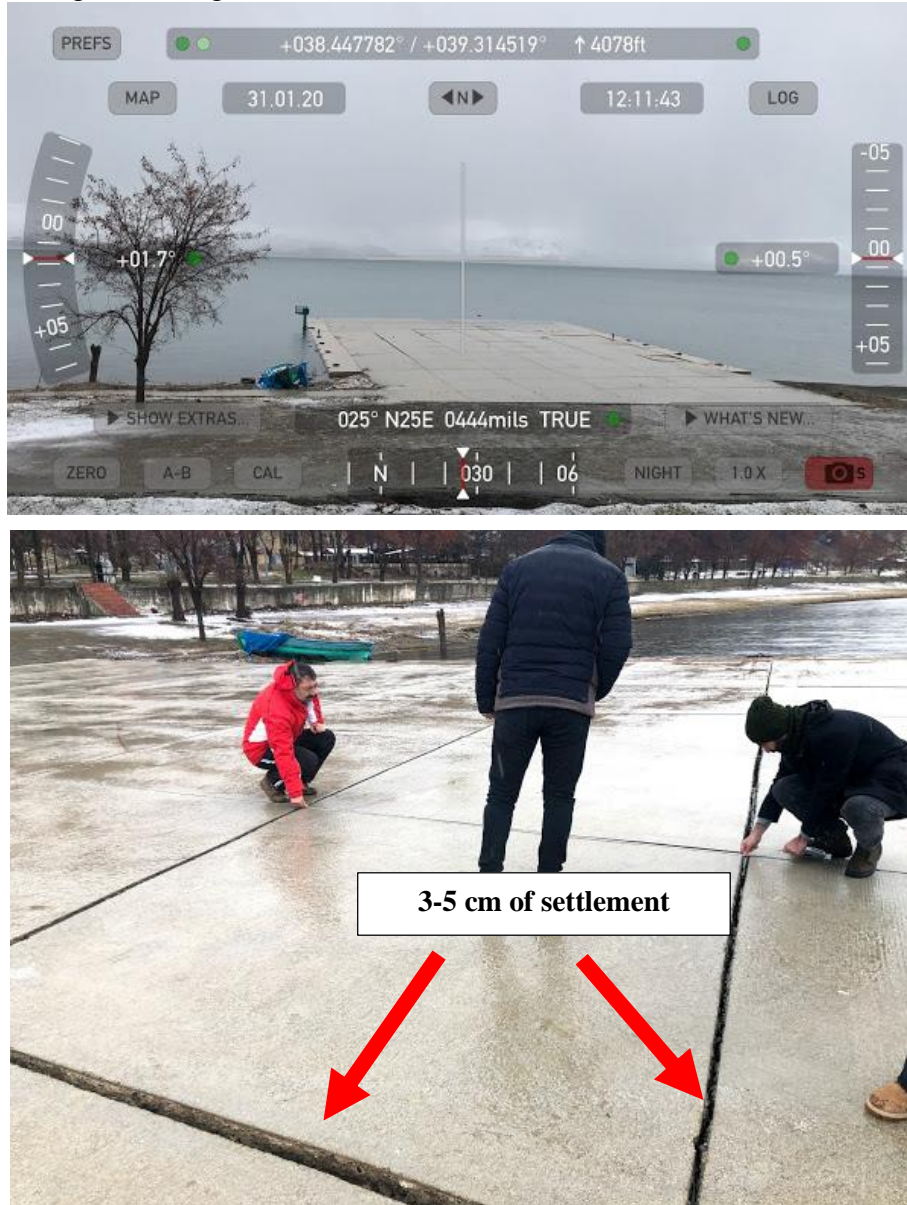
Seismically-induced lateral spreading and volumetric settlements were observed on the natural beach of Hazar Lake shoreline and Sivrice dock. Observed ground failure was mapped and discussed in a detailed manner in Section 4.7. Distribution of volumetric settlement and lateral displacements are mapped as shown in Figures 4.12 to 4.19, respectively. Next to the lake beach, where liquefaction manifestation is observed, a neighboring beach has exhibited no signs of ground failure, as given in Figure 4.20 and 4.21.

Figure 4.12. Seismically-induced volumetric settlement in the dock of Hazar Lake
(38°28'10.0"N 39°17'03.6"E / 31.01.2020 / 12:11 & 38°26'53.2"N 39°18'53.4"E / 31.01.2020 / 12:14)

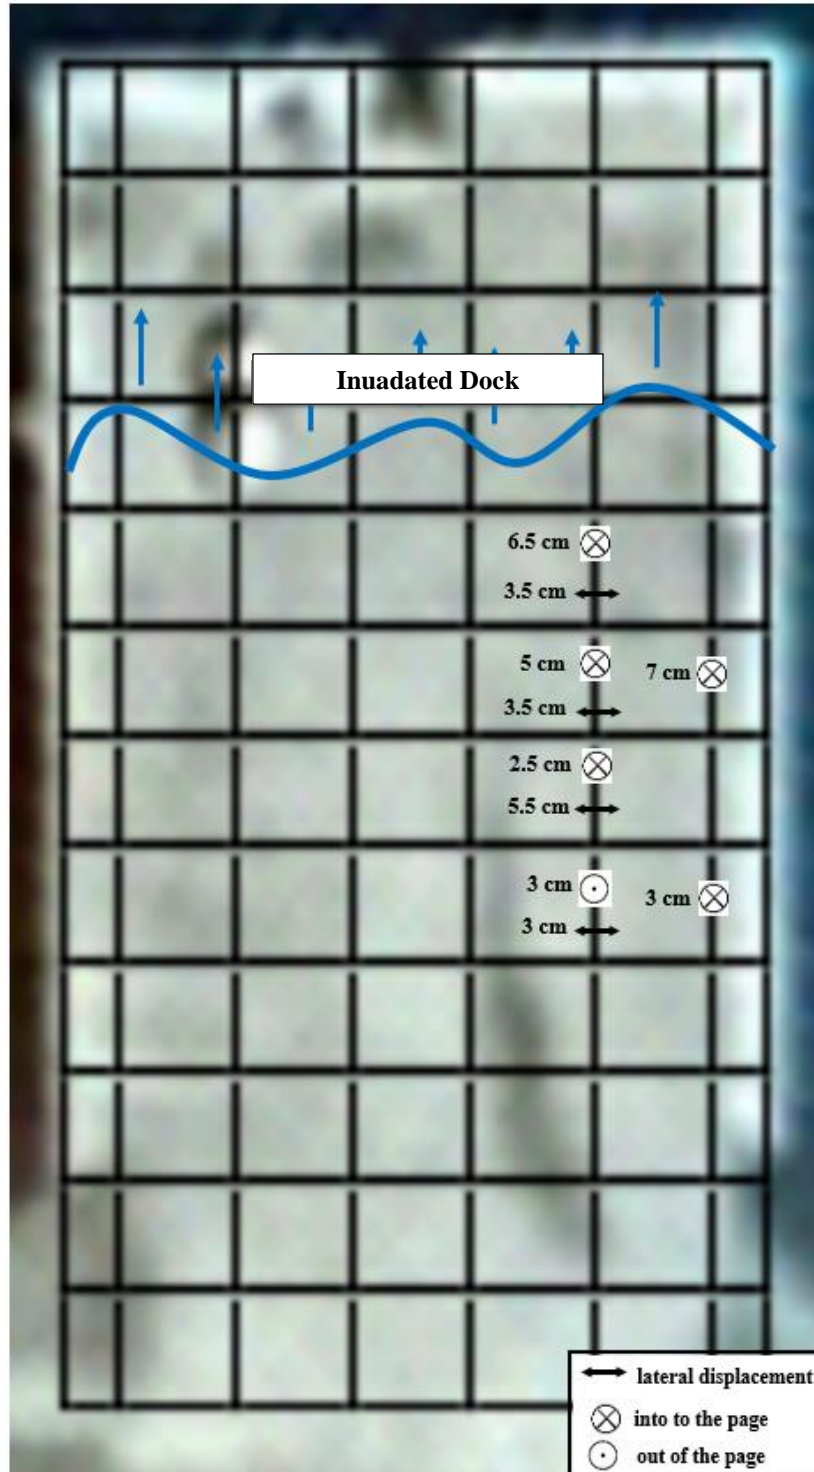
Figure 4.14. Displacements observed on reinforced concrete dock blocks

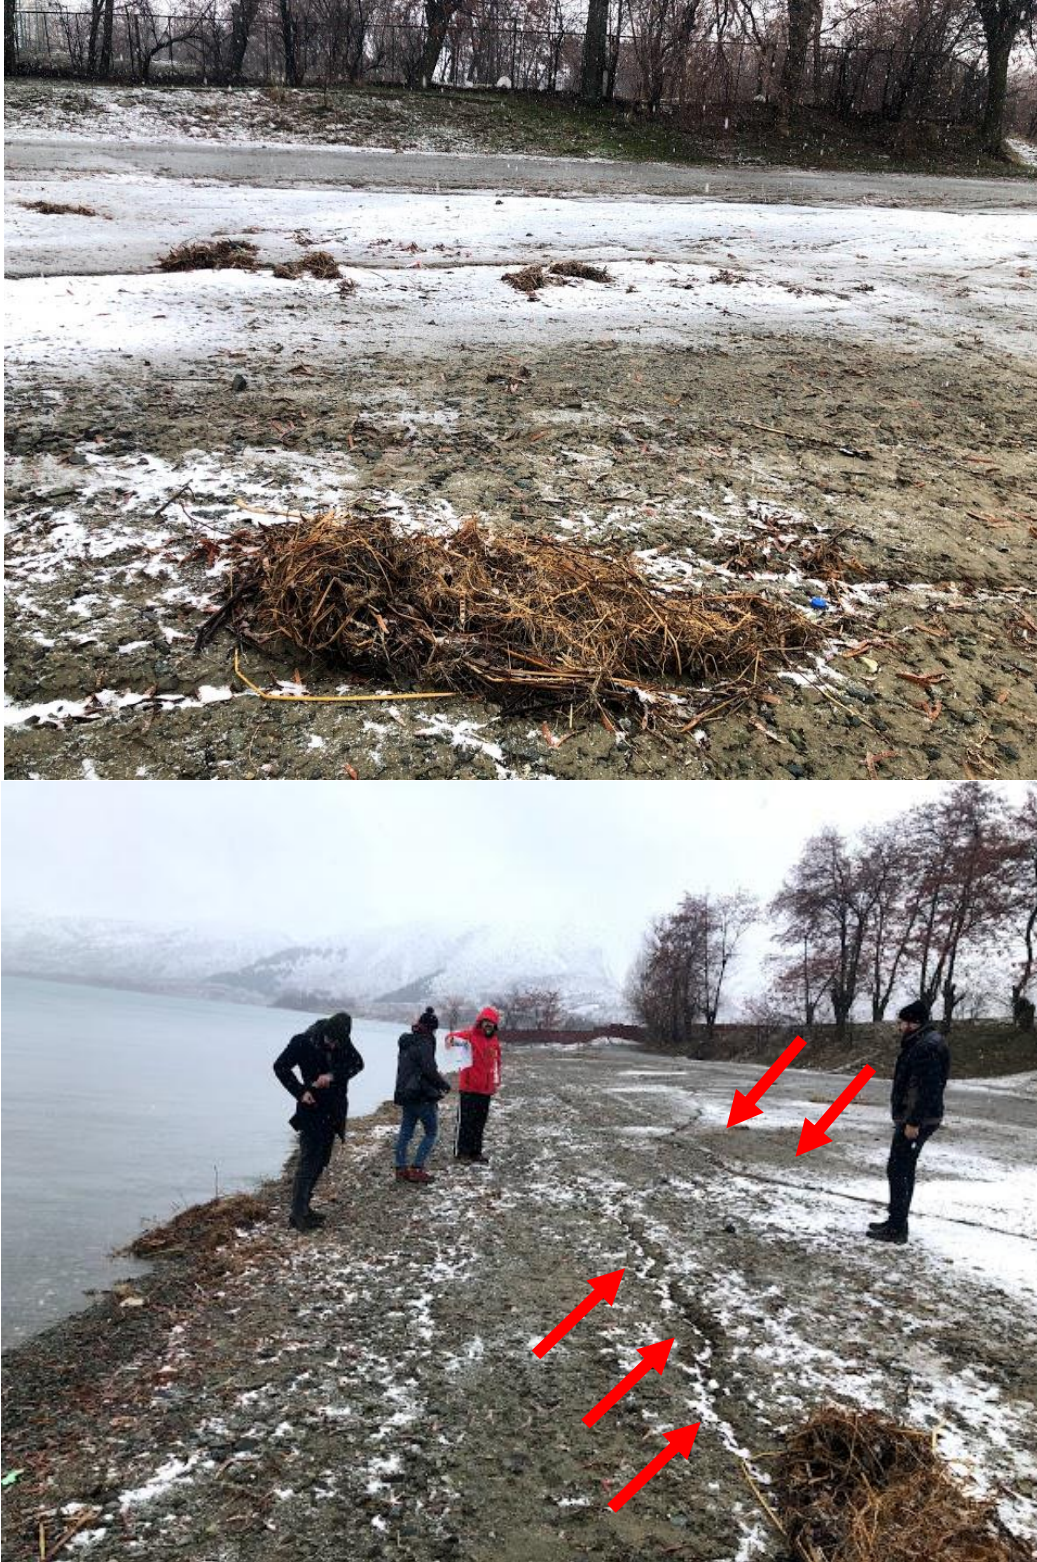
Figure 4.15. Seismically-induced lateral spreading on the beach of Hazar Lake
($38^{\circ}26'53.7''N$ $39^{\circ}18'54.2''E$ / 31.01.2020 / 12:21 & $38^{\circ}26'50.7''N$ $39^{\circ}18'56.9''E$ / 31.01.2020 / 12:21)

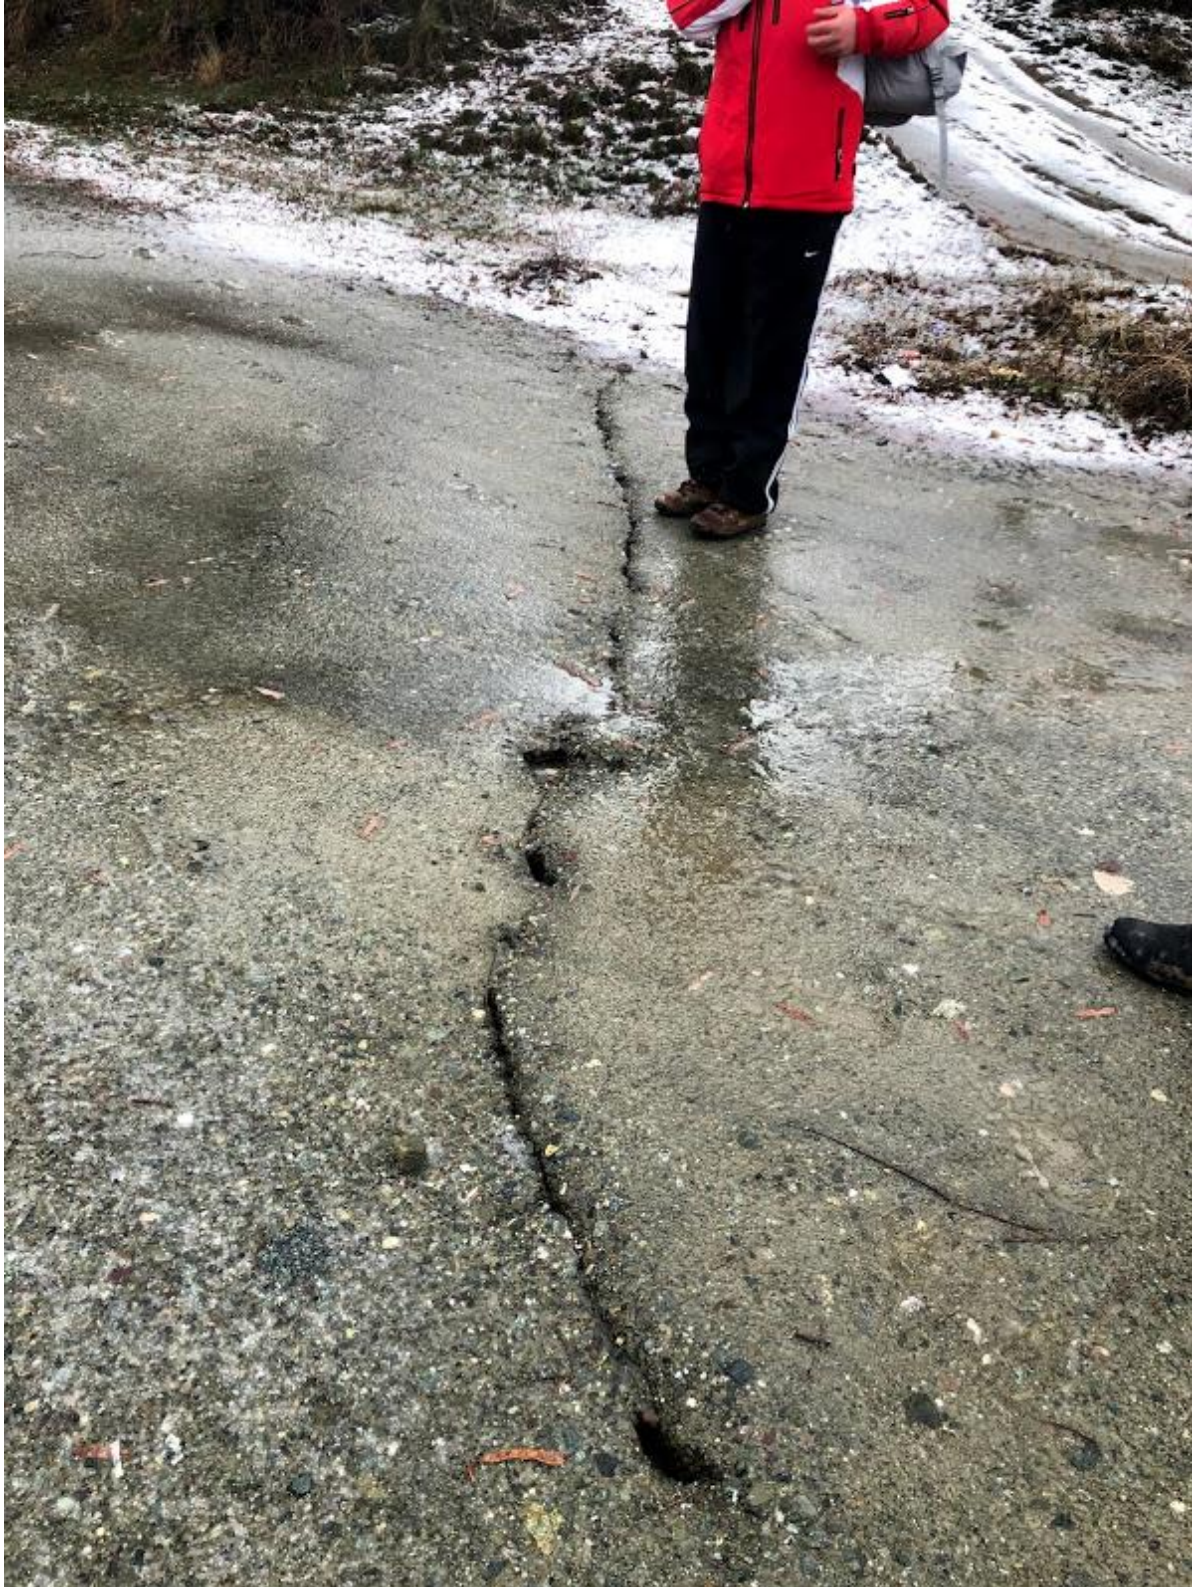
Figure 4.18. Another view of seismically-induced lateral spreading cracks
(38°26'50.7"N 39°18'55.4"E / 31.01.2020 / 12:36)

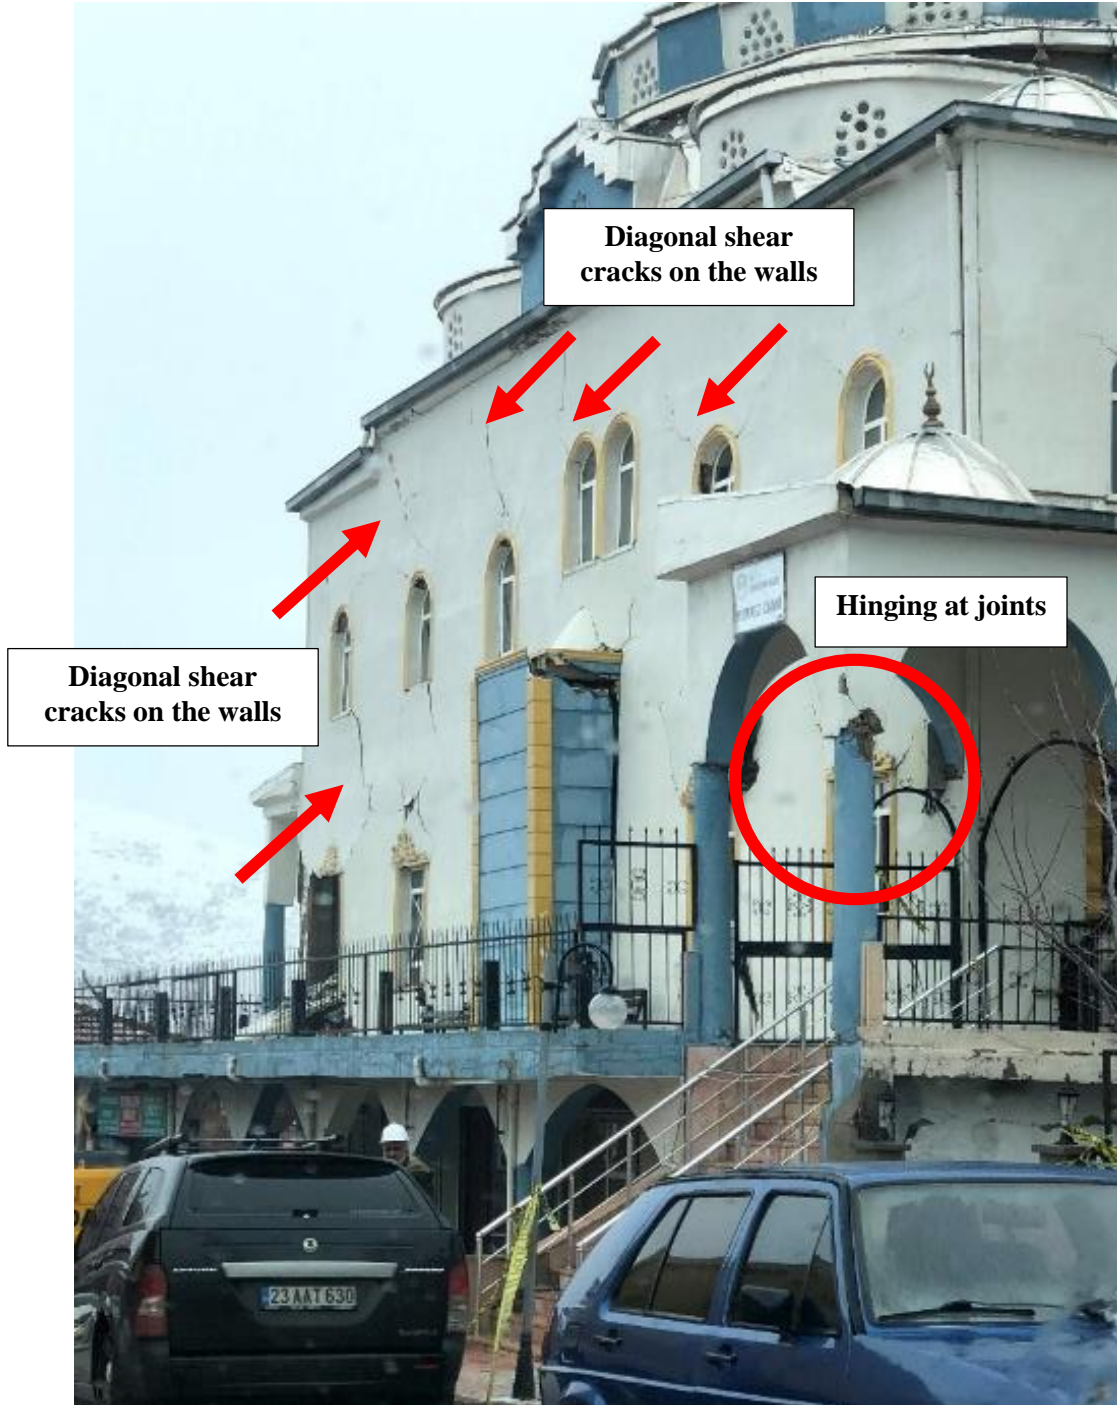
A structurally damaged Mosque located in Sivrice is shown in Figure 4.22.

Figure 4.22. A view of a damaged Mosque at Sivrice (Merkez Camii)
($38^{\circ}26'54.2''N$ $39^{\circ}18'34.6''E$ / 31.01.2020 / 13:25)

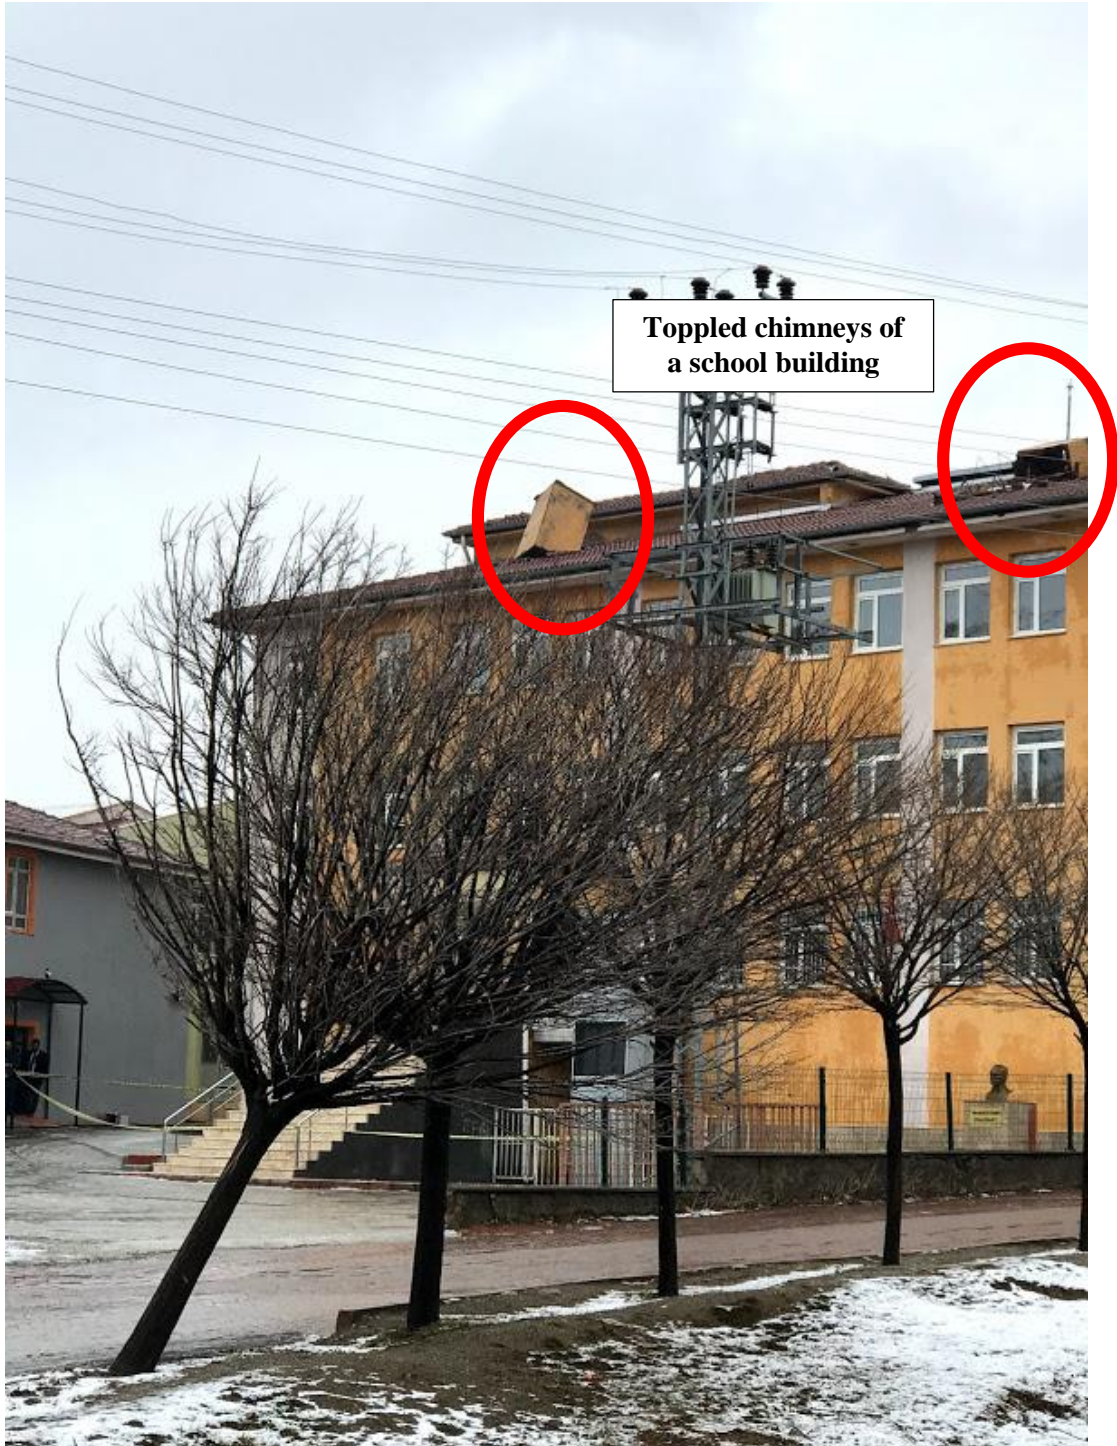
Toppled chimneys were observed as presented in Figure 4.24 and Figure 4.25. These failures show the intensity of shaking observed at the site, indicating a Mercalli intensity scale of VIII.

Figure 4.24. Toppled chimneys in Sivrice
(38°26'49.6"N 39°18'32.9"E / 31.01.2020 / 13:29)

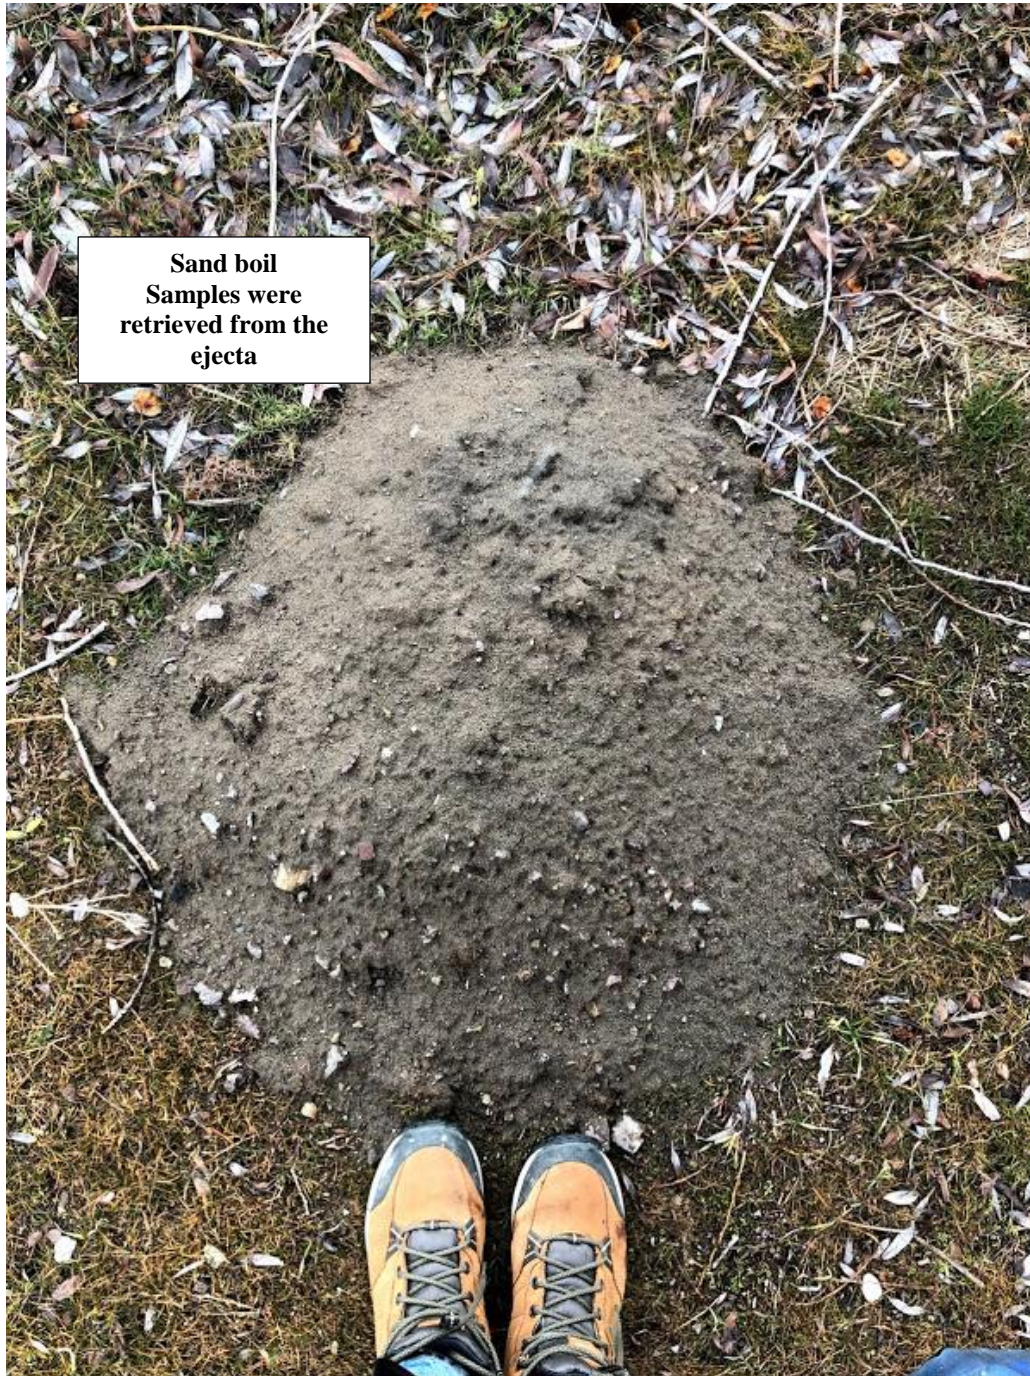
Figure 4.32. Sand boil observed in Stop 8
(38°27'49.7"N 39°24'01.1"E / 31.01.2020 / 14:38)

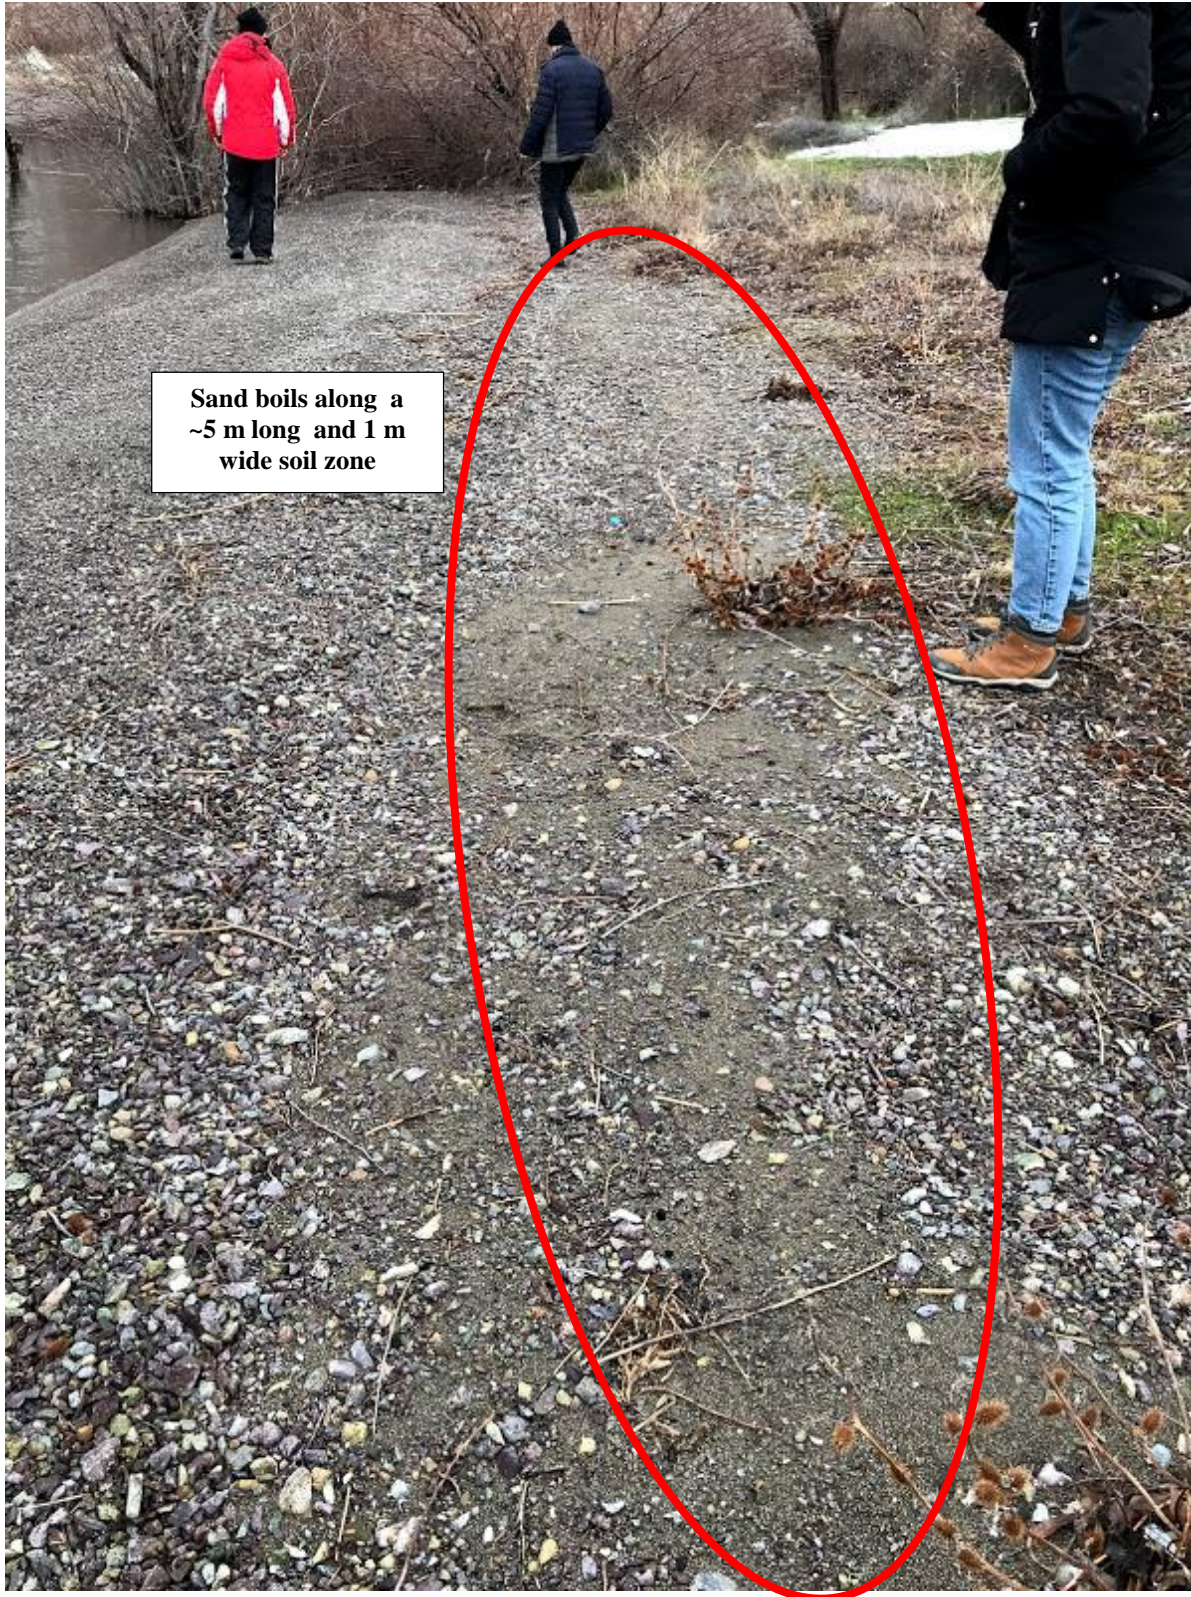
Figure 4.33. Sand boils observed in Stop 8
(38°27'49.8"N 39°24'03.0"E / 31.01.2020 / 14:14)

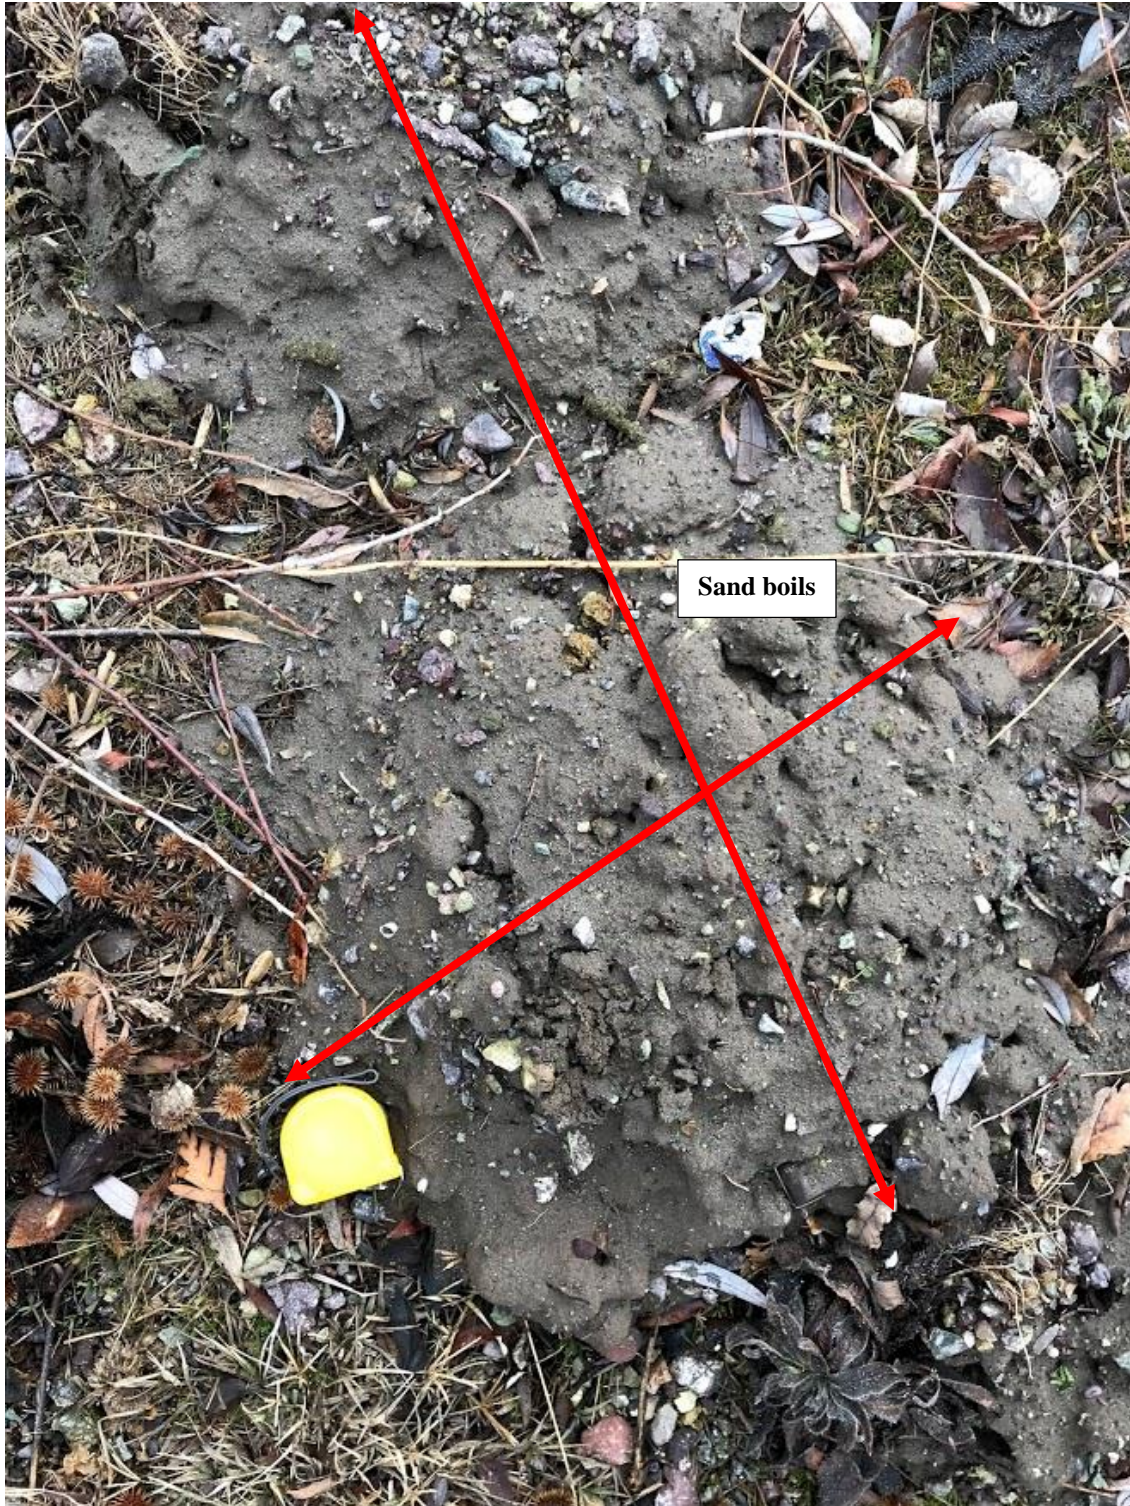
Figure 4.34. Sand boils observed in Stop 8
(38°27'49.9"N 39°24'02.8"E / 31.01.2020 / 14:17)

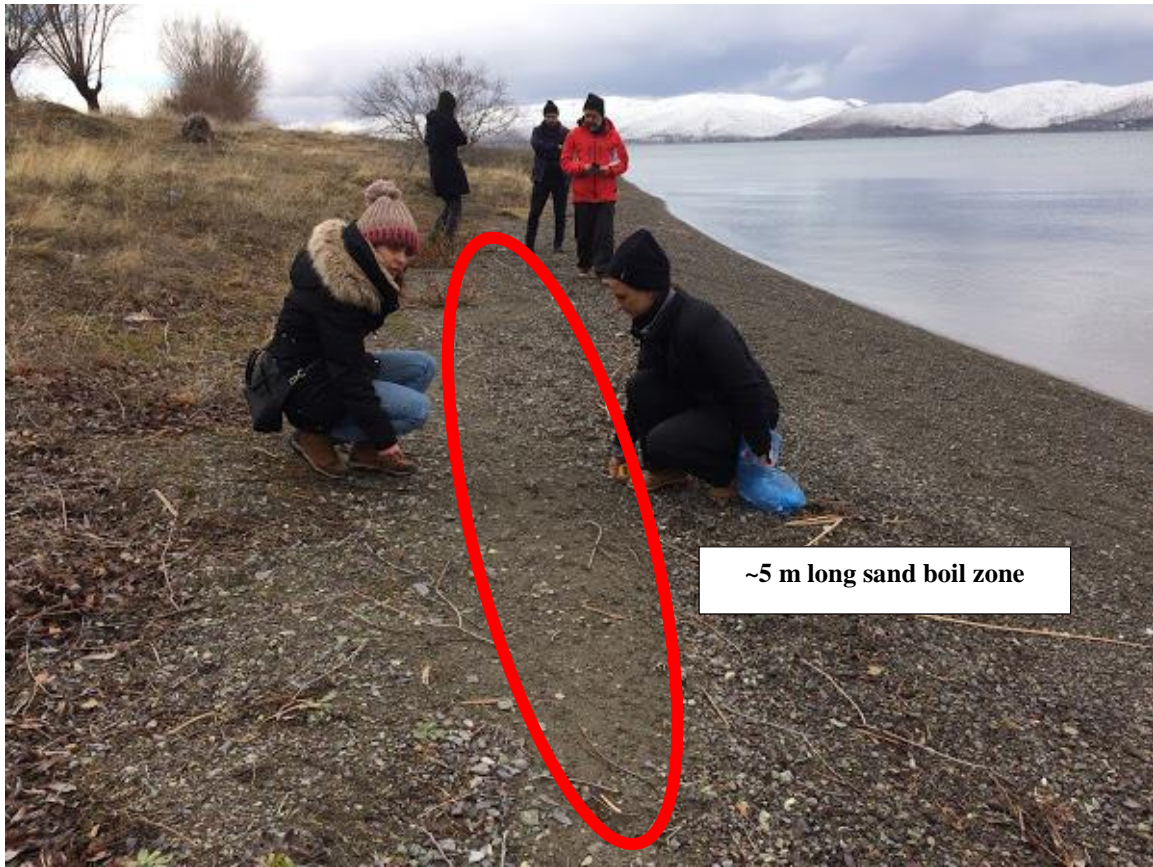
Figure 4.36. A line of sand boils observed in Stop 8
($38^{\circ}27'49.7''N$ $39^{\circ}24'03.3''E$ / 31.01.2020 / 14:16)

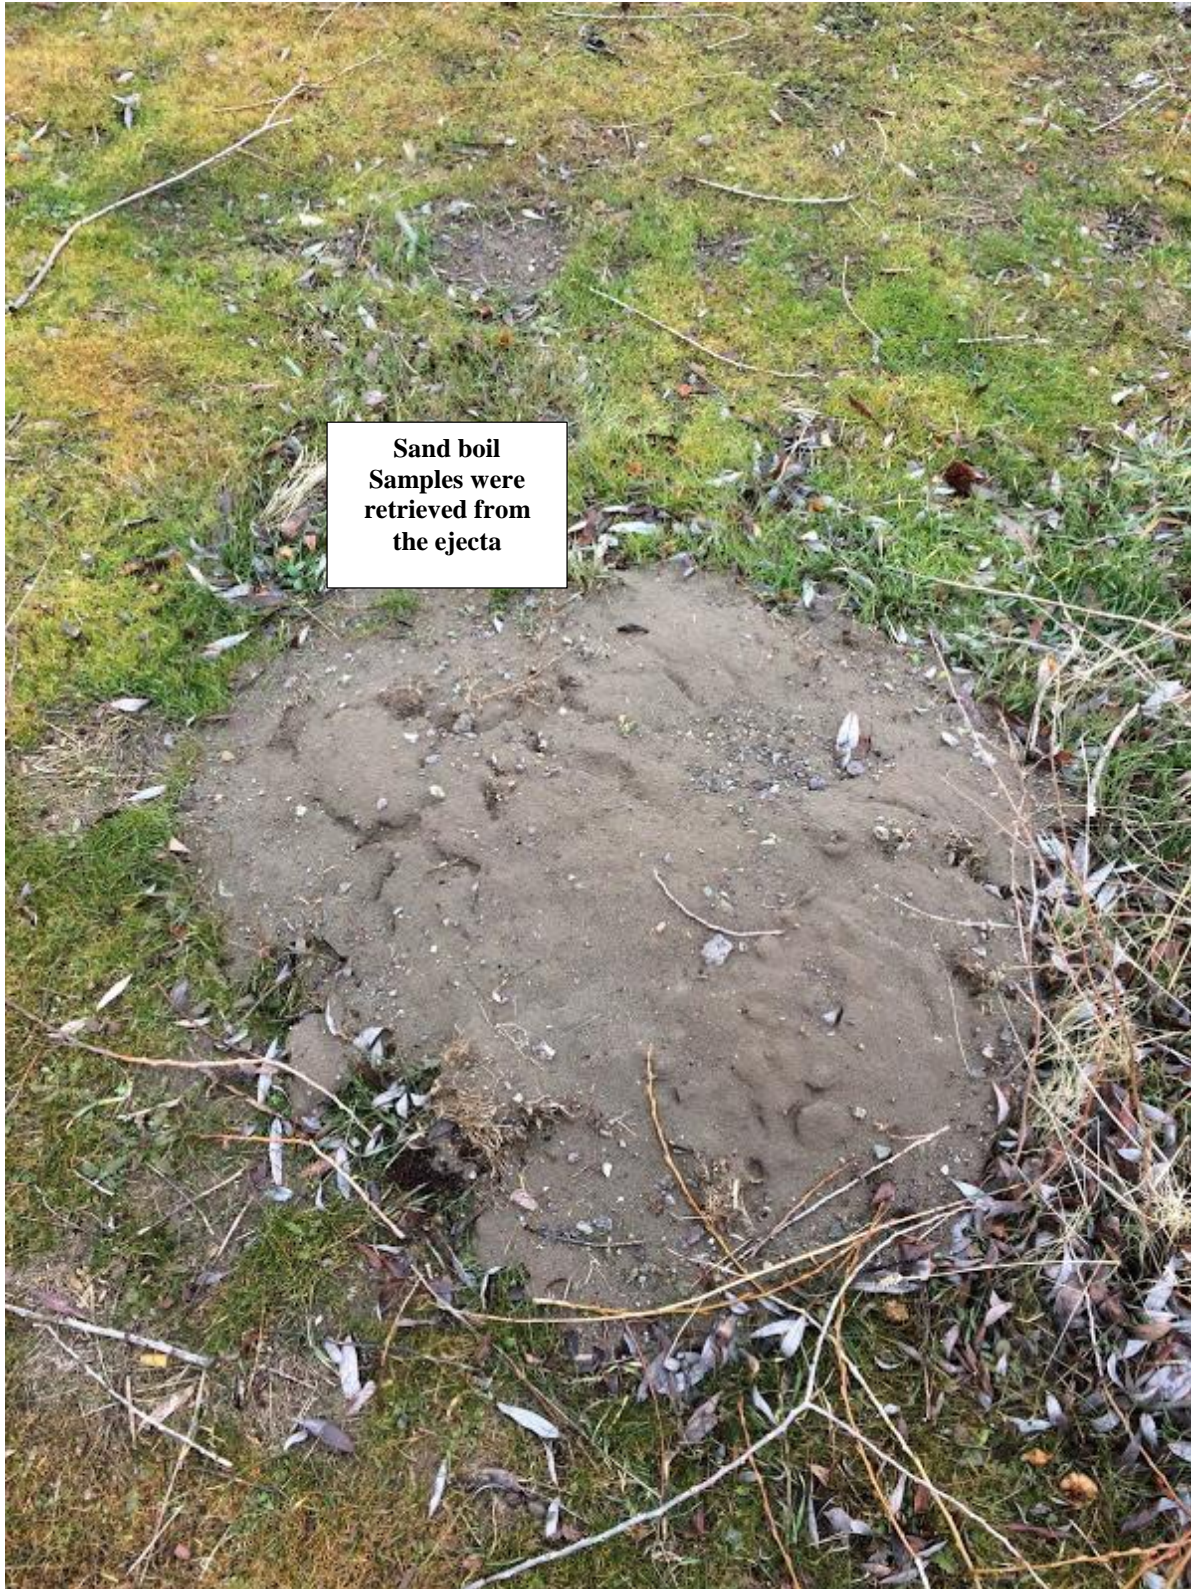
Figure 4.37. Sand boil observed in Stop 8
(38°27'49.6"N 39°24'01.7"E / 31.01.2020 / 14:38)
