**January 24, 2020 Elazığ-Sivrice Earthquake ($M_w=6.8$)
Reconnaissance Study Report**

**MIDDLE EAST TECHNICAL UNIVERSITY
EARTHQUAKE ENGINEERING RESEARCH CENTER**

REPORT NO: METU/EERC 2020-01

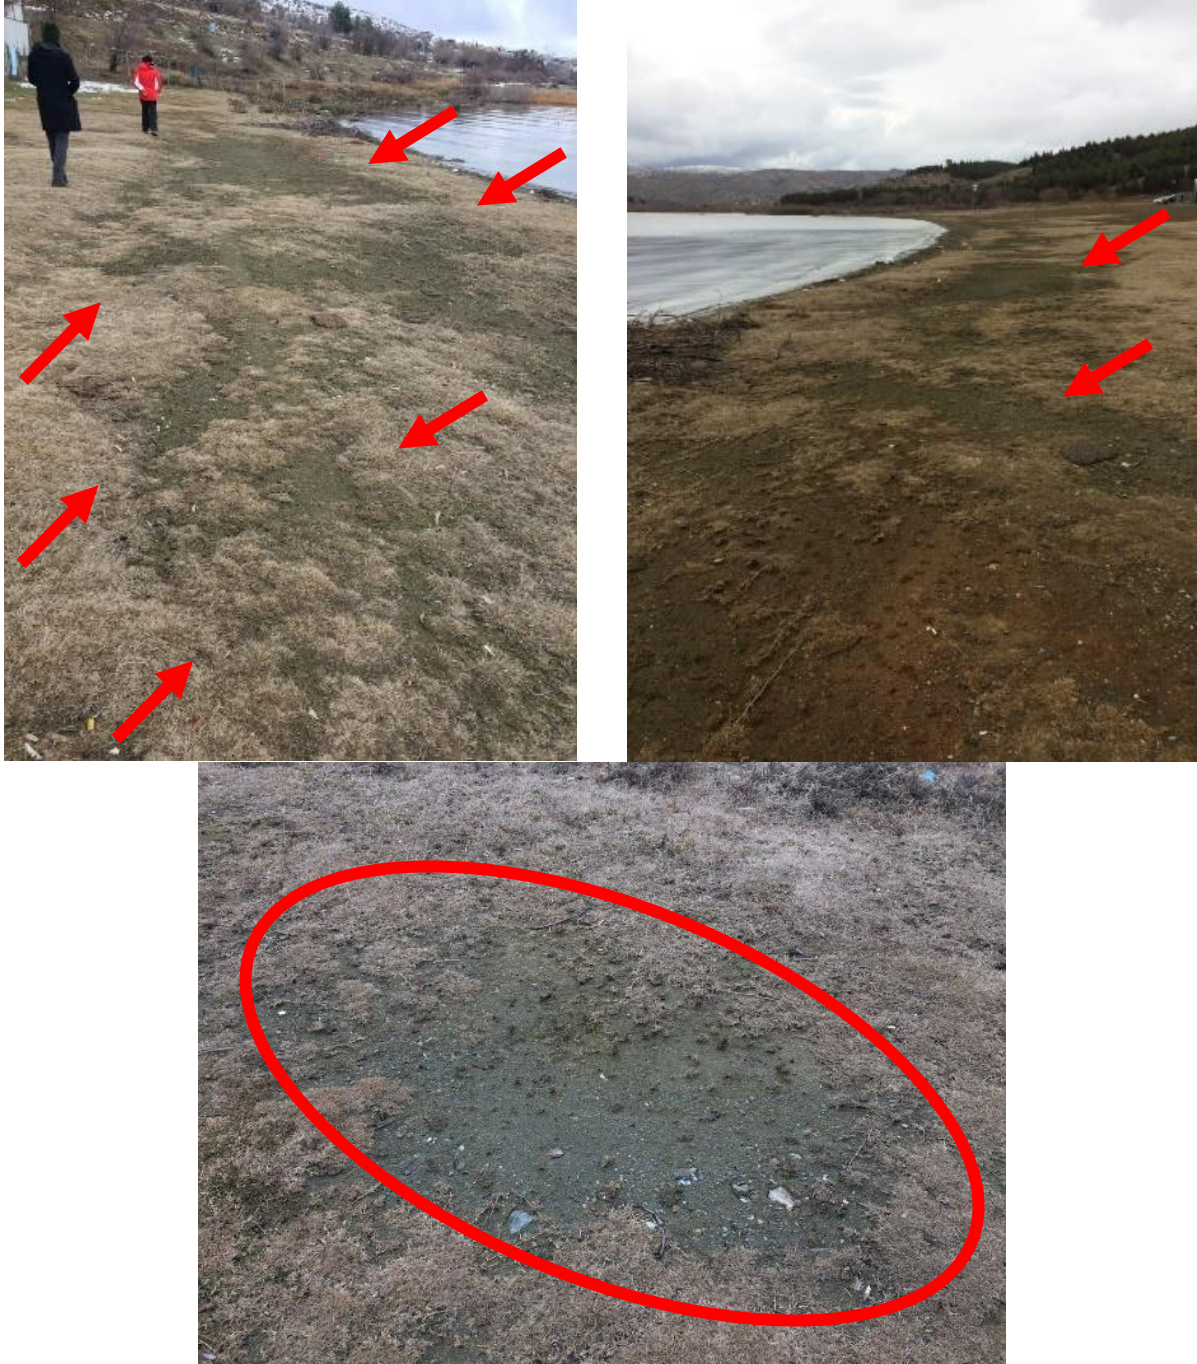
Figure 4.46. Sand boils observed
(38°29'58.5"N 39°30'24.6"E / 31.01.2020 / 15:29 & 38°29'57.6"N 39°30'23.9"E / 31.01.2020 / 15:30
& 38°29'57.7"N 39°30'24.0"E / 31.01.2020 / 15:30)

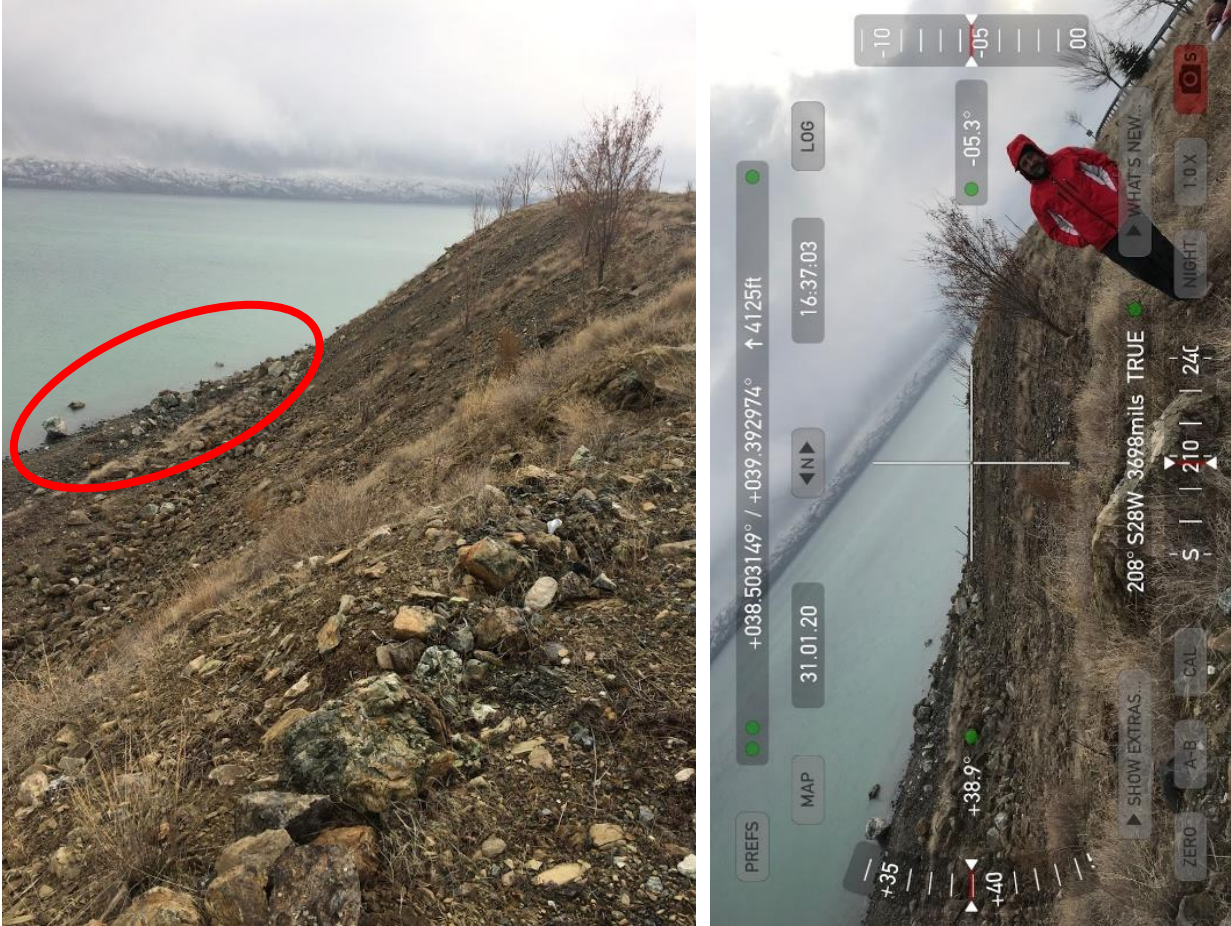
Figure 4.54. Rockfalls at 14th stop
($38^\circ30'11.4''N$ $39^\circ23'34.9''E$ / 31.01.2020 / 16:37 & $38^\circ30'11.3''N$ $39^\circ23'34.7''E$ / 31.01.2020 / 16:37)

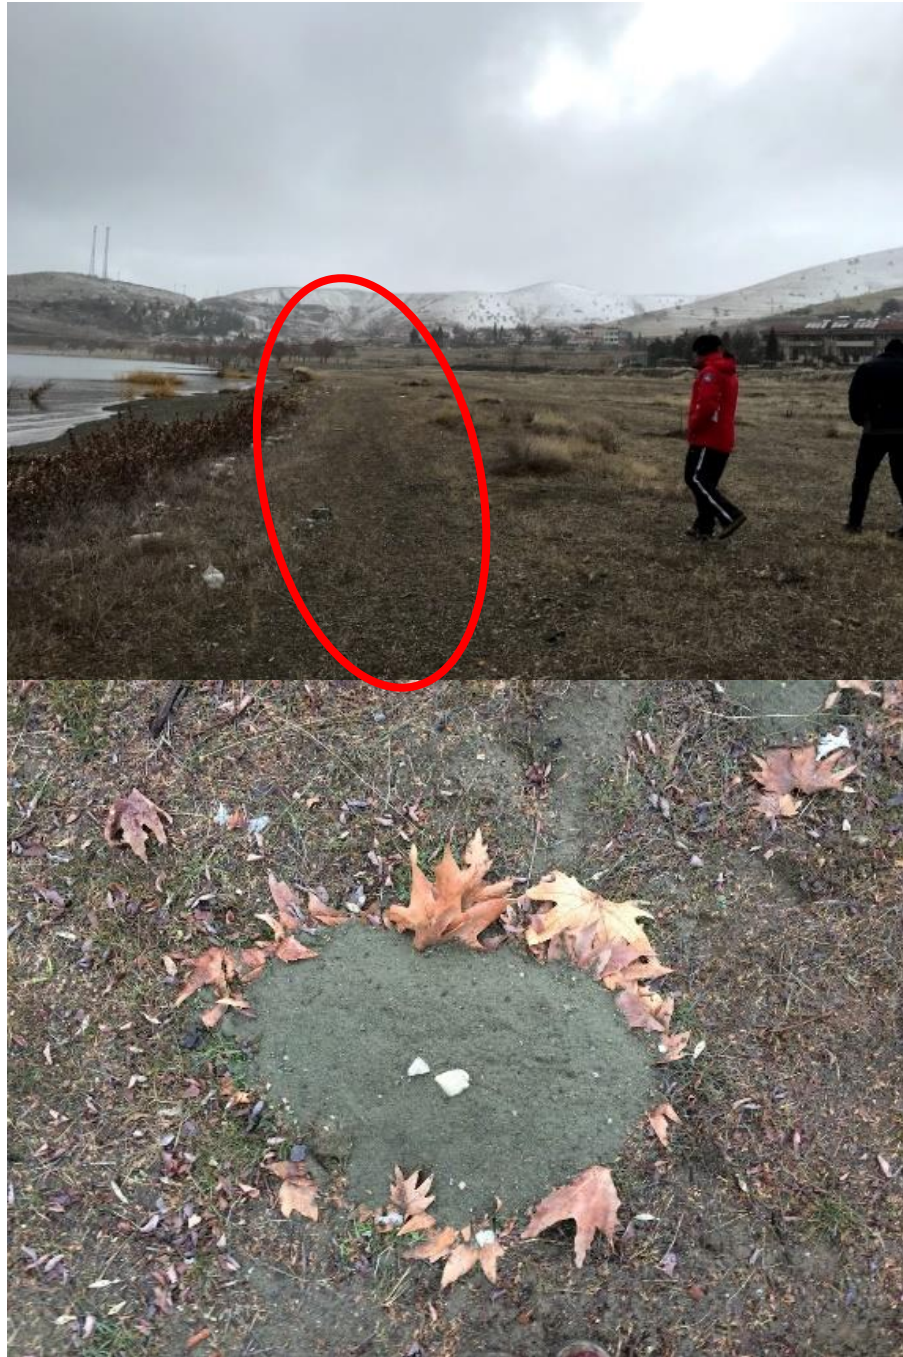
Figure 4.55: Seismic soil liquefaction-induced sand boils at Stop 15
(38°29'32.3"N 39°21'03.8"E / 31.01.2020 / 16:57 & 38°29'34.5"N 39°21'03.6"E / 31.01.2020 / 17:11)

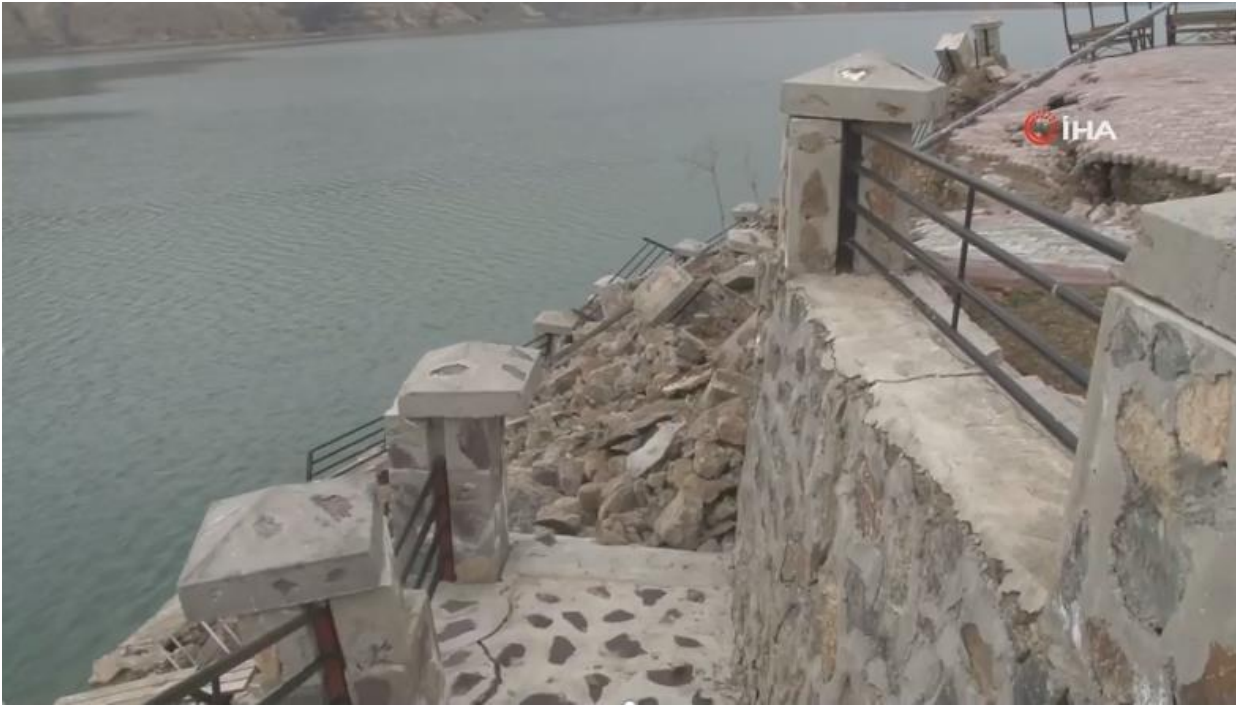
Figure 4.58. Doğanyol Port Failure adapted from IHA report
(38°33'34.6"N 39°04'10.6"E)

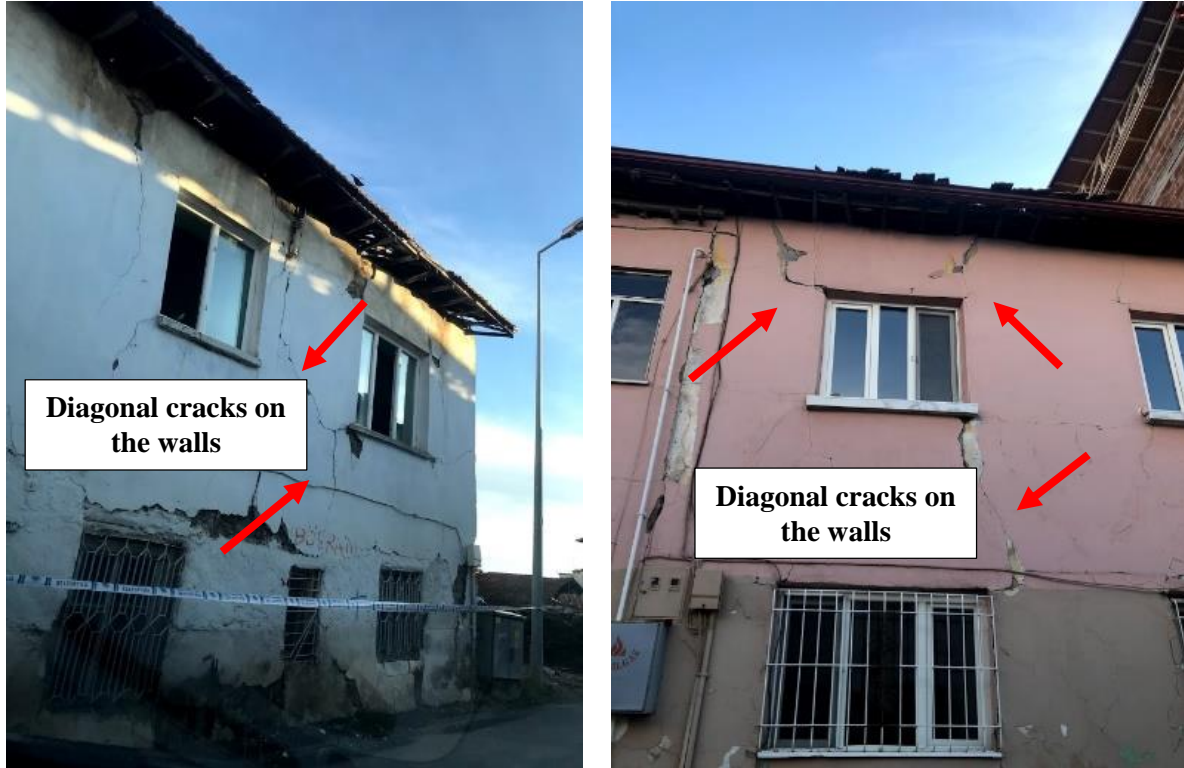
Figure 4.62. Cracks on the wall of a residential building in Battalgazi Village
(38°25'21.7"N 38°21'56.9"E / 01.02.2020 / 8:30 & 38°25'24.4"N 38°21'53.6"E / 01.02.2020 / 8:28)

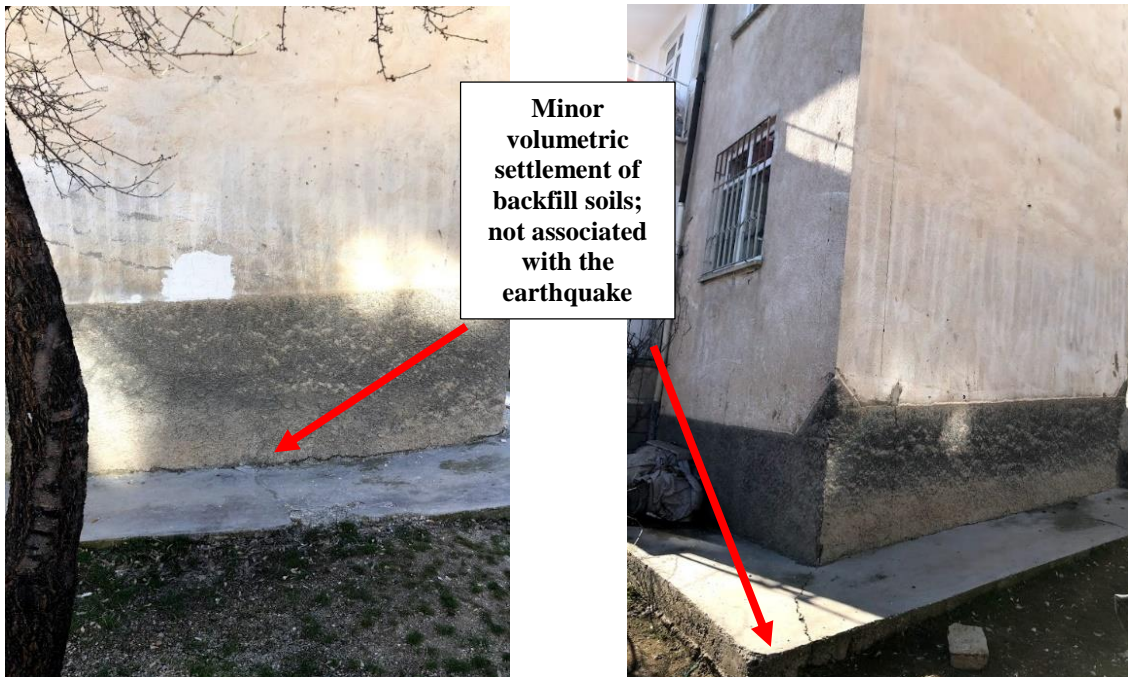
Figure 4.94. Volumetric settlement at the foundation of a residential building
(38°39'29.8"N 39°08'58.4"E / 01.02.2020 / 14:29 & 38°39'28.9"N 39°09'01.9"E / 01.02.2020 / 14:30)

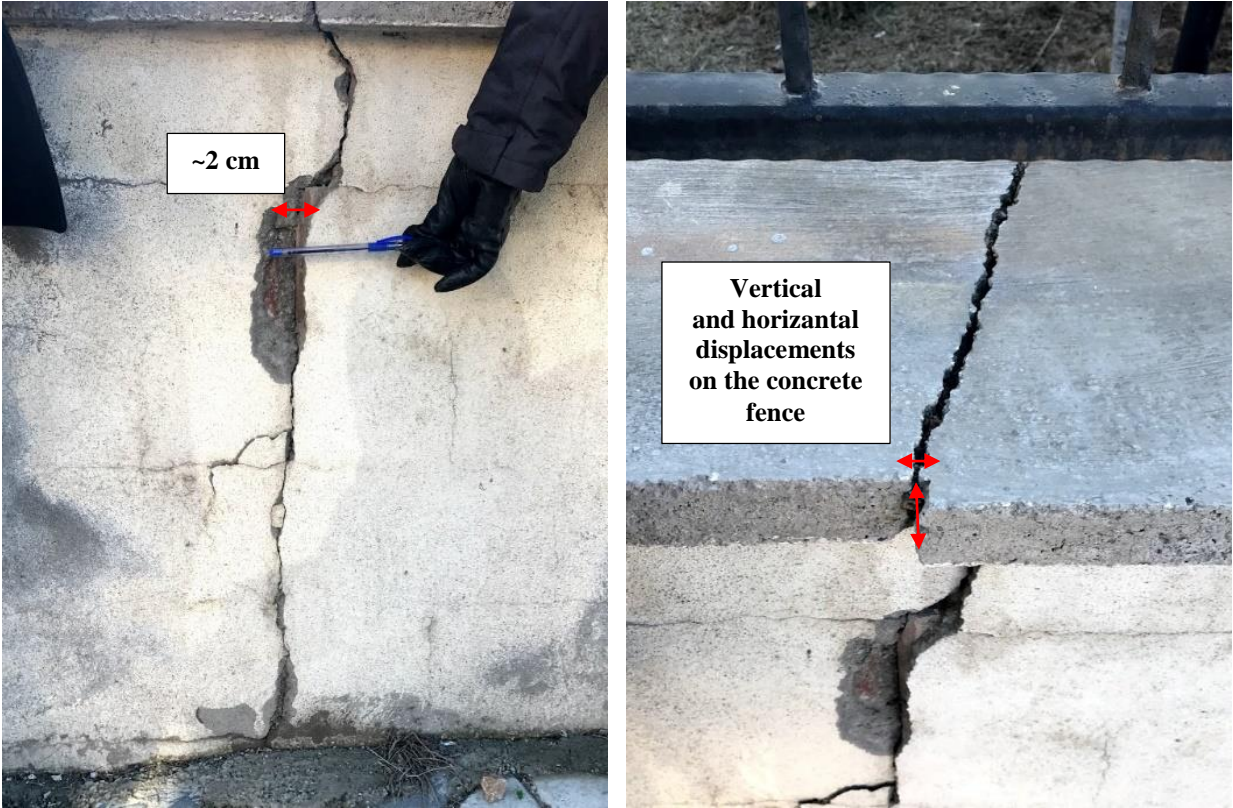
Figure 4.102. A crack on a concrete fence in Sürsürü district of Elazığ city center
(38°40'05.5"N 39°11'12.4"E / 01.02.2020 / 15:28 & 38°40'05.5"N 39°11'12.4"E / 01.02.2020 / 15:28)

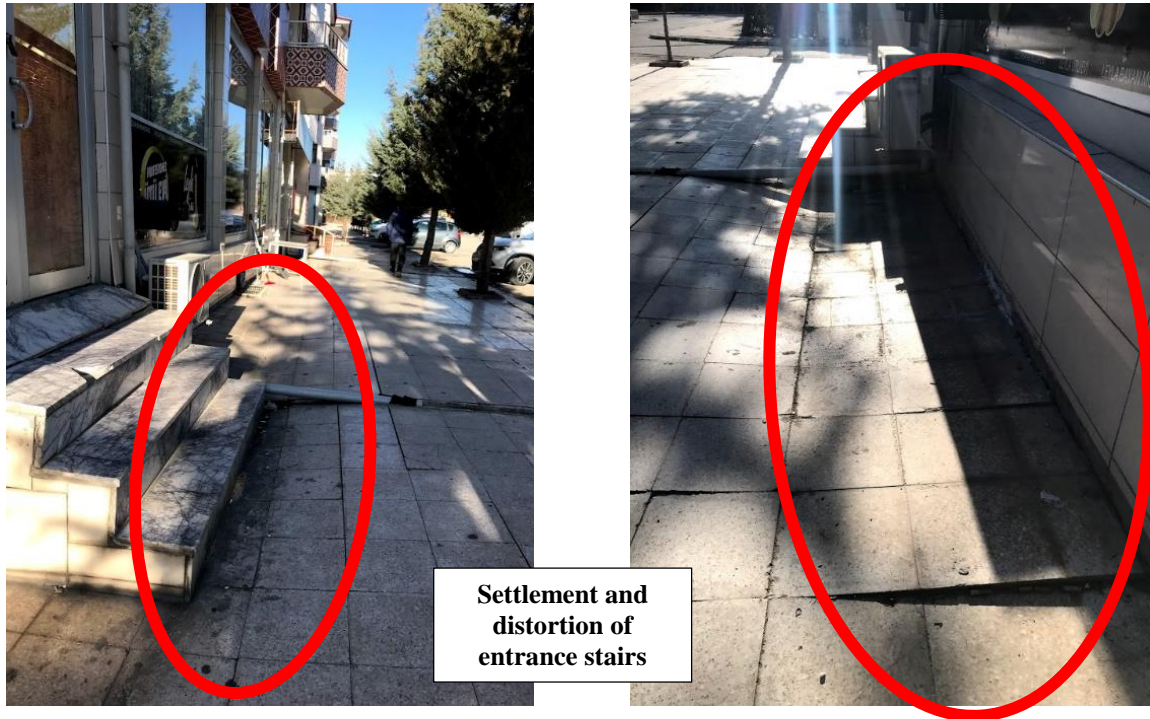
Figure 4.104. Settlements observed
($38^{\circ}40'05.7''N$ $39^{\circ}11'09.6''E$ / 01.02.2020 / 15:57 & $38^{\circ}40'05.1''N$ $39^{\circ}11'10.0''E$ / 01.02.2020 / 15:57)

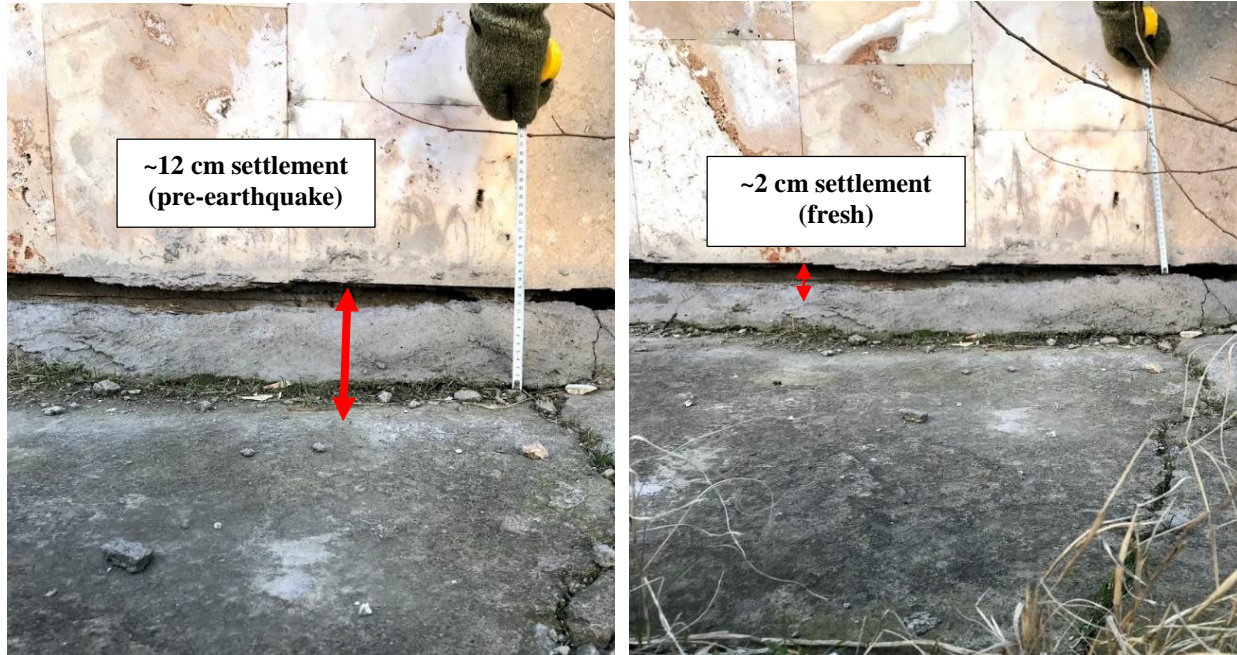
Figure 4.105. Settlement observed.
($38^{\circ}40'07.0''N$ $39^{\circ}11'04.8''E$ / 01.02.2020 / 15:47)

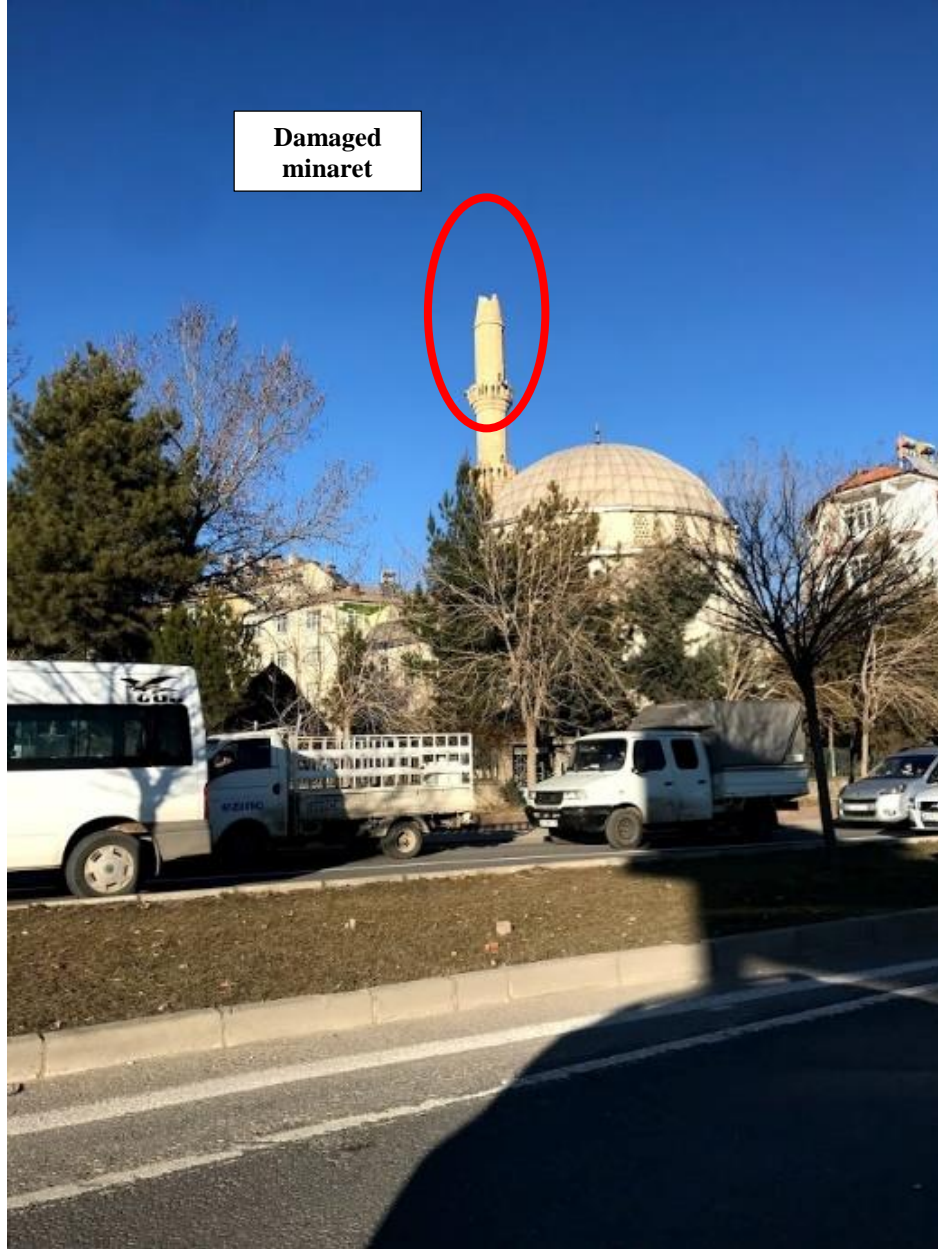
Figure 4.108. Damaged Minaret of Rüstem Paşa Yol Üstü Mosque
in Rüstem Paşa district of Elazığ city center
(38°39'58.4"N 39°13'54.7"E / 01.02.2020 / 16:22)

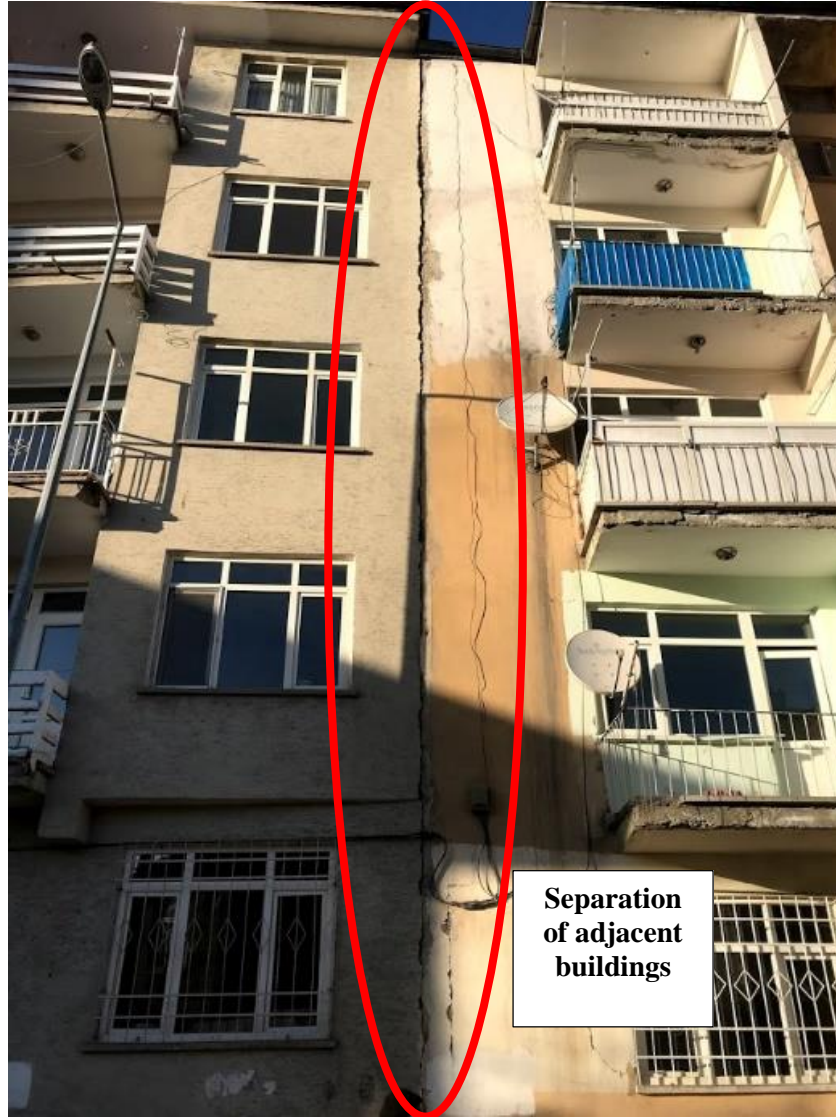
Figure 4.109. Longitudinal cracks observed on a building located in the Mustafa Paşa district ($38^{\circ}40'15.9''N$ $39^{\circ}13'59.9''E$ / 01.02.2020 / 16:34)

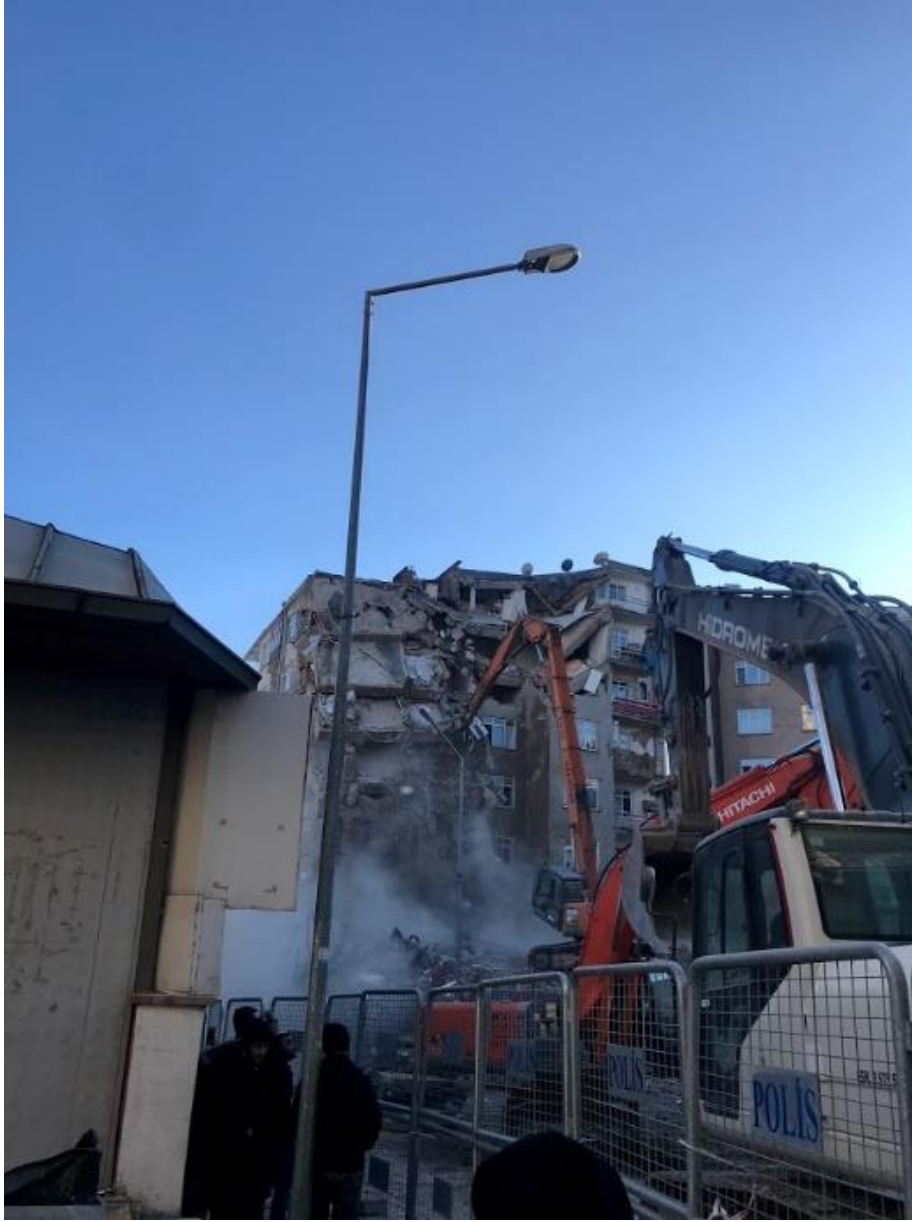
Figure 4.110. Demolishment of a heavily-damaged building in the Mustafa Paşa district of
Elazığ city center
(38°40'15.2"N 39°13'57.5"E / 01.02.2020 / 16:31)

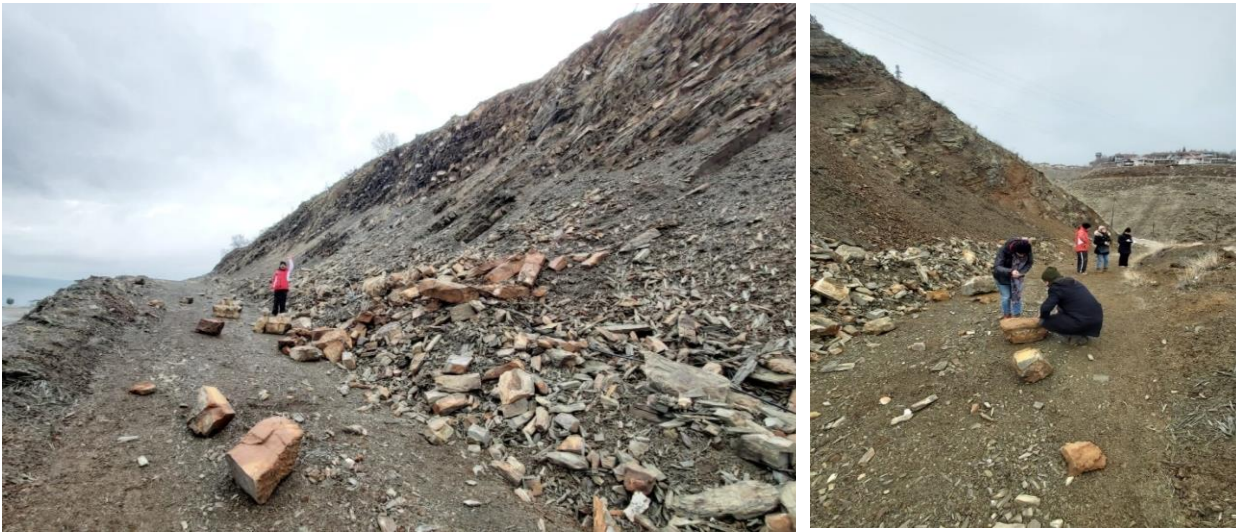
Figure 4.111. Rock falls observed at the shores of Hazar Lake at 13th stop
($38^\circ 31' 40.0''\text{N}$ $39^\circ 28' 01.5''\text{E}$ / 31.01. 2020 / 16:08)

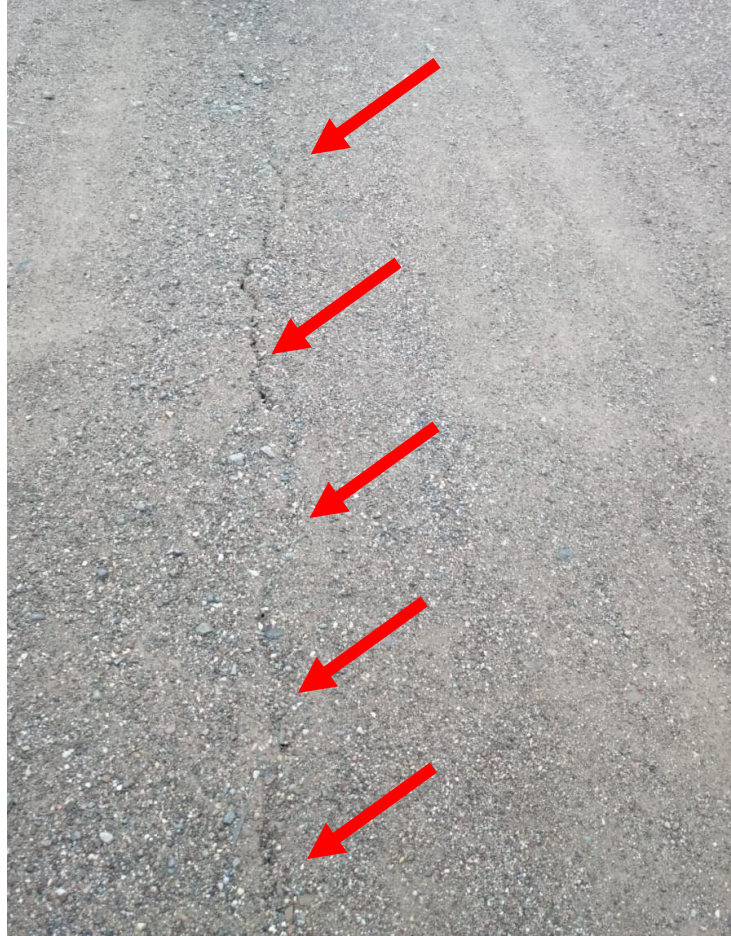
Figure 4.119. Longitudinal cracks on Dedeyolu Dam crest (DSİ)

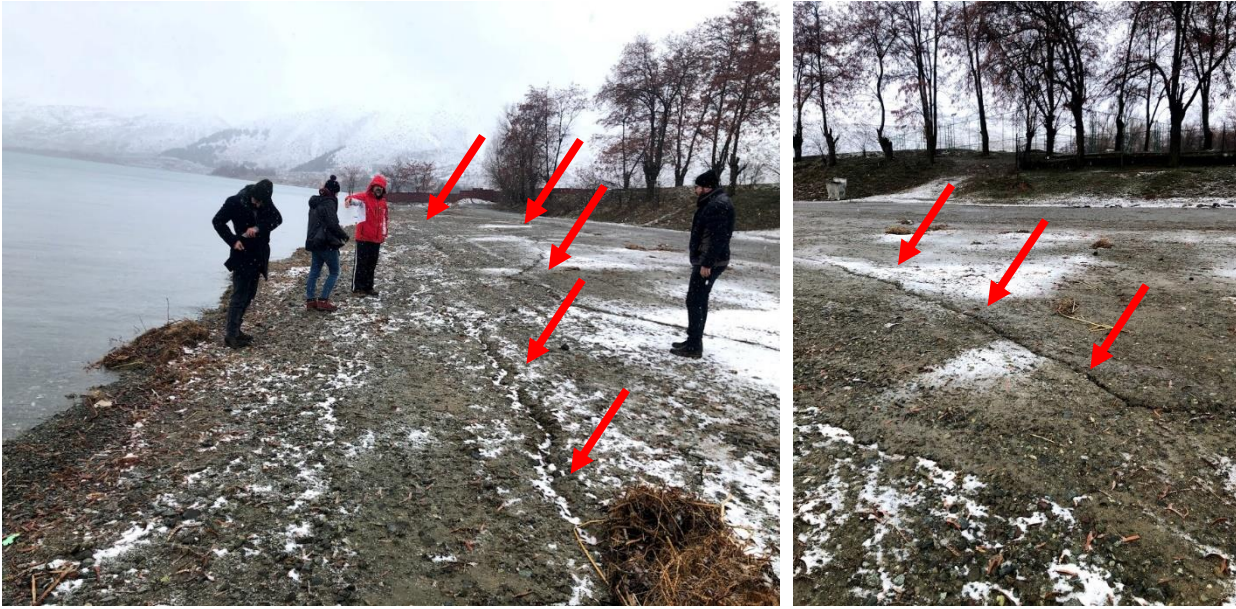
Figure 4.124. Deformations and cracks due to lateral spreading observed along
Hazar Lake (2nd stop)
($38^{\circ}26'50.7''N$ $39^{\circ}18'56.9''E$ / 31.01.2020 / 12:21 & $38^{\circ}26'50.5''N$ $39^{\circ}18'56.9''E$ / 31.01.2020 / 12:28)

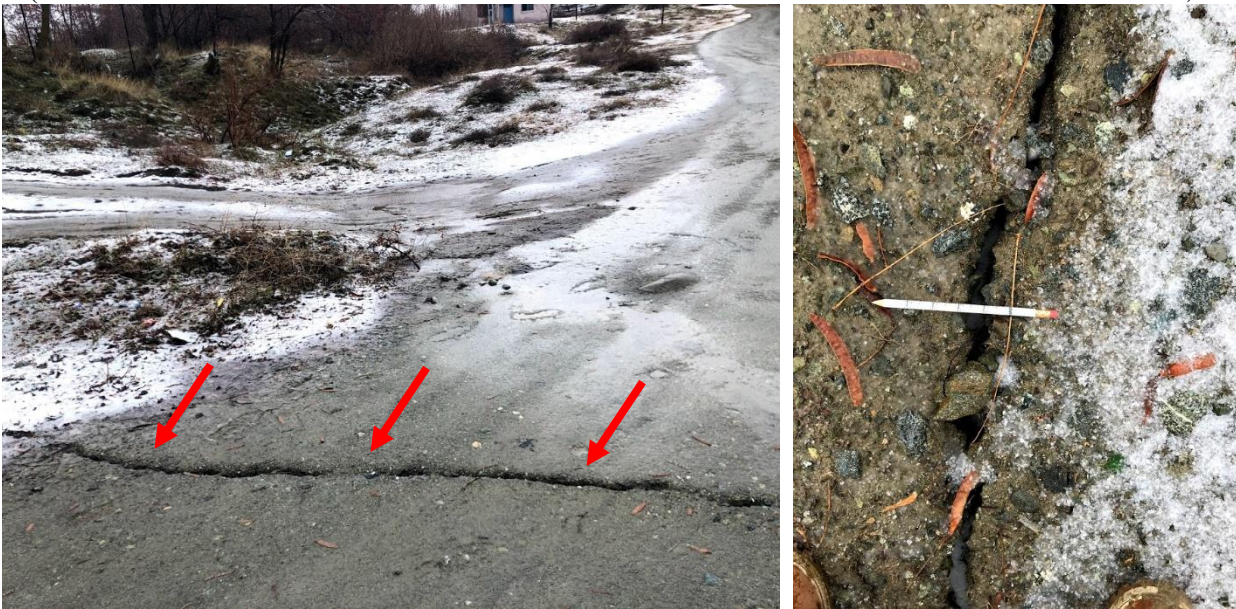
Figure 4.125. Deformations and cracks due to lateral spreading observed along
Hazar Lake (2nd stop)
($38^{\circ}26'50.8''N$ $39^{\circ}18'55.6''E$ / 31.01.2020 / 12:34 & $38^{\circ}26'50.3''N$ $39^{\circ}18'57.1''E$ / 31.01.2020 / 12:27)
