Chapter 1: Introduction

1.1 Background

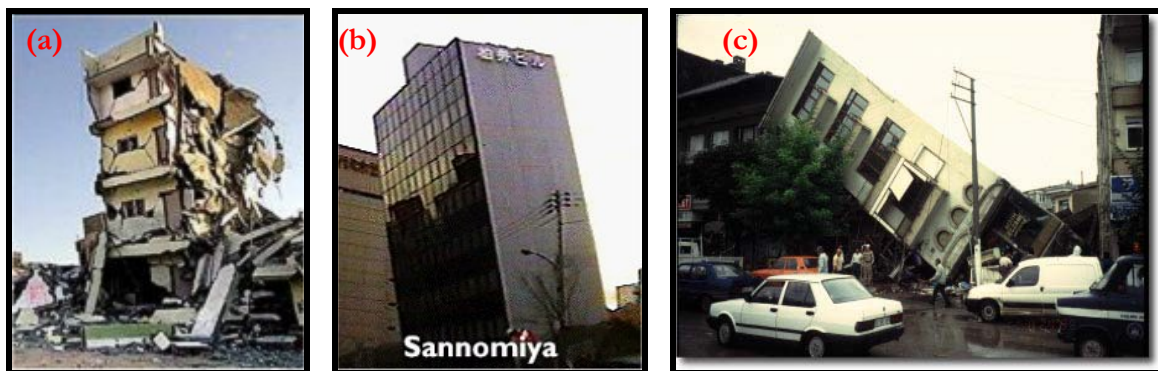
Figure 1.1: (a) Failure of a residential building during the 2001 Bhuj earthquake (India); (b): A highrise building during the 1995 Kobe earthquake, after U.C. Berkeley (1995); (c): Tilting of a building during the 1999 Koceli earthquake (Turkey), after EERI (1999).

Normally the failure of structures during earthquakes is the result of structural inadequacies, foundation failure, or a combination of both. Figure 1.1(a) shows the failure of a residential

building predominantly due to structural inadequacies such as poor ductility and improper beam-column detailing. On the other hand, the failures shown in Figures 1.1(b & c) are not due to any structural inadequacies but due to foundation failure. In such failures the soil supporting the foundation plays an important role.

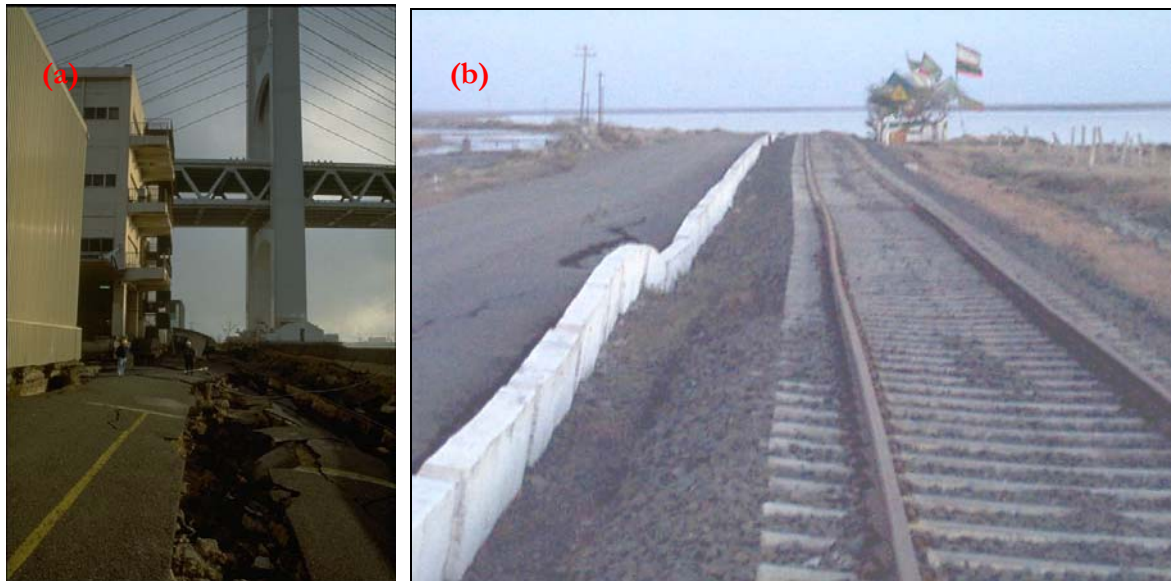
Figure 1.5 (a): Surface observations of lateral spreading at a bridge site in 1995 Kobe earthquake after NISEE; (b): Navalakhi port in 2001 Bhuj earthquake, Madabhushi et al (2001).

The *current* understanding of pile failure is as follows. Soil liquefies, it loses its shear strength, causing it to flow and dragging with it any overlying non-liquefied crust. These soil layers drag the pile with them, causing a bending failure as shown in Figure 1.4. This is often referred to as failure due to lateral spreading. In terms of soil pile interaction, the current mechanism of failure assumes that the *soil pushes the pile*. The deformation of the ground surface adjacent to piled foundations is often suggestive of this mechanism. Figure 1.5 shows surface observations of lateral spreading observed after earthquakes.

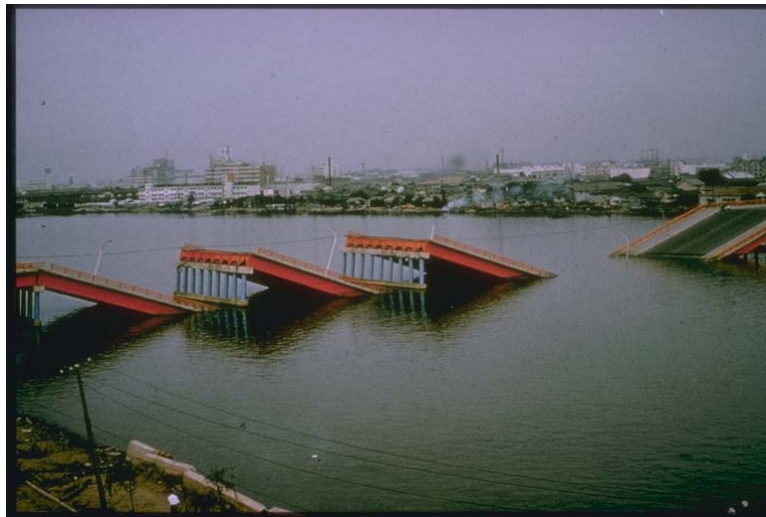
Figure 1.7: Failure of Showa Bridge after NISEE.

This section highlights the shortcomings of the current understanding of pile failure in the light of a well-documented case history of Showa Bridge during the 1964 Niigata earthquake. The failure of the bridge as shown in Figures 1.2 (b), 1.7 and 1.8 is widely accepted as being due to lateral spreading of the surrounding soil: see, for example, Hamada (1992a), Ishihara (1993).
