# **Chapter 3: Analysis of reported case histories of pile foundation performance during earthquakes**

## **3.1 Introduction**

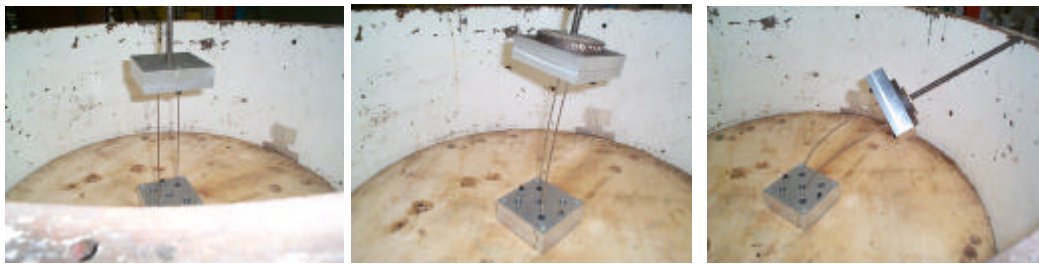
Figure 3.1: A row of slender columns representing a row of piles.

Thus the pile length in unsupported zone during liquefaction is 19 m. From the buckled shape (shown as original position in Figure 3.3 (a)), it is clear that the pile had fixed-free boundary conditions and hence the effective length is twice the length in unsupported zone. It is also in some way similar to the shape observed in Figure 3.1. The following section estimates the buckling load of the pile.

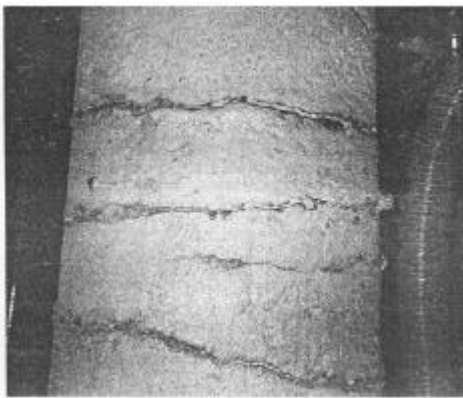
This case study describes the failure of a four-storey R.C building constructed on hollow concrete piles. The pile had a diameter of 350 mm and thickness of 75 mm. After the earthquake the building tilted about 1degree. Figure 1.3(a) shows the structural arrangement of the building. The pile only extended 500mm in the non-liquefied layer and can be assumed as pinned bottom. The photograph of Figure 3.16 corresponds to failure of Pile 2 in Figure 1.3(a).

Lower part of the pile

Upper part of the pile

Figure 3.16: Failure of pile marked 2 of Niigata family Court House (after Hamada, 1992a).

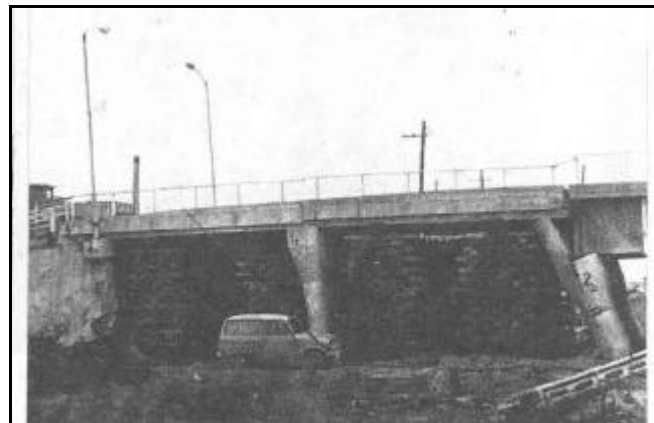
The tenth case study presents the damage of Yachiyo Bridge over river Shinano adjacent to Showa Bridge. Extensive lateral spreading occurred in the river and the river width decreased. Figure 3.17 illustrates the damage to the abutments and piers of the bridge. The foundations of both abutments and piers were RCC piles of 300 mm in diameters and a length of 10 to 11 m. The figure also shows the deformed shape after excavation. The pile can be seen to form a plastic hinge at the depth of 8 m i.e. at the bottom of the liquefiable layer. The pile head displaced by 1.1m whereas the free field deformation is reported to be 2 to 5 metres, (see Dobry and Abdoun, 2001).

The buckling load is estimated to be 383kN whereas the allowable load is 340kN. Appendix C shows in detail derivation of these parameters.

Figure 3.17: Failure of Yachiyo Bridge after Hamada (1992a).
