# The General Principle of the Authenticity and the Foundations of Monuments

C. Tsatsanifos

Pangaea Consulting Engineers Ltd., Athens, Greece

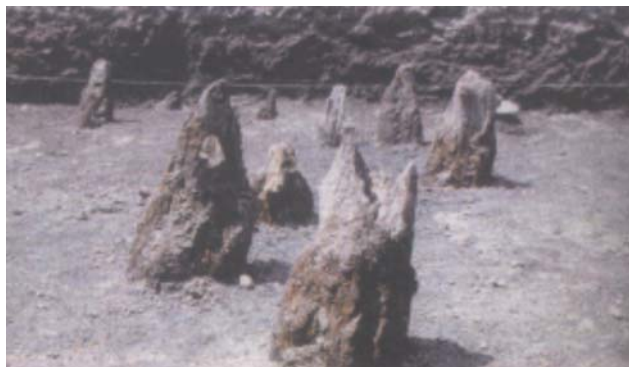
Figure 1: Wooden piles after the archaeological excavations at the site of the Dispilio Neolithic settlement at the Kastoria Lake, Western Macedonia, Greece

It was the summer of 1932, after a very dry season, that the lowering of the water level of the Kastoria Lake, Western Macedonia, Greece, revealed the existence of a great number of wooden piles at the south shore of the lake. Extensive archaeological excavations brought up about 2,000 piles (see Fig. 1), embedded by 0.20 m to more than 2 m in the soil, which consisted the foundations

of a Neolithic settlement of the 6<sup>th</sup> millennium B.C. [3]. It is obvious that these foundations are historical heritage by themselves and any interventions should take into account the materials and the methods of construction in the period of the original construction. Fig. 2 shows the reconstruction (not the *anastylosis*) of a part of the settlement.

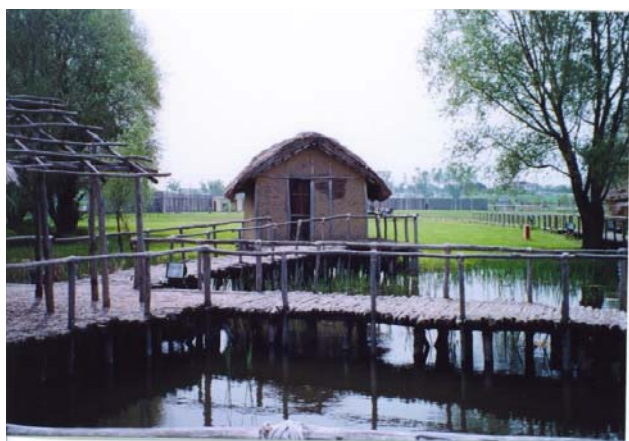
Figure 2: Reconstruction of part of the Dispilio Neolithic settlement at the Kastoria Lake, Western Macedonia, Greece
