CULTURAL MUSEUM

Cultural History and Geologic Setting

A geotechnical and flood hazard investigation was performed to support construction of the Agua Caliente Cultural Museum. The Museum will showcase the culture and history of the Agua Caliente Band of Cahuilla Indians, who have long inhabited the region. The Museum site is located in the Palm Canyon area, at the base of the San Jacinto Mountains, just south of Palm Springs, California. As currently envisioned, the Museum Building will have two floors and a footprint of about 59,000 square feet. Parking will be provided for approximately 110 vehicles.

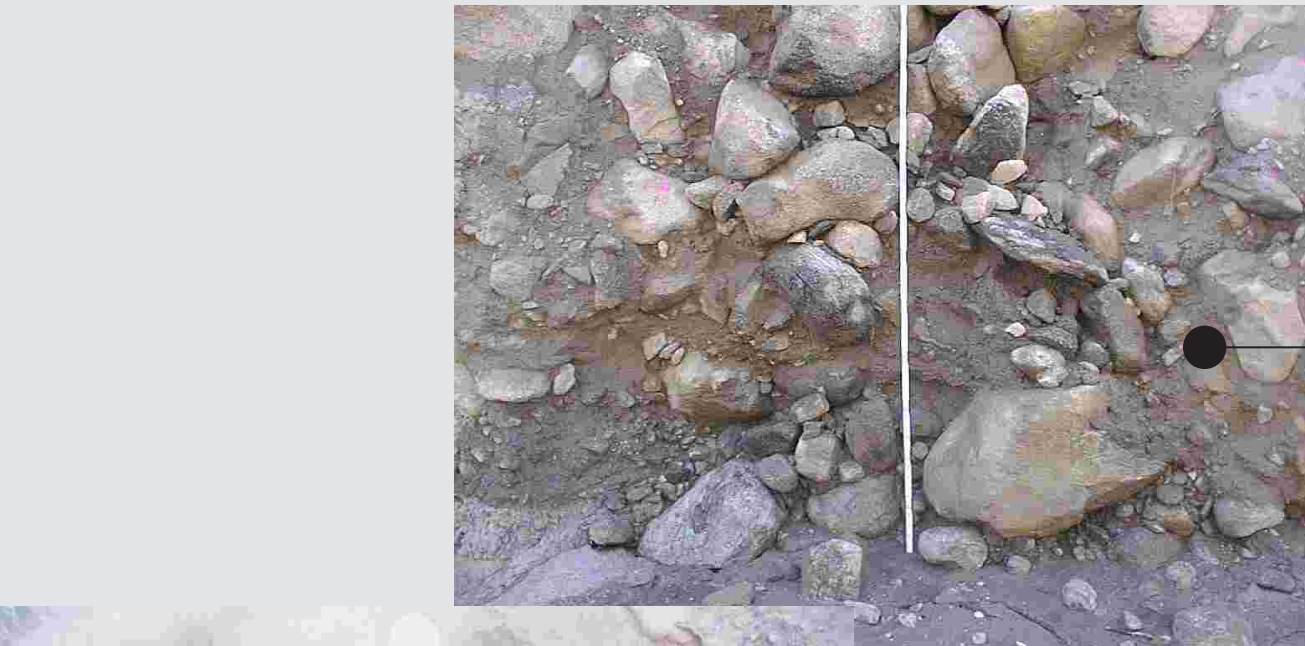
**Exhibit 8** Site index map

Exponent performed a field investigation consisting of fourteen test pits (TP-1 to TP-15, excluding TP-14) excavated by a four-man crew using shovels and pry bars. Test pits TP-1 to TP-7 and TP-10 to TP-13 were excavated to a depth of 4 feet. Test pits TP-8, TP-9 and TP-15 were excavated to depths ranging from 7.2 to 9 feet.

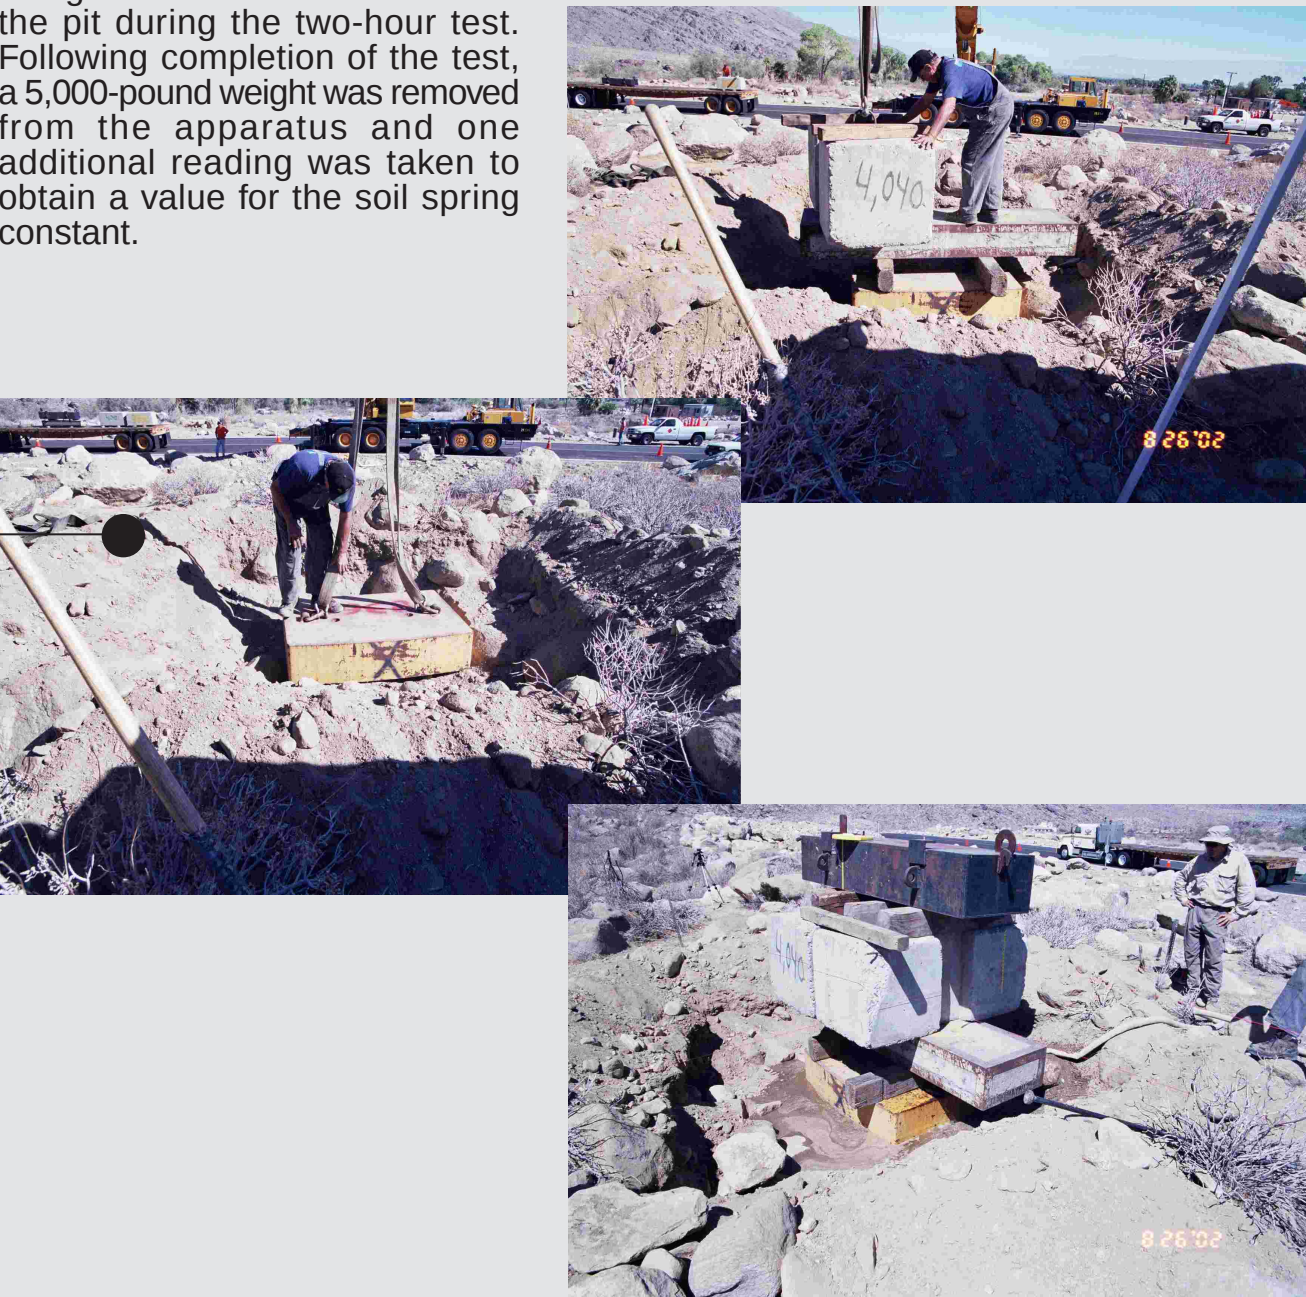
**Exhibit 9** Hydroconsolidation test results Agua Caliente Cultural Museum

Exponent personnel performed a field hydroconsolidation test at the northern edge of the subject site. The pit was excavated over a 10-foot square area to a depth of approximately 1.5 feet, exposing debris flow deposits across the floor of the pit. A crane was used to set a series of weights into the test pit to simulate a footing load. A test weight of 24,980 pounds was applied over a 17.1 square foot area, resulting in a load of 1,461 lb/ft<sup>2</sup>.

Water was added to the test pit and the settlement recorded over a two-hour period using three lasers directed at the apparatus from different sides. The water level was maintained at about 1 foot deep in the test pit by intermittent addition of water from a nearby fire hydrant.

The test apparatus recorded a total of \_ to \_ inch of settlement during the two-hour test. Most of the settlement occurred within the first 45 minutes. A total of approximately 200 gallons of water was added to the pit during the two-hour test. Following completion of the test, a 5,000-pound weight was removed from the apparatus and one additional reading was taken to obtain a value for the soil spring constant.
