# Better Understanding the Strengths of Serpentinite Bimrock and Homogeneous Serpentinite

By Ulrich Glawe and Bishal N. Upreti

This paper describes two projects in which serpentinite caused significant problems: during design of the Kusan-3 HEPP dam in Indonesia; and during construction of the Berke powerhouse access tunnel in Turkey.

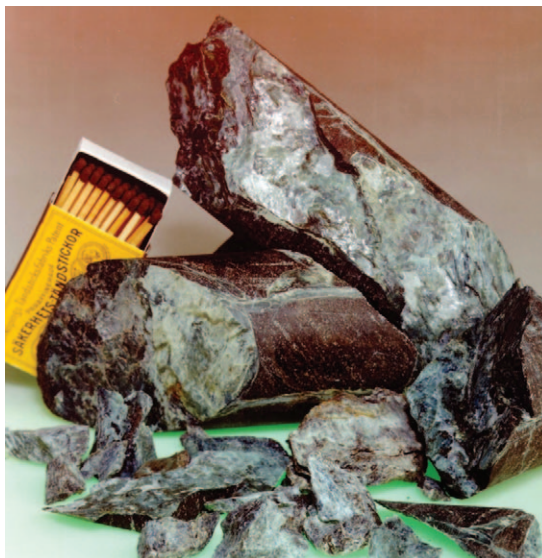
**Fig. 3** Drilled core specimen of the Kusan serpentinite.

Site matrix rock is a "mini-breccia" or a fine-grained cataclasite, but it has the visual appearance of a homogeneous weak material. It was practically impossible to conventionally sample representative specimens for laboratory tests at outcrops or in the adit. Core recovery with conventional diamond drilling using triple-tube core barrels was very difficult. Intact core samples failed if bent with force by hand, or disintegrated into pieces at a light hammer blow. This fact is considered to reflect very low tensile strength of pre-existing discontinuities. The broken rock pieces exhibit slickensided and undulating fracture surfaces (Figure 3).

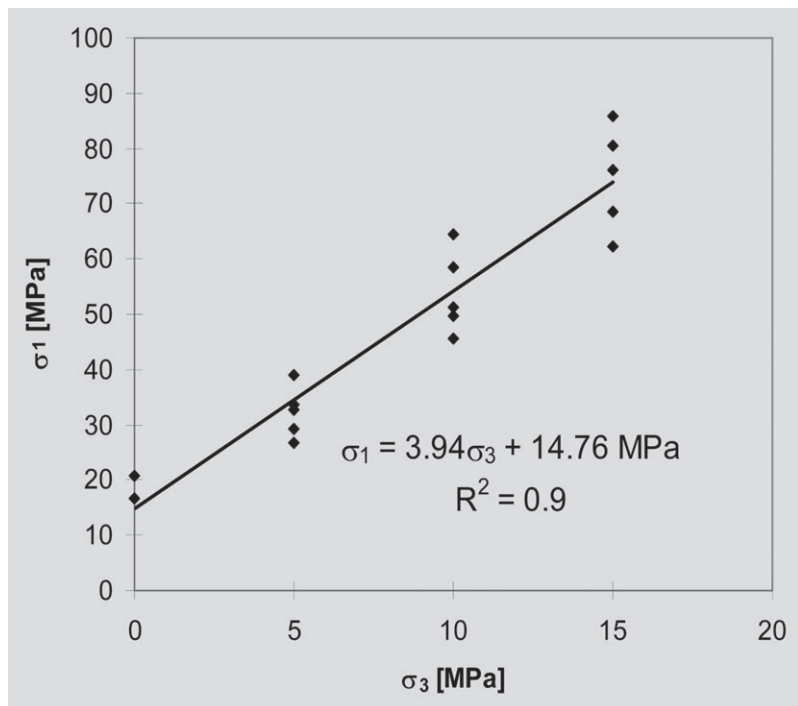
**Fig. 4** Results of two uniaxial and five triaxial tests on the Kusan serpentinite.  
**Bild 4** Resultate von zwei einachsialen und fünf triaxialen Druckversuchen des Kusan Serpentinits.

Eight samples of the matrix rock were tested to determine the serpentinite matrix rock strength: Two in uniaxial compression and five in multistage triaxial compression (Figure 4). The strength parameters, derived by simple stress transformation, are 36° for the friction angle and 3.76 MPa for the cohesion (Figure 5).

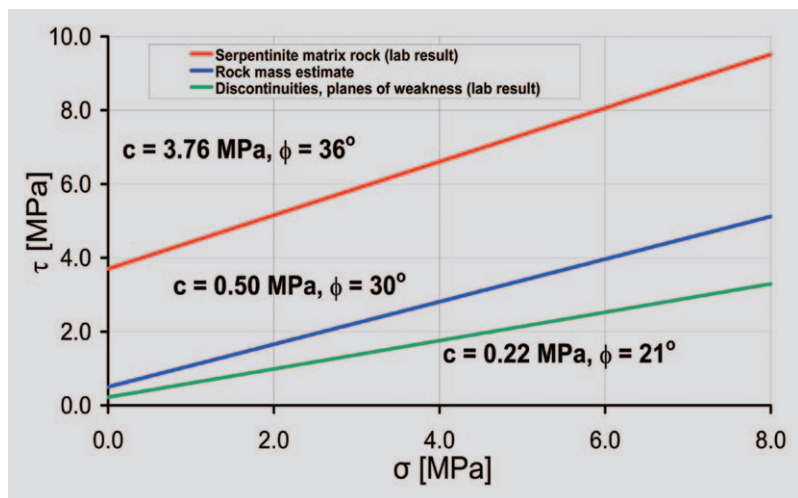
**Fig. 5** Mohr-Coulomb strength envelopes for the Kusan serpentinite.  
**Bild 5** Mohr-Coulomb Bruchgeraden des Kusan Serpentinits.

The derivation of the strength parameters are summarized in Table 2. The shear strength envelopes for the serpentinite are presented in Figure 5. These represent the peak shear strength of intact matrix rock and discontinuities, both as measured in the laboratory. The selected strength for the serpentinite rock mass for design purposes is also indicated.

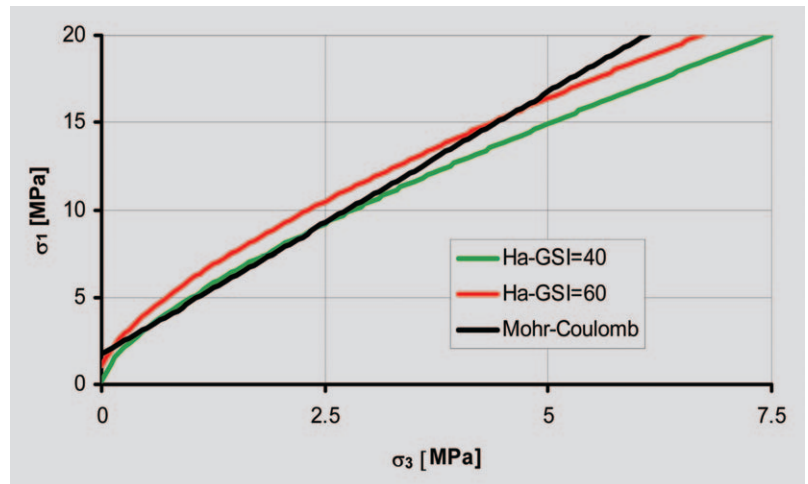
**Fig. 6** Strength envelopes for the Kusan serpentinite rock mass for the criterion for GSI 40 and 60 (after 15). The Mohr-Coulomb envelope with the derived design parameters ( $c = 0.5 \text{ MPa}$ ,  $\phi = 30^\circ$ ) is indicated for comparison.

Hoek's GSI classification method (13, 14) was extended by (15) to account particularly for tectonized cataclastic rocks. It is understood that Hoek's classification and Habimana's extension must be considered as "work in progress". Following (15) and classifying the serpentinite rock mass as "tectonized" leads to a GSI of 40 to 60. Note however: Rock mass structures that actually meet the serpentinite bimrock structural condition are not available from this classification. In Figure 6, the failure envelopes for the serpentinite are presented based on the extended Hoek/Brown failure criterion and the Mohr-Coulomb criterion selected for the dam design.

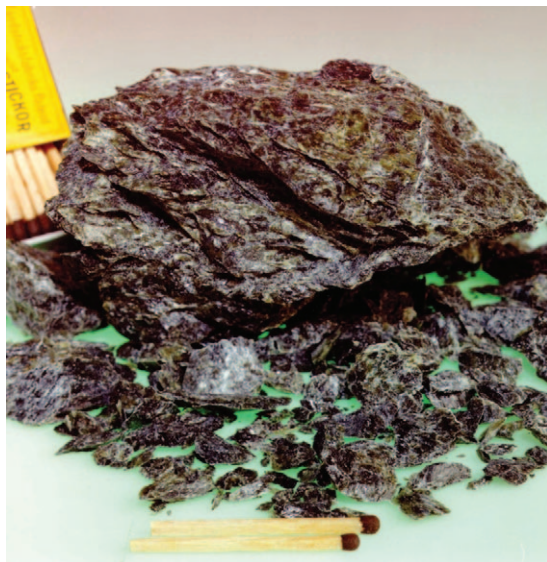
**Fig. 7** Drilled core specimen of the Berke serpentinite.

In general the serpentinite at this site is extremely closely fractured, with chlorite and talc infilling. The serpentinite exhibits a flaky and cataclastic rock texture (Figure 7) and is at some locations completely mylonized. The serpentinite rock mass could be easily excavated with a pick and the remaining small blocks of the serpentinite could be disintegrated by hand to sandy gravel size. The contact with the limestone sections was water-bearing and is also heavily tectonized.

The serpentinite encountered in Berke tunnel was an extremely weak rock, which caused significant problems during tunnel construction, as one would expect when engineering in serpentinite. Hence, why did the serpentinite of the Kusan-3 dam site exhibit higher strength than reported elsewhere for serpentinite? On the basis of the case histories reported in this paper, varying high strength values for serpentinite may result from differences in localized lithologic factors, micro and macro structures, mineralogical compositions, and variations of interlocking of smaller grains, sheared and angular rock fragments, and re-cementation of matrix in serpentinite with bimrock fabric. A comparison of the serpentinites shown in the photographs of the serpentinites in Figures 2 and 7 indicate how differences in structure may impact rock mass strength.
