# Lecture 3

## Anticipating and Solving Problems with Excavations and Slopes in Bimrocks

**Dr. Edmund Medley PE, CEG**

**Bimrocks Short Course, Hacettepe Univ, Ankara,  
June 21, 2004**

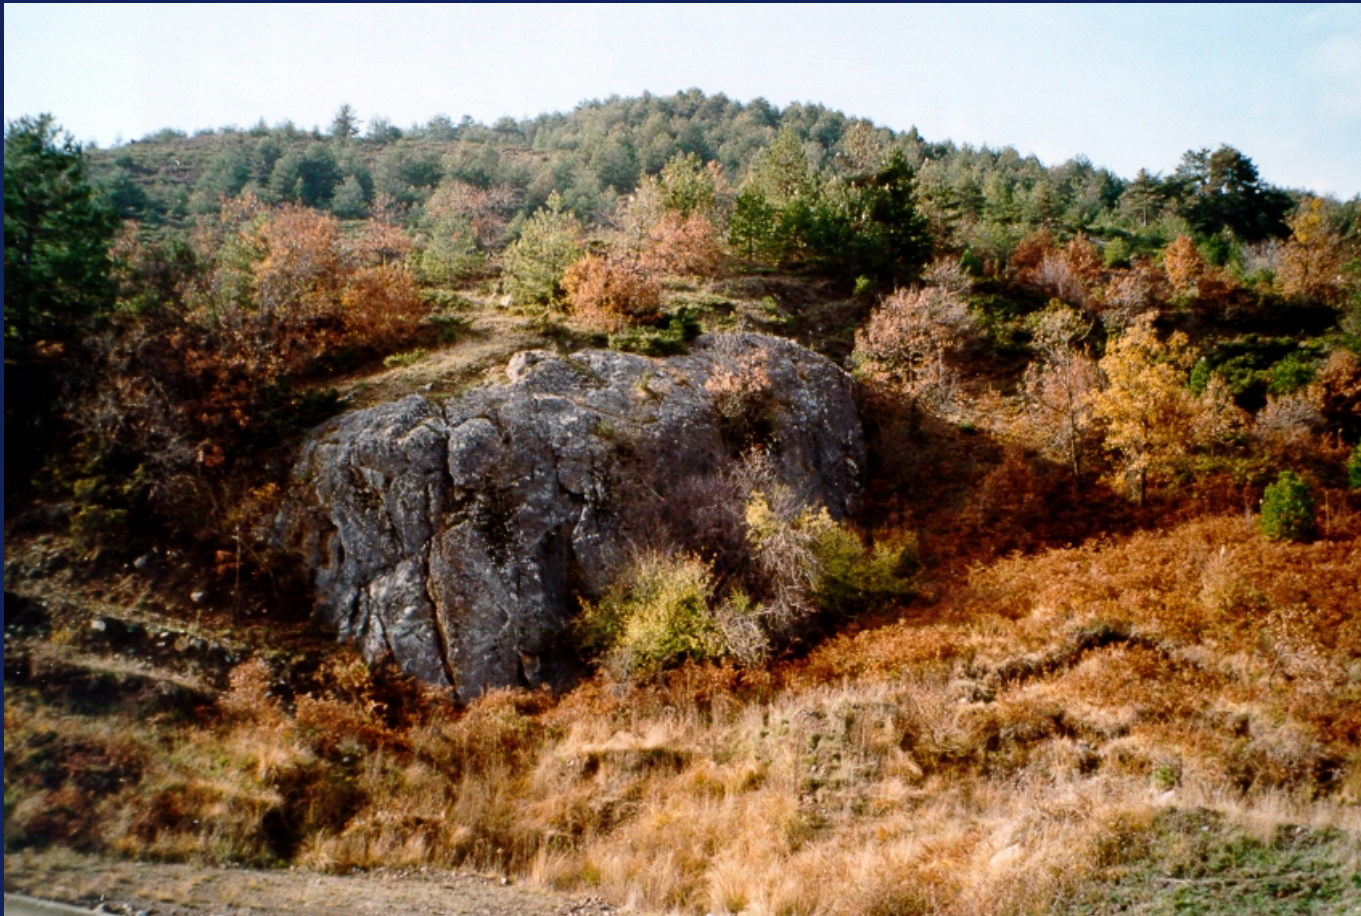
*Limestone Olistolith (**Block**) Embedded in an Irregularly Foliated Matrix of Shale, Siltstone and Sandstone*

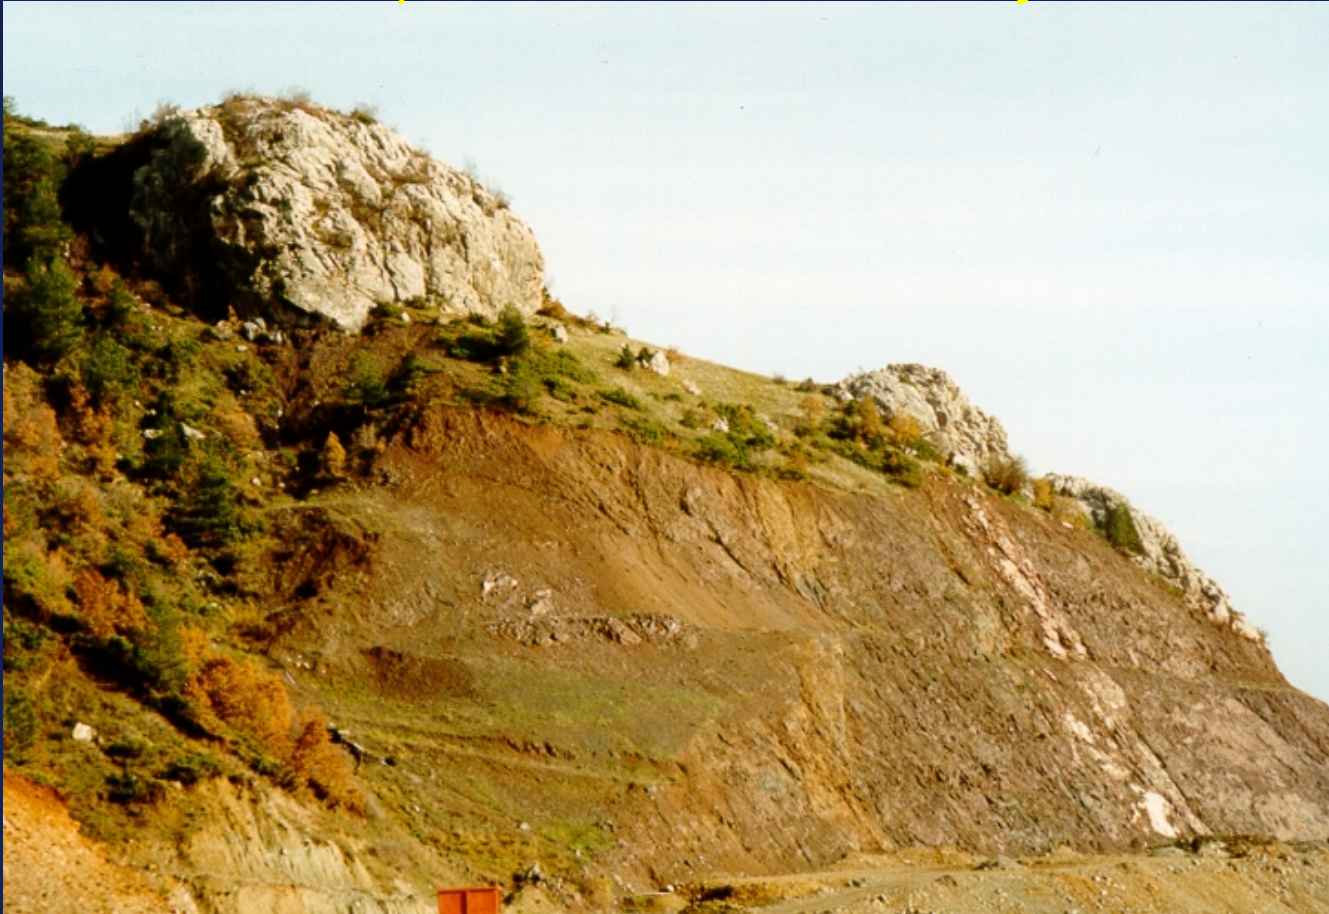
*Limestone Olistolith Embedded in an Irregularly  
Foliated Matrix of Shale, Siltstone and Sandstone  
Slope Excavated for Motorway*

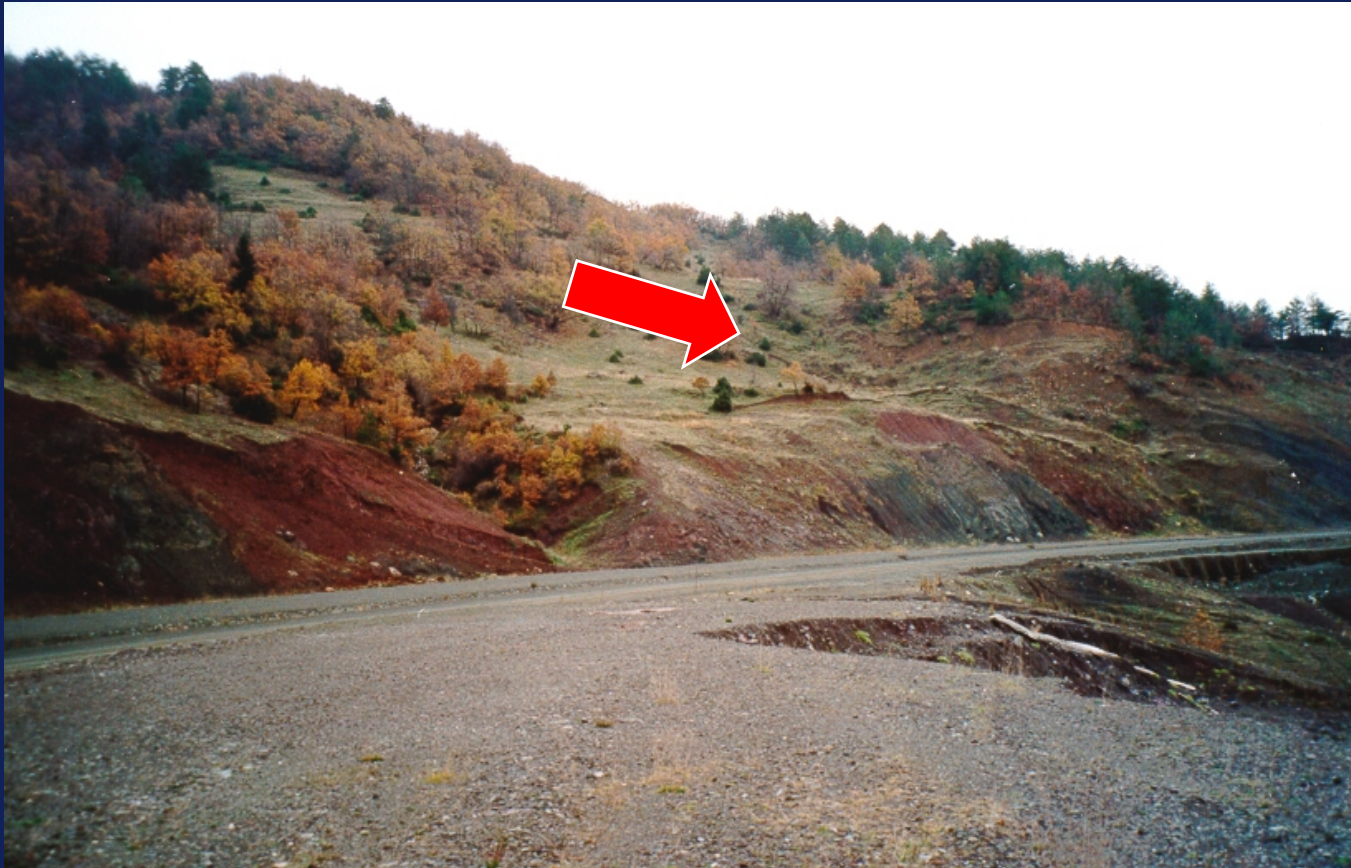
*Development of **Landslides** Caused by the Construction of the Motorway*

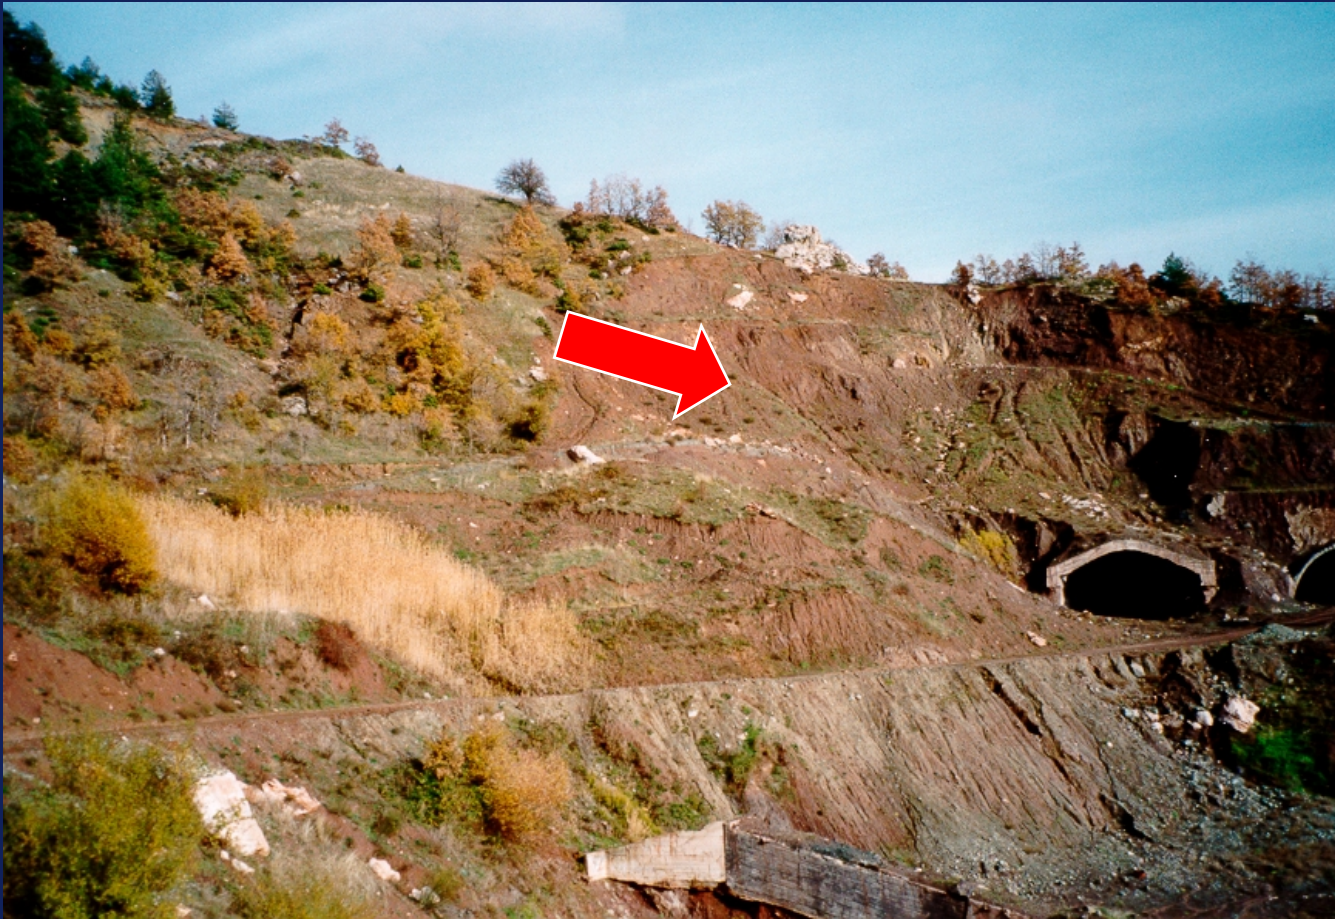
## *Damaged Pre-Cut of the Tunnel M2 West Portal*

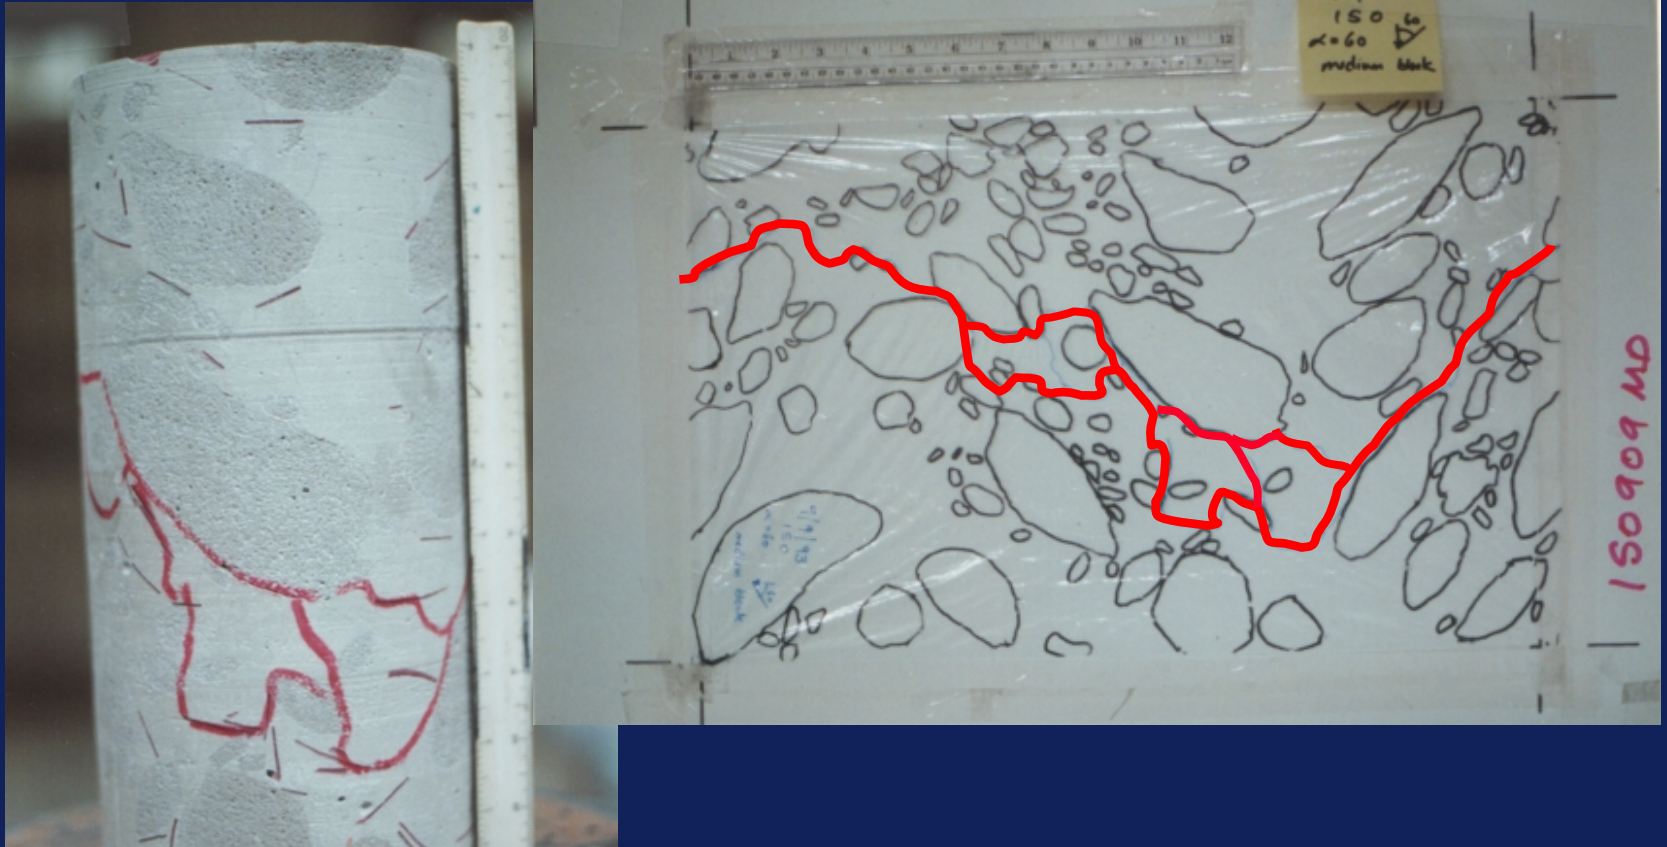
# Failed physical model melanges

150 mm diameter Tx specimens (Lindquist, 1994)

failure surfaces tortuously negotiate blocks

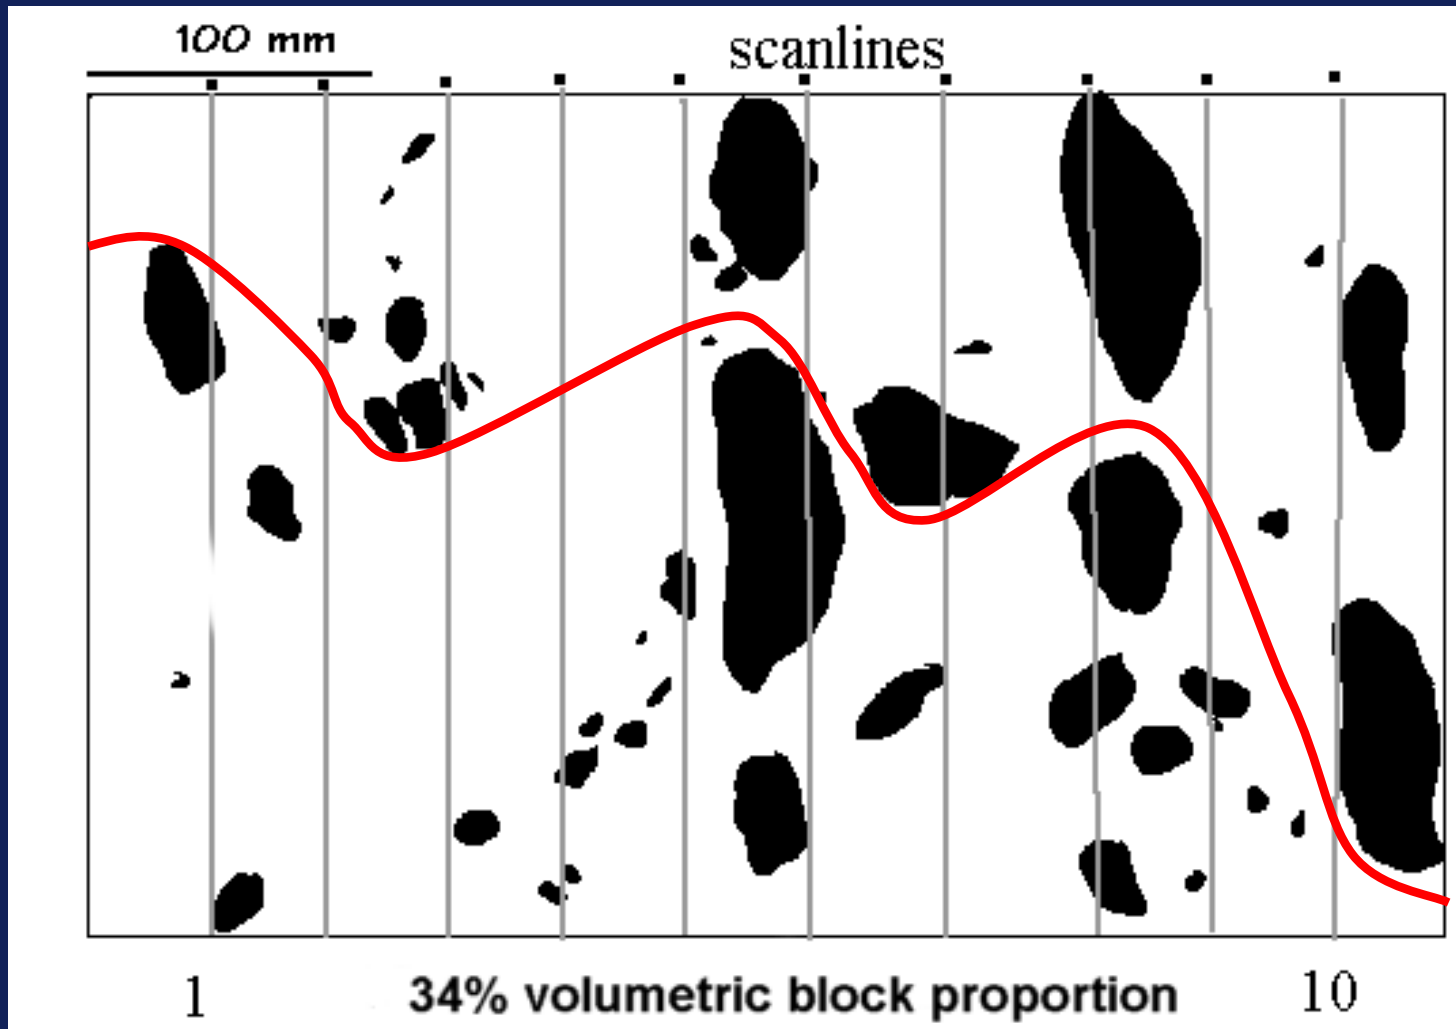
# Tortuosity of failure surfaces influenced by low block proportion and vertical orientation

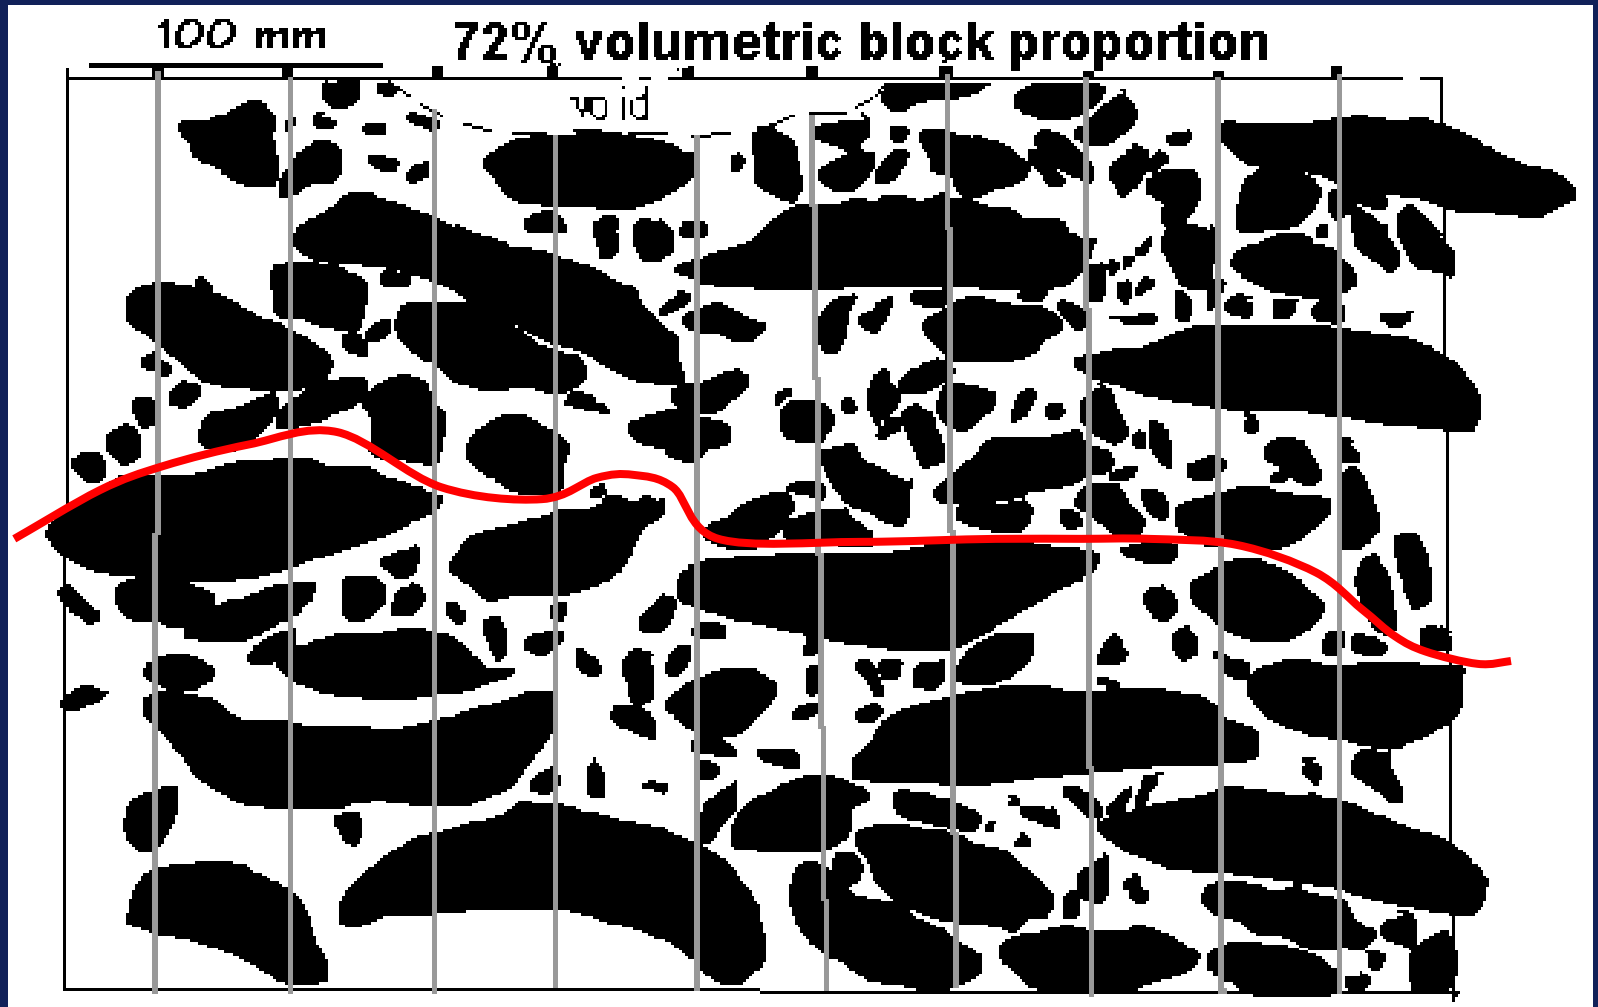
# Tortuosity influenced by high proportion but horizontal orientation

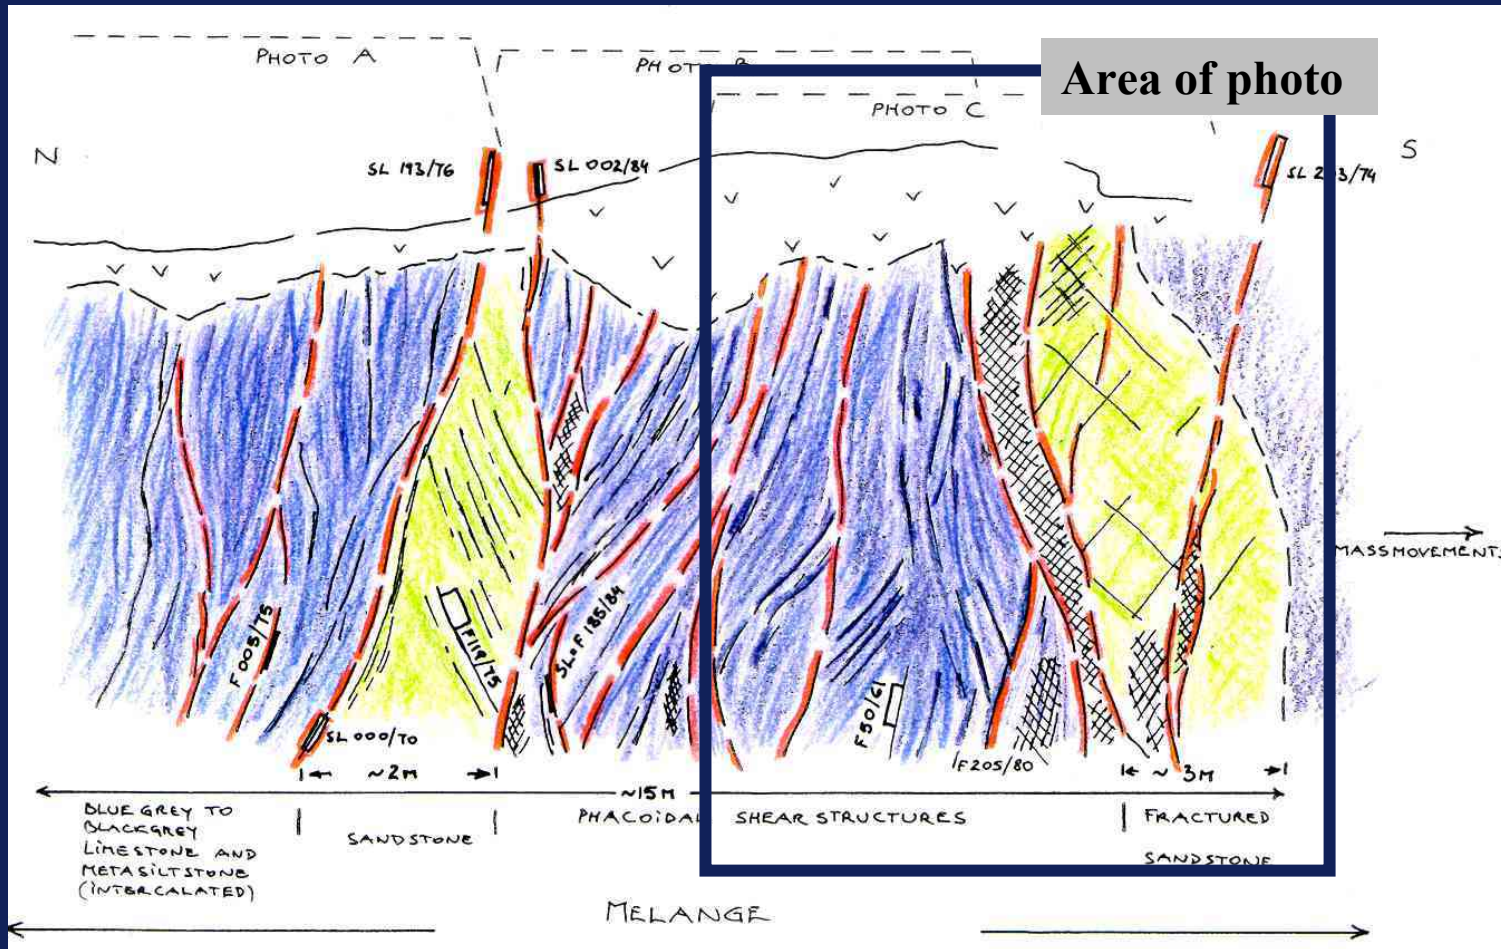
# Mapping of slopes (Bolu Tunnel, Turkey)

*Typical Melange Showing Diverse Elongate Blocks and Irregular Foliated Matrix (S-M-C-Cataclasites)*

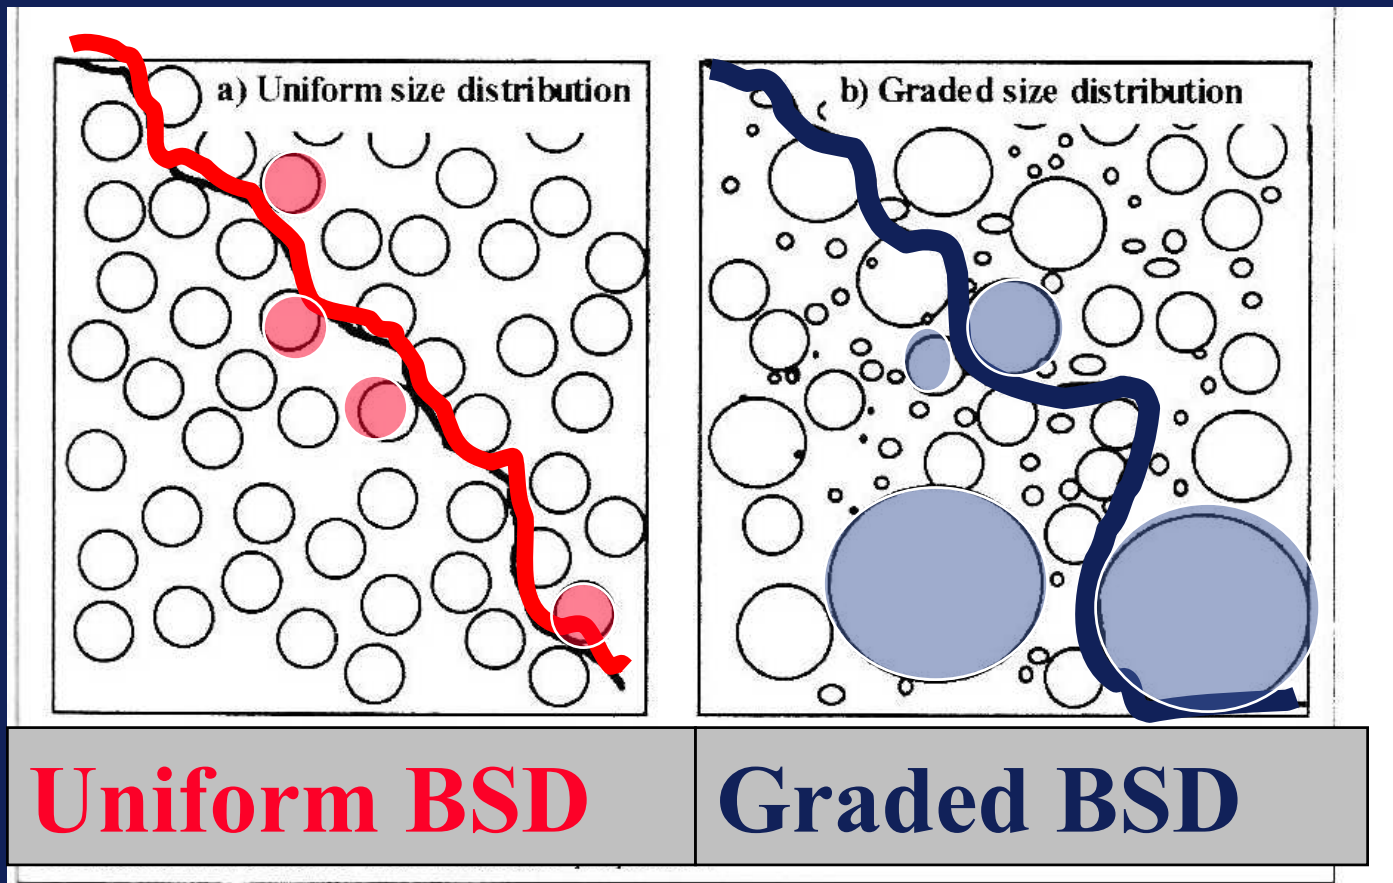
# Tortuosity influenced by Block Size Distribution (BSD) and block shapes

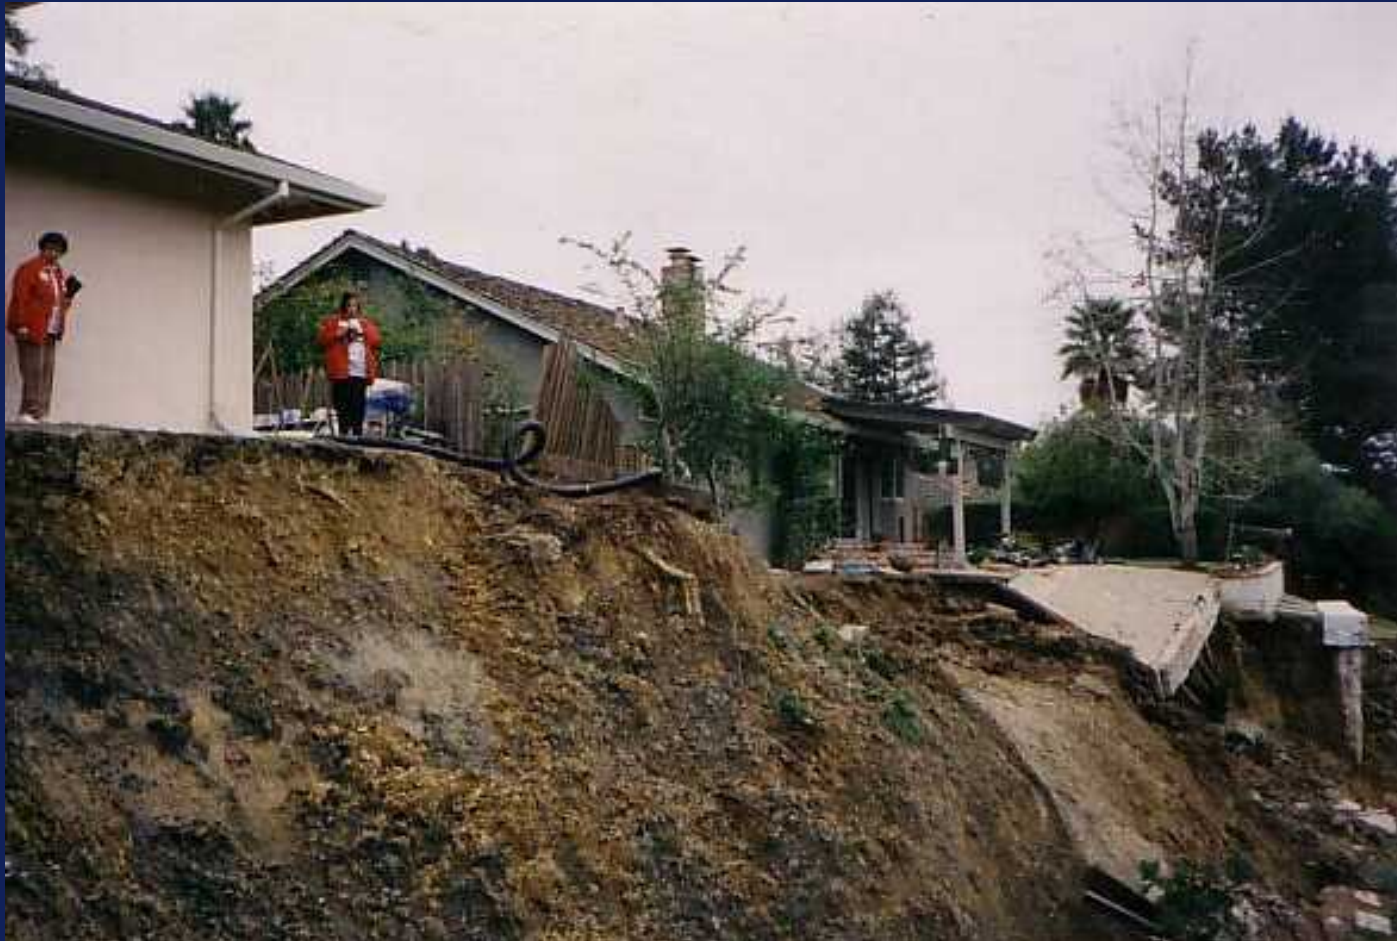
# Landslide in Franciscan melange...

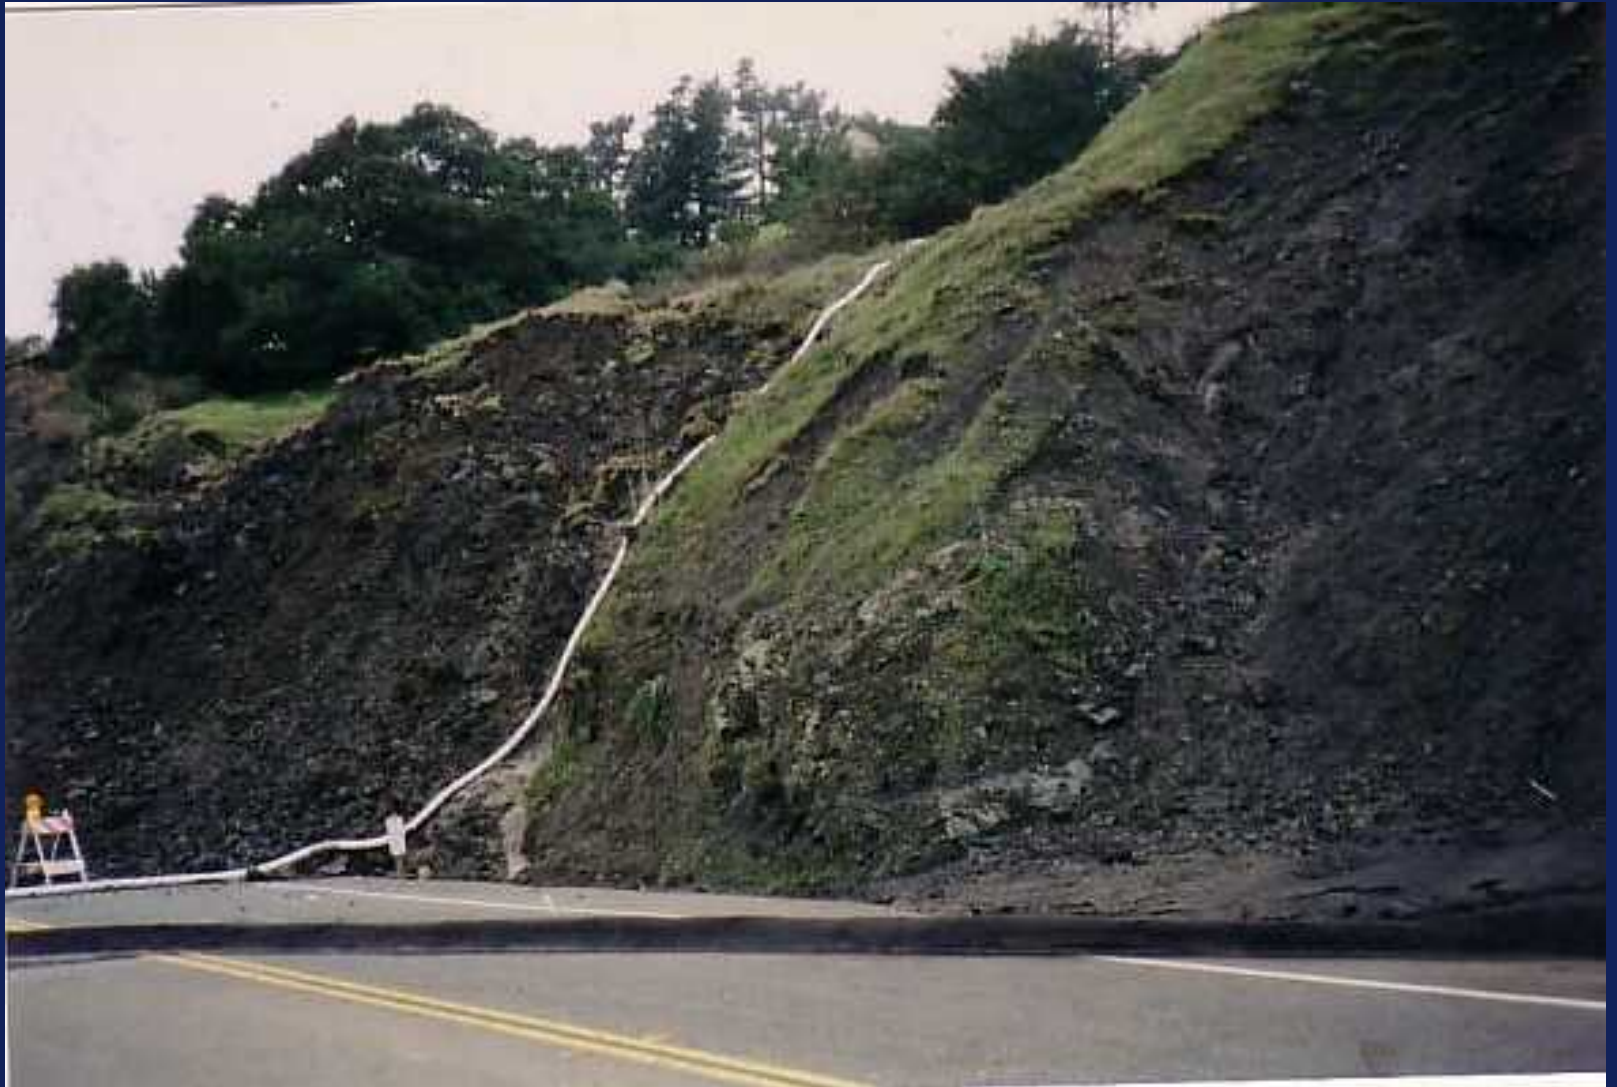
# block-rich melange at toe resisted movement

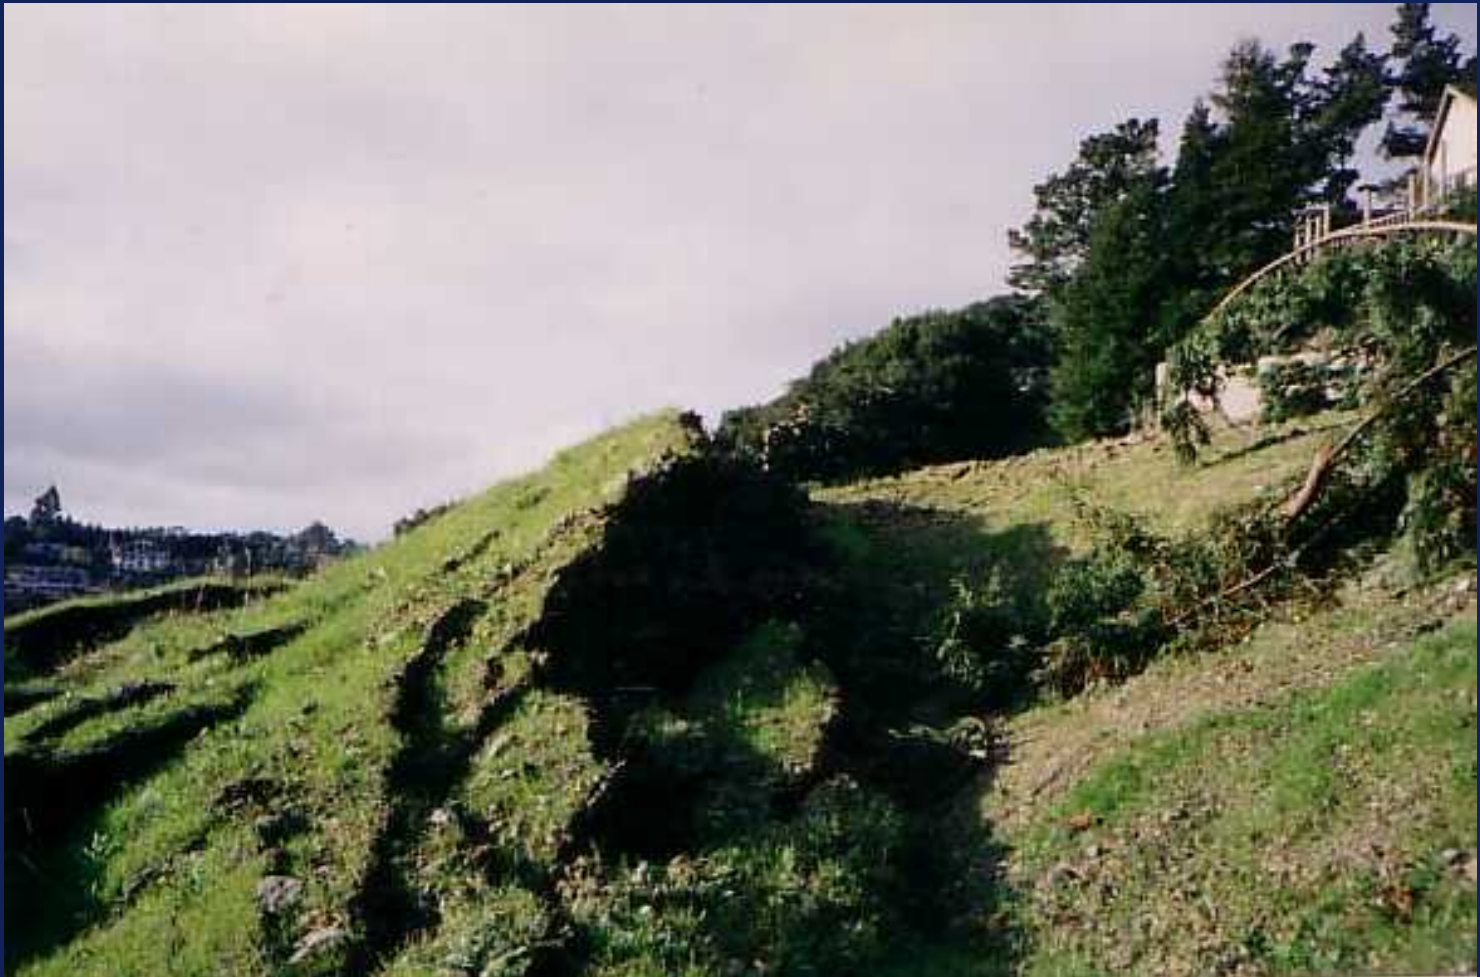
**..leading to back-facing scarps**

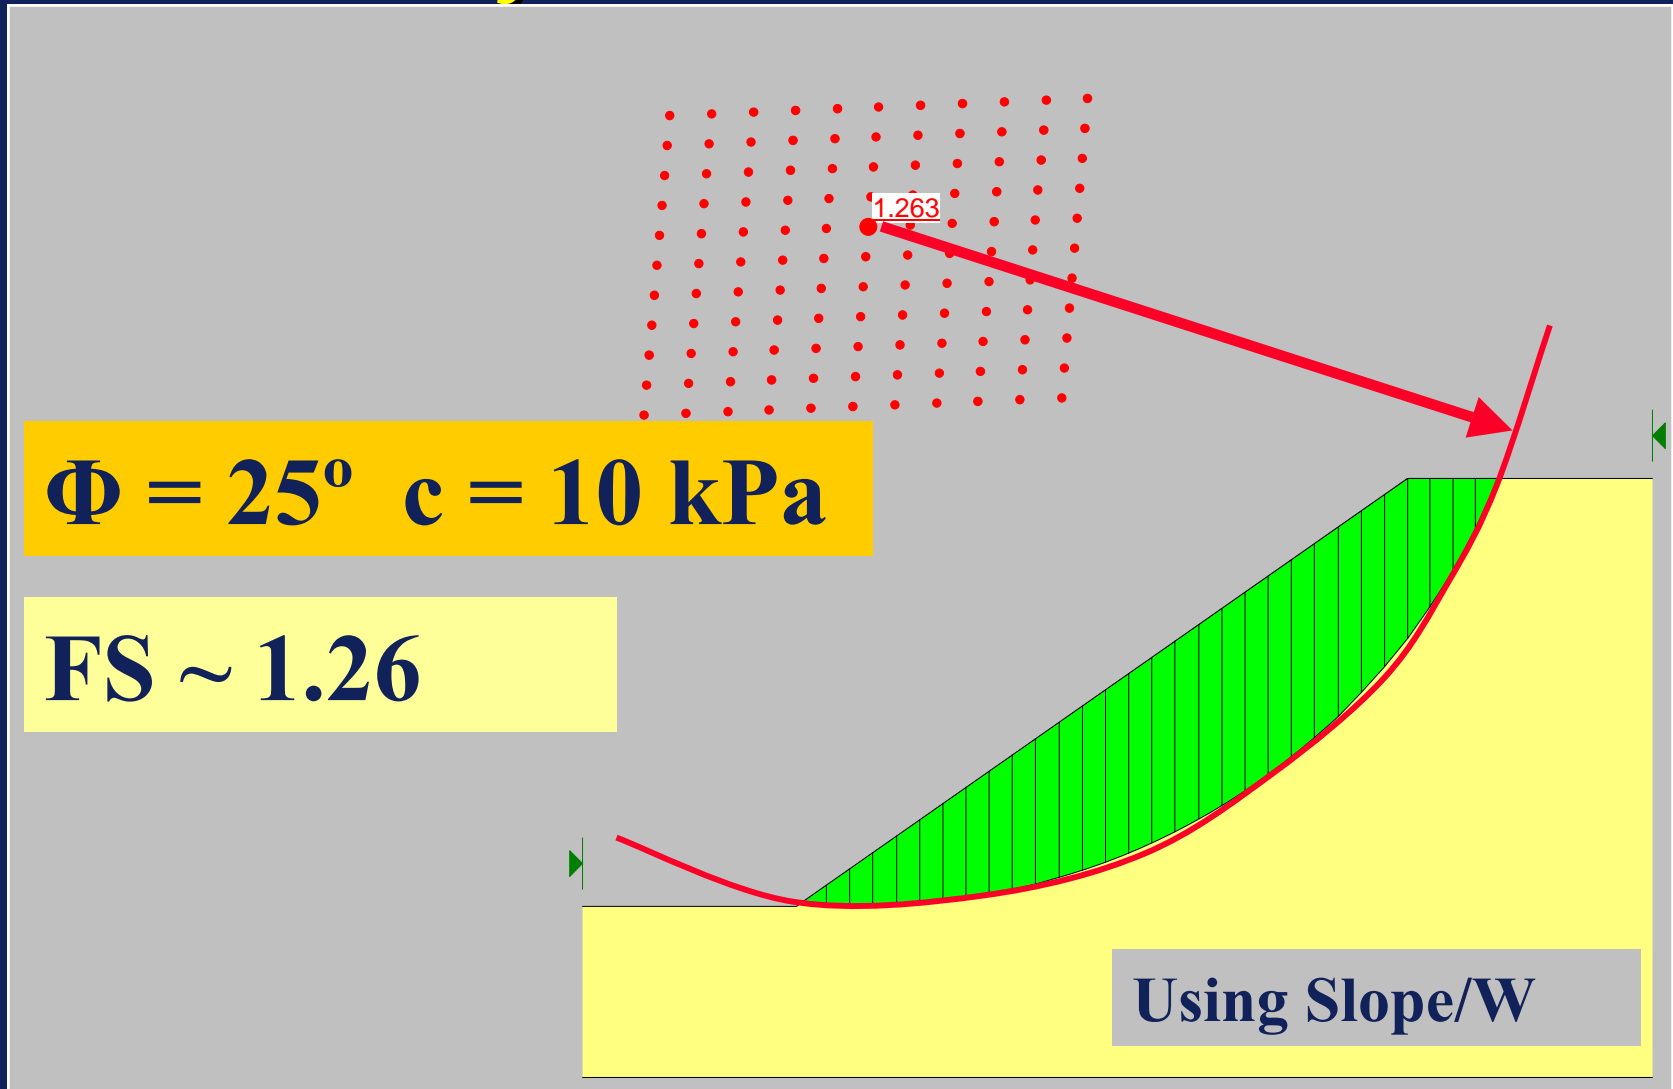
# Matrix only: Critical failure surface

- **matrix :  $\Phi = 25^\circ$   $c = 10$  kPa ( $\sim 200$  psf)**
- **block strengths not considered**
- **no block/matrix contact strengths**
- **no water**

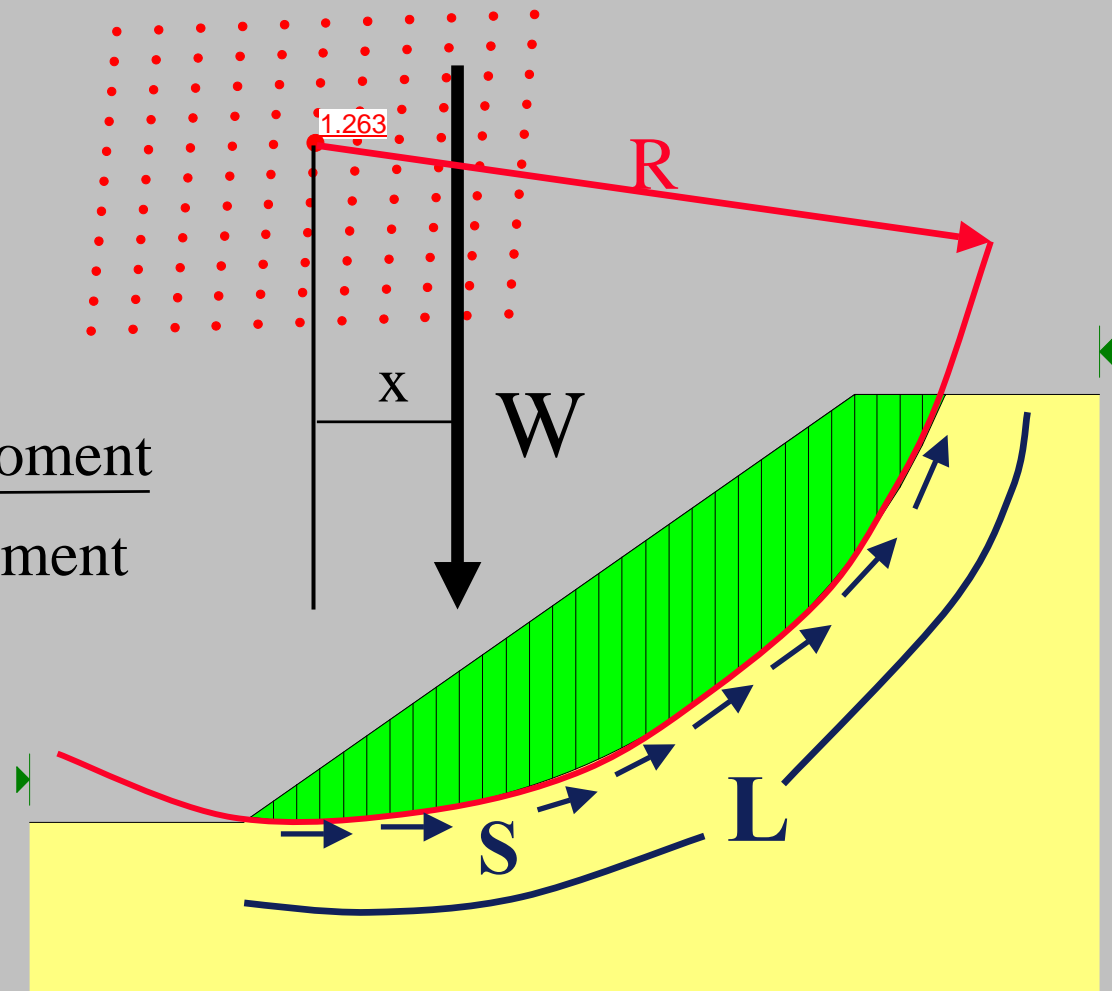
# Factor of Safety (FS)

$$FS = \frac{\text{Resisting Moment}}{\text{Driving Moment}}$$

$$= \frac{RSL}{Wx}$$

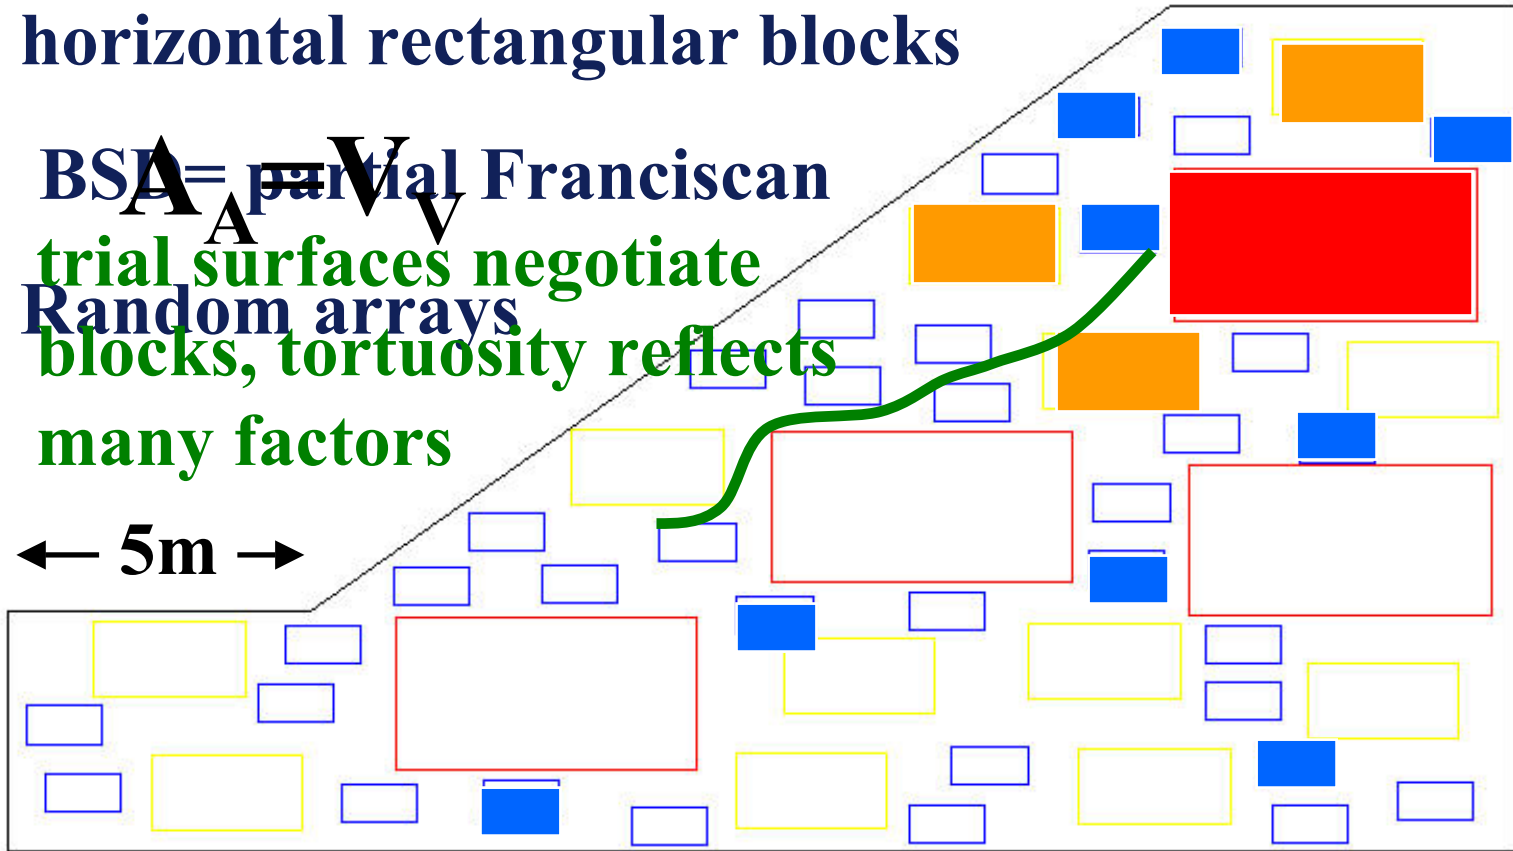
# Model Assumptions

horizontal rectangular blocks

$\mathbf{A} = \mathbf{V} \mathbf{A} \mathbf{V}^T$  partial Franciscan  
trial surfaces negotiate  
Random arrays  
blocks, tortuosity reflects  
many factors

- **BSD = part 2D Franciscan ( $\sim 2n^{1.3}$ )**
- **horizontal block orientations**
- **random arrays of blocks**
- **Areal = Volumetric block proportions**
- **failure surfaces pass around blocks**
- **2D analyses suffice (for now...)**

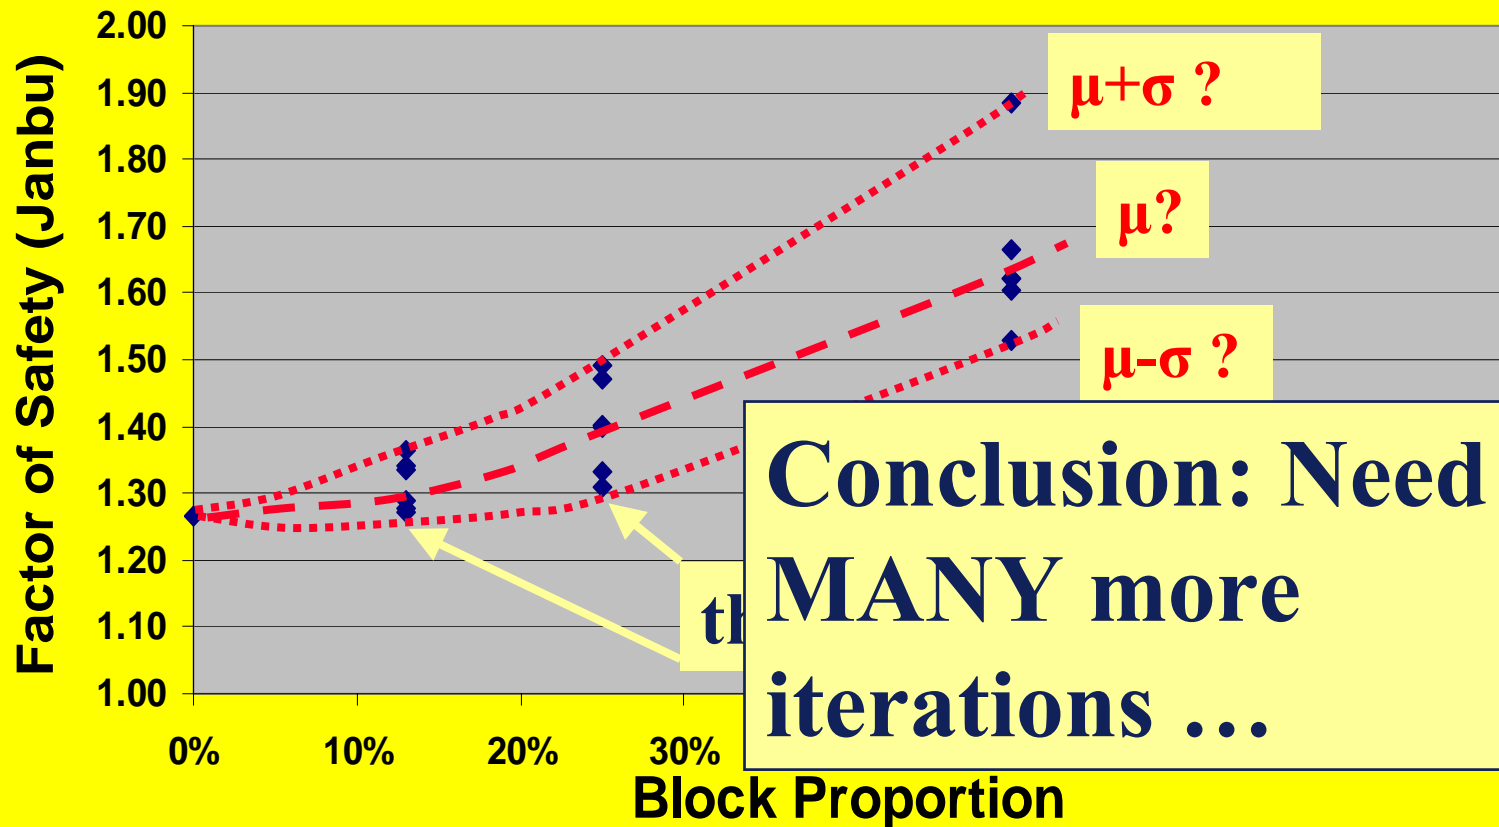
# "First cut": Slope stability increases with block proportion

# 50% block proportion: FS for a tortuous trial surface

**FS ~ 1.65**

# 25% block proportion: FS for a tortuous trial surface

**FS ~ 1.40**
