# Lecture 3

## Anticipating and Solving Problems with Excavations and Slopes in Bimrocks

**Dr. Edmund Medley PE, CEG**

**Bimrocks Short Course, Hacettepe Univ, Ankara,  
June 21, 2004**

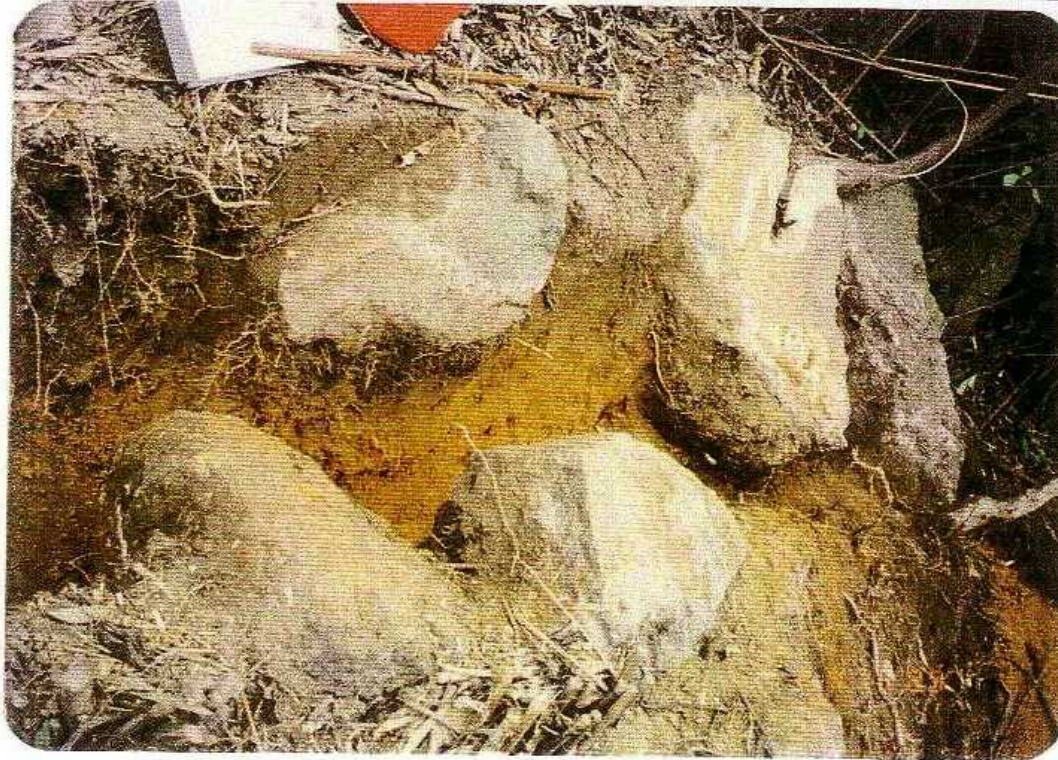
# Compare with Hong Kong experience of slope stability of Boulder Colluvium

Plate 29 - Colluvium Layer No. 1, Slope behind Fairmont Gardens

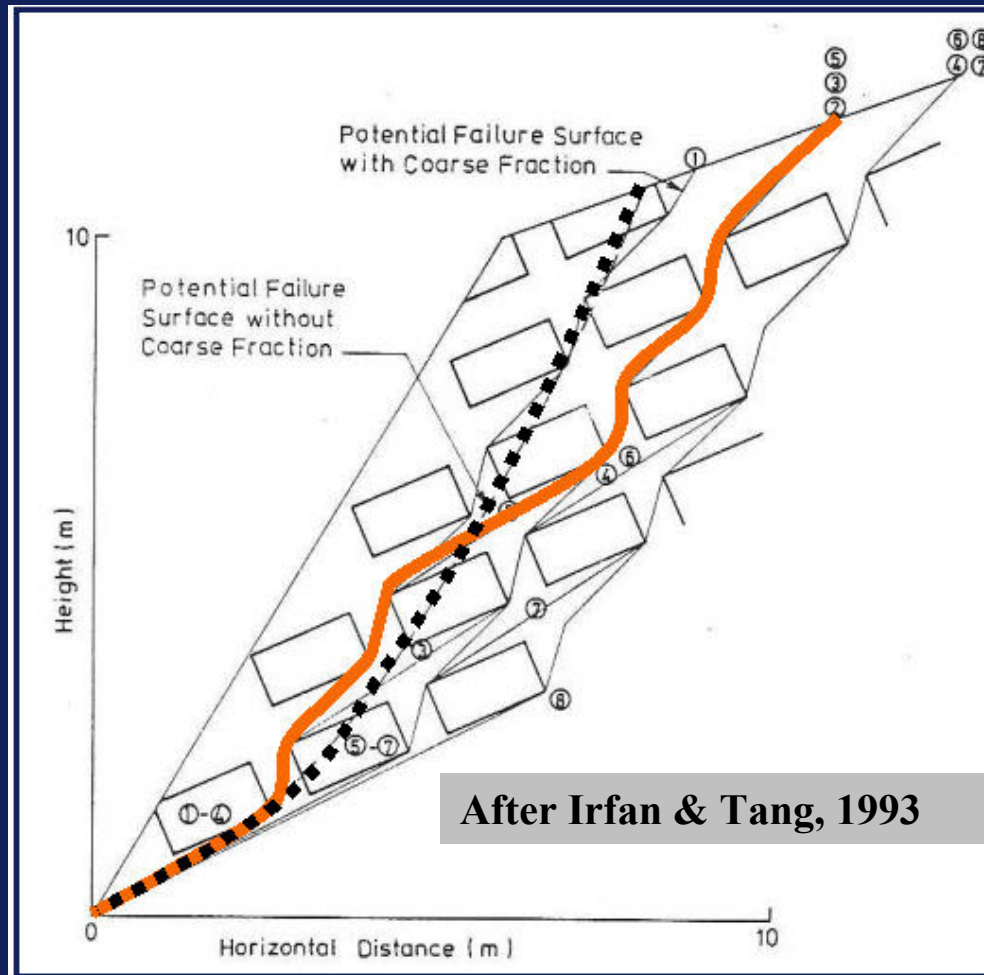
# Trial tortuous failure surfaces with blocks oriented out-of-slope

Figure 6.2 - Locations of Typical Potential Failure Surfaces in the Theoretical Slope Model

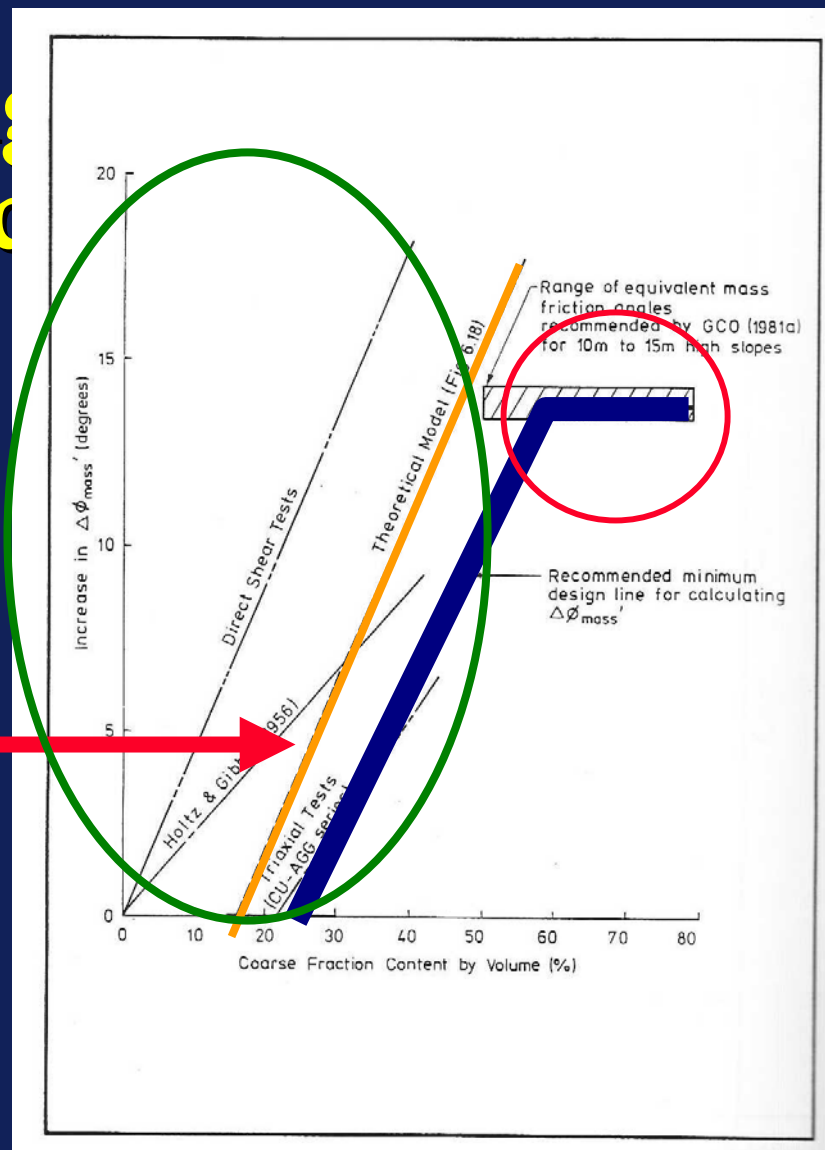
Figure 7.3 - Summary of the Hong Kong Study and the Recommendation for Mass Strength Increases For Slope Analysis in Colluvium

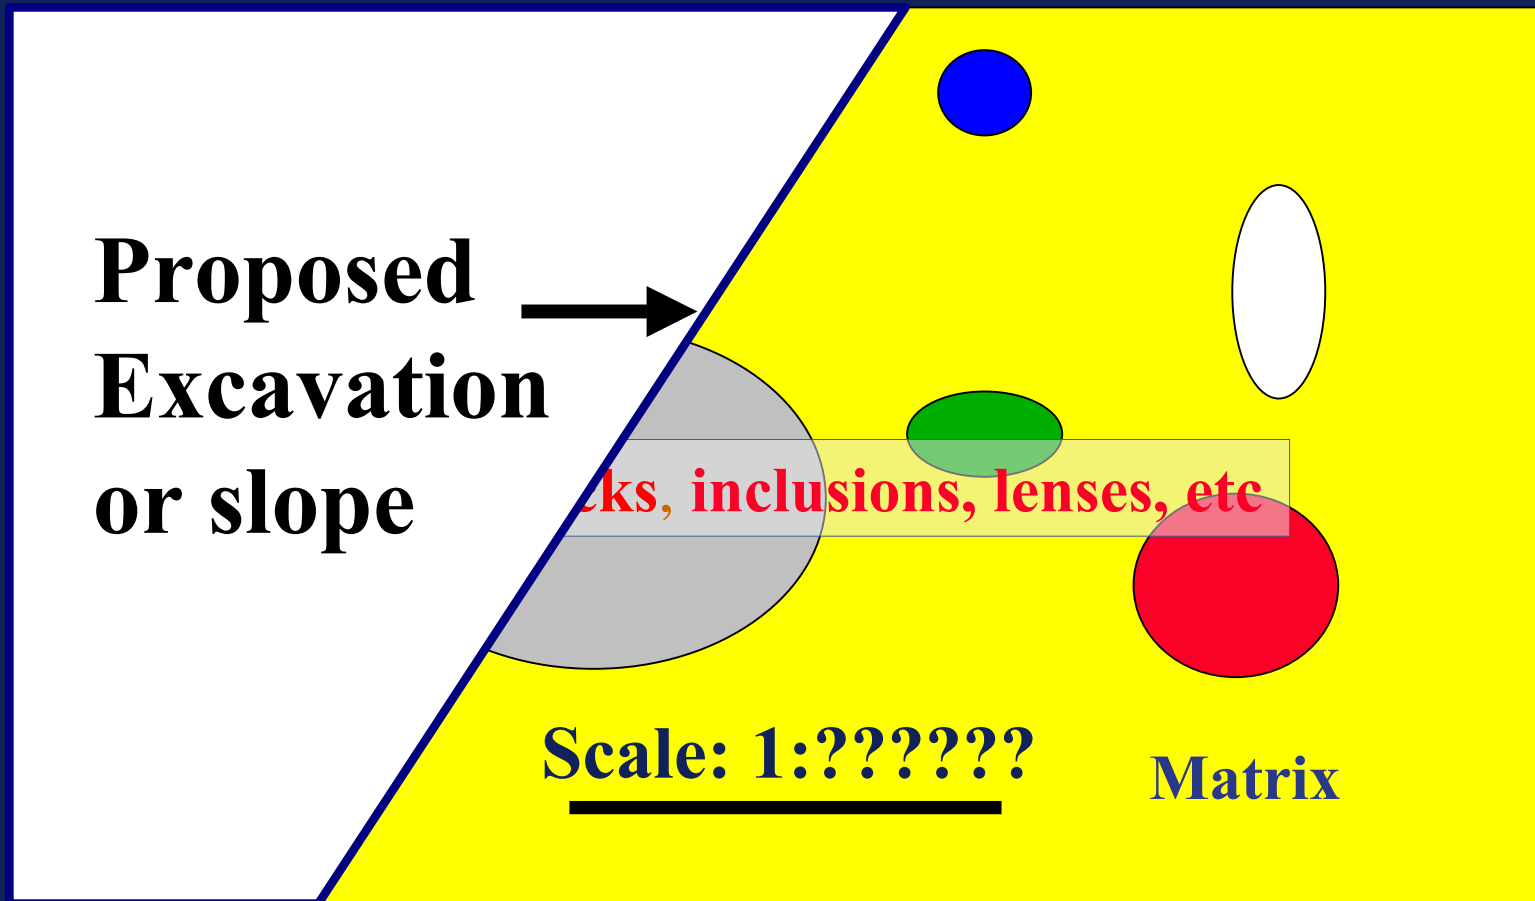
**Actual Distribution of Blocks**
