# The $M_{JMA}$ 7.6 “Noto Peninsula” Japan Earthquake of January 1<sup>st</sup> 2024

**Preliminary Report with  
Emphasis on Recorded Motions and Soil Effects**

GeoEngineers Without Borders (GeoWB), ISSMGE

8 January 2024

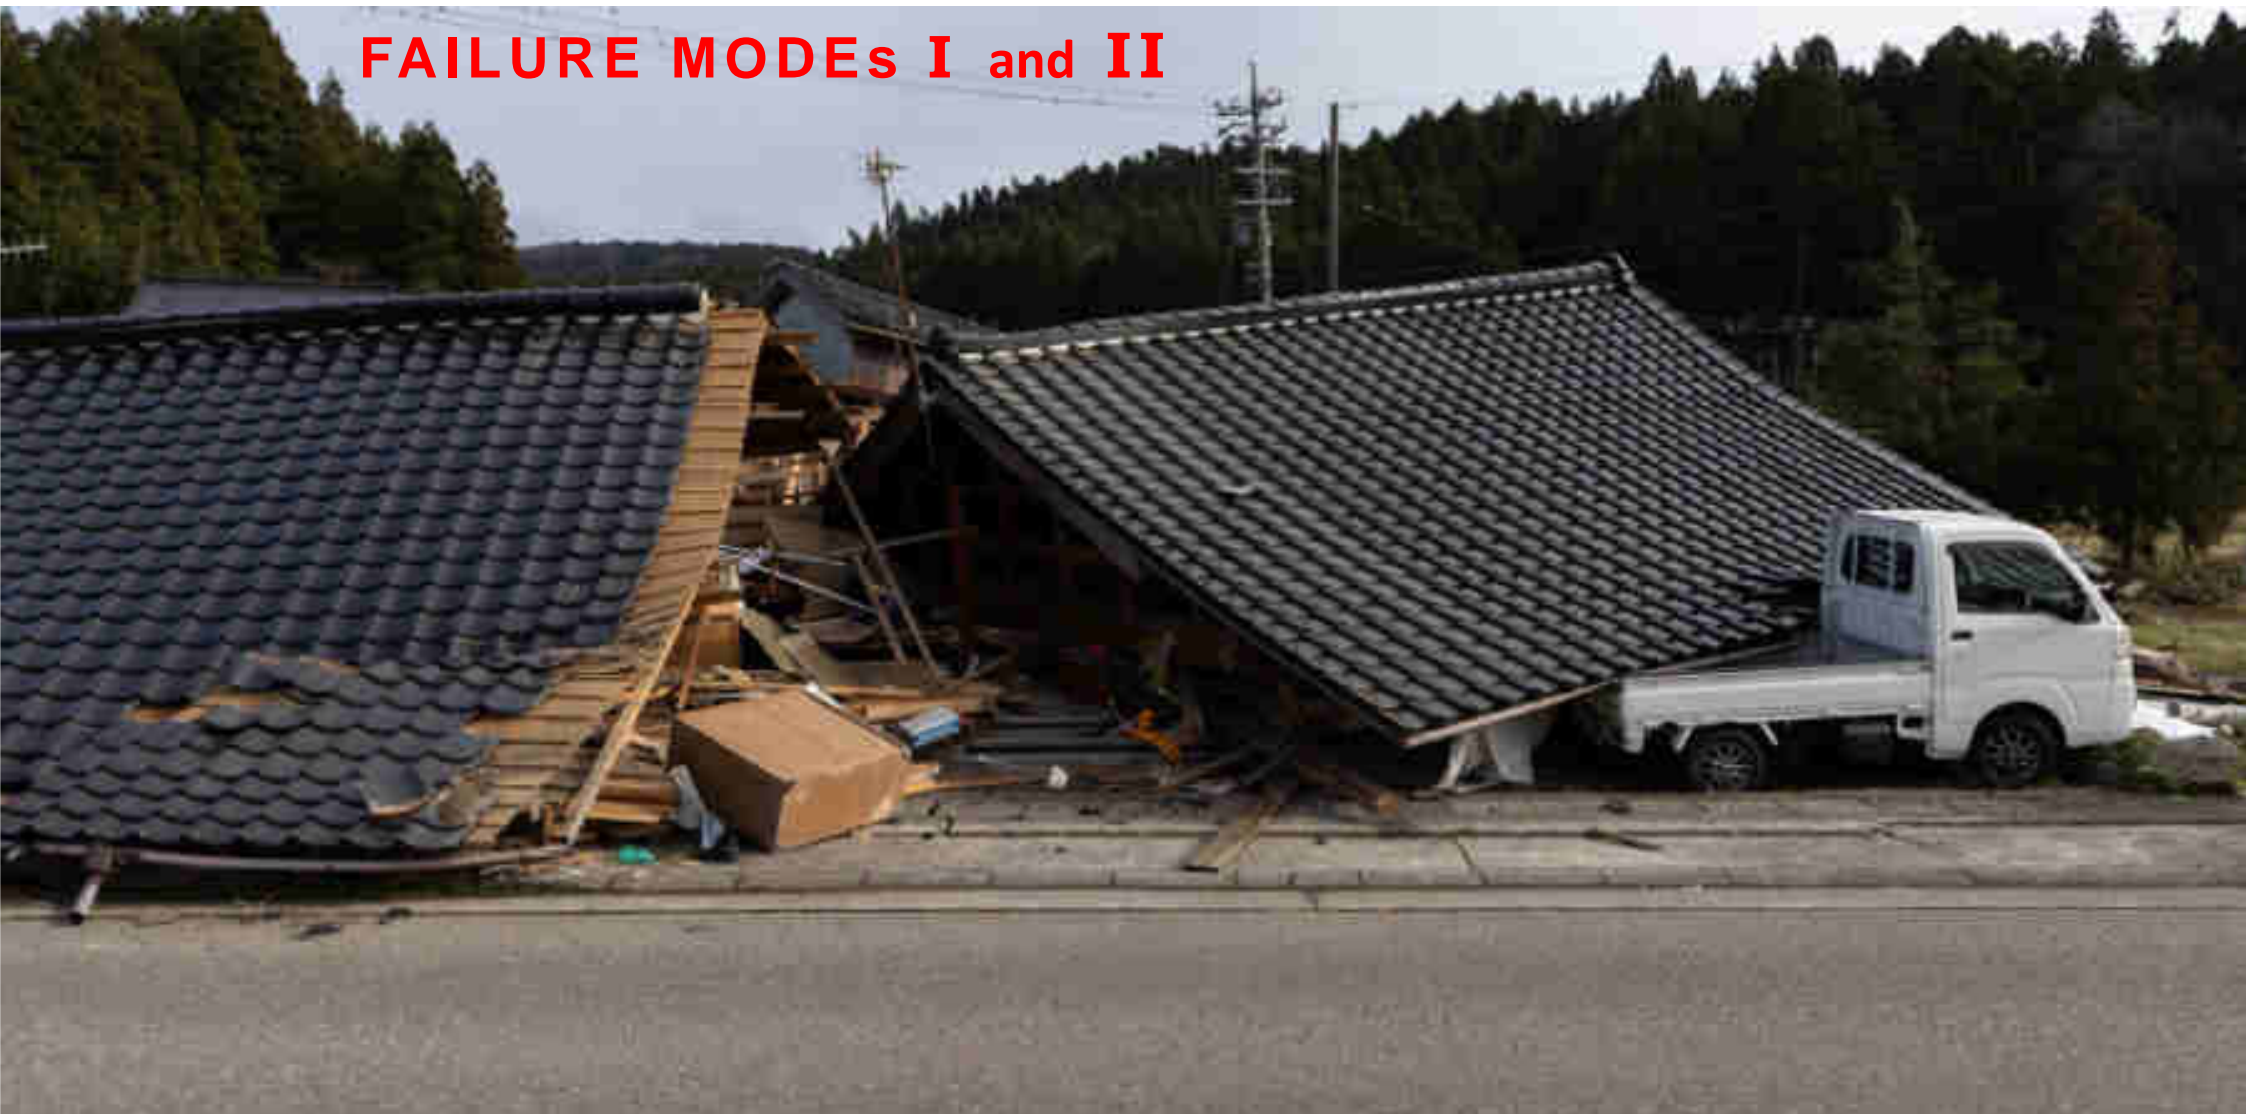
**FAILURE MODEs I and II**

**WAJIMA.**

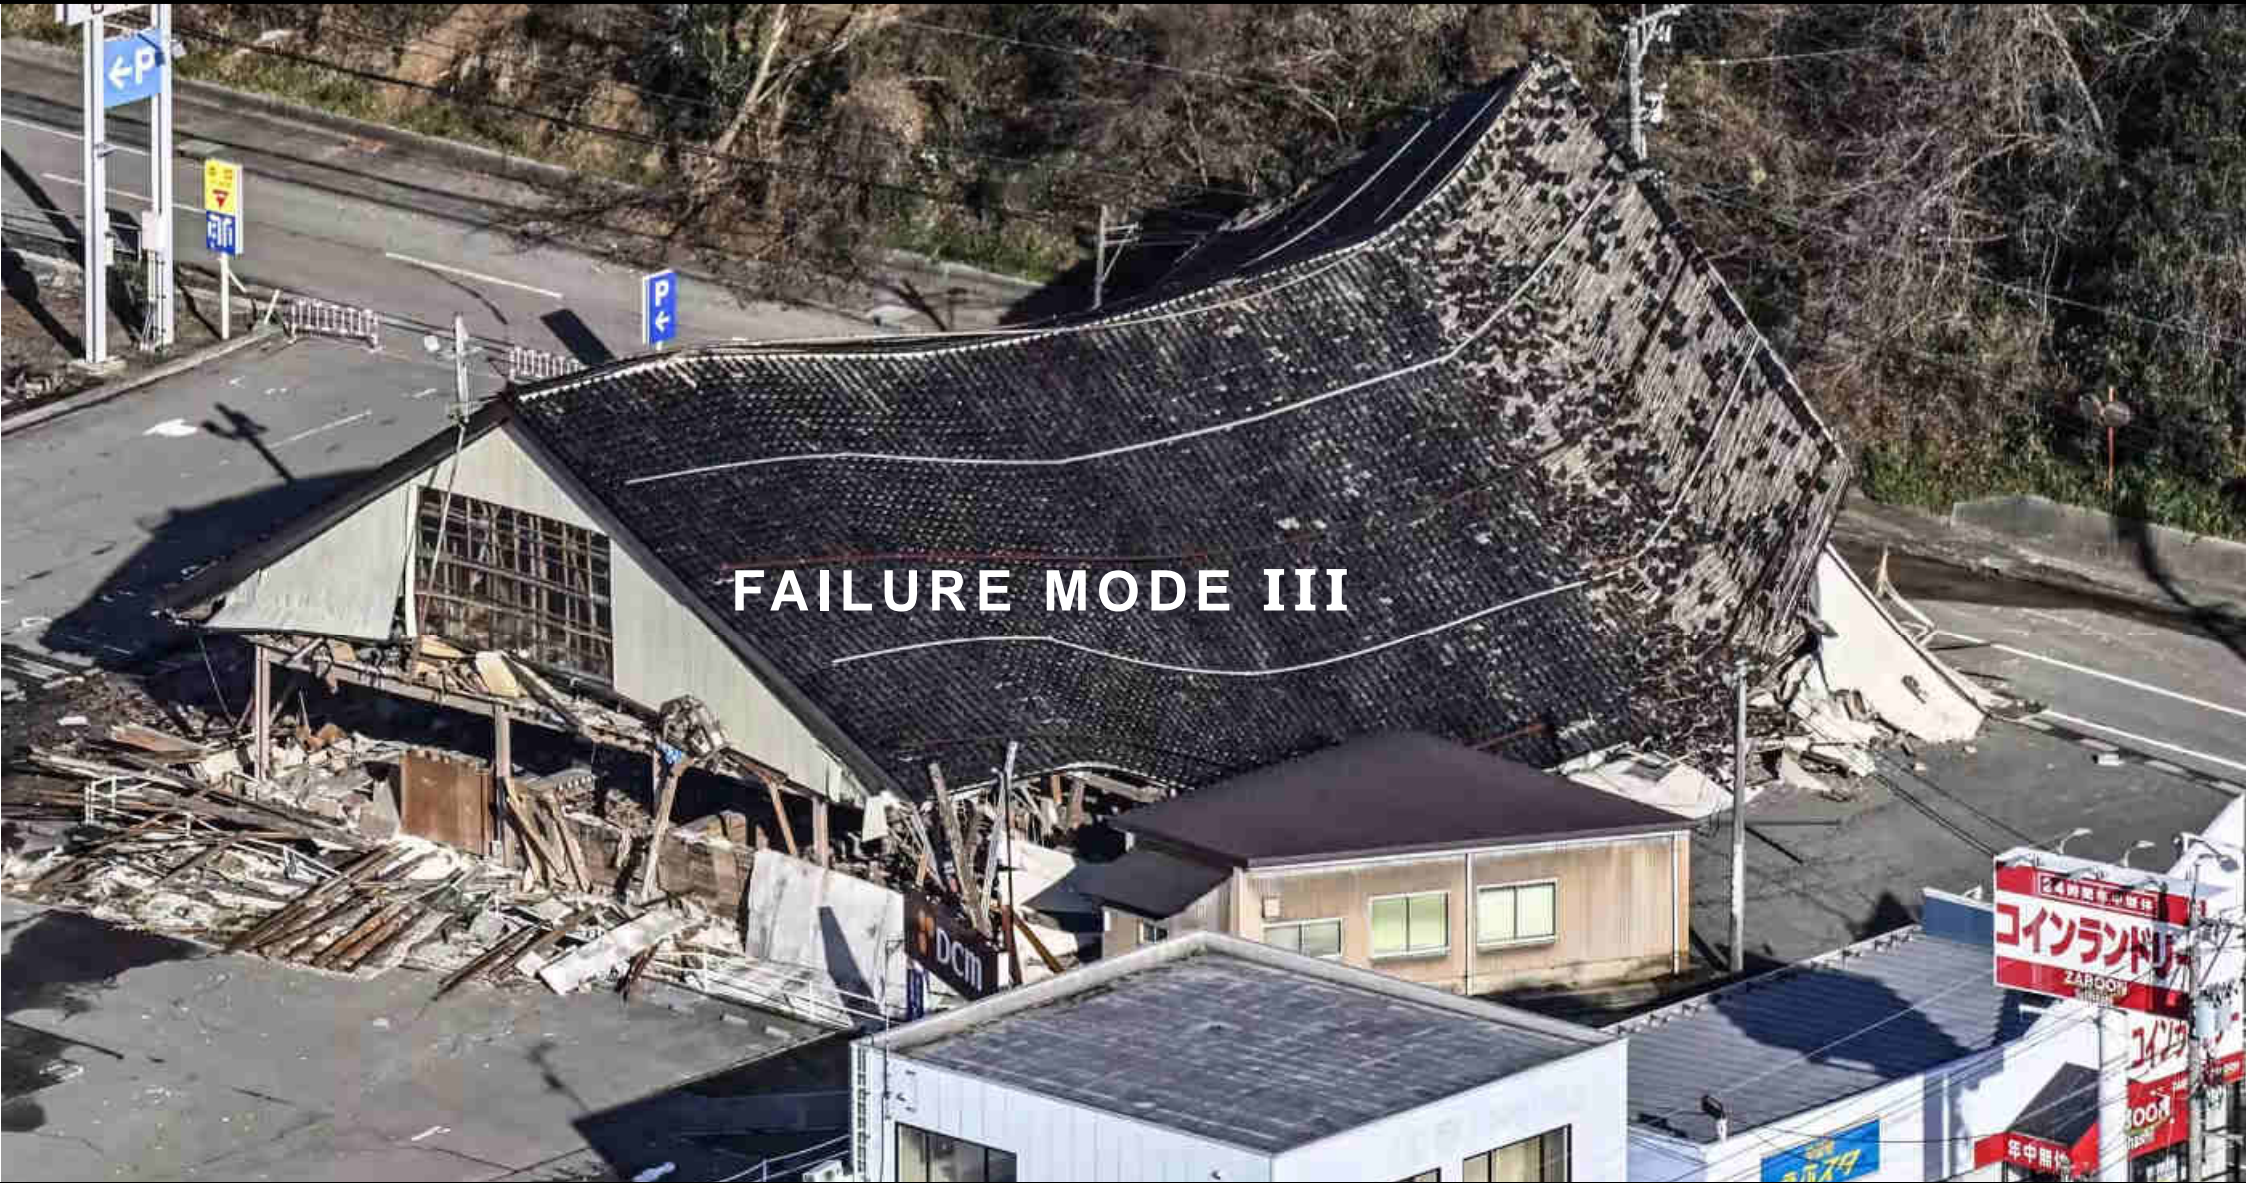
**FAILURE MODE III**

**Collapsed building in Nanao**

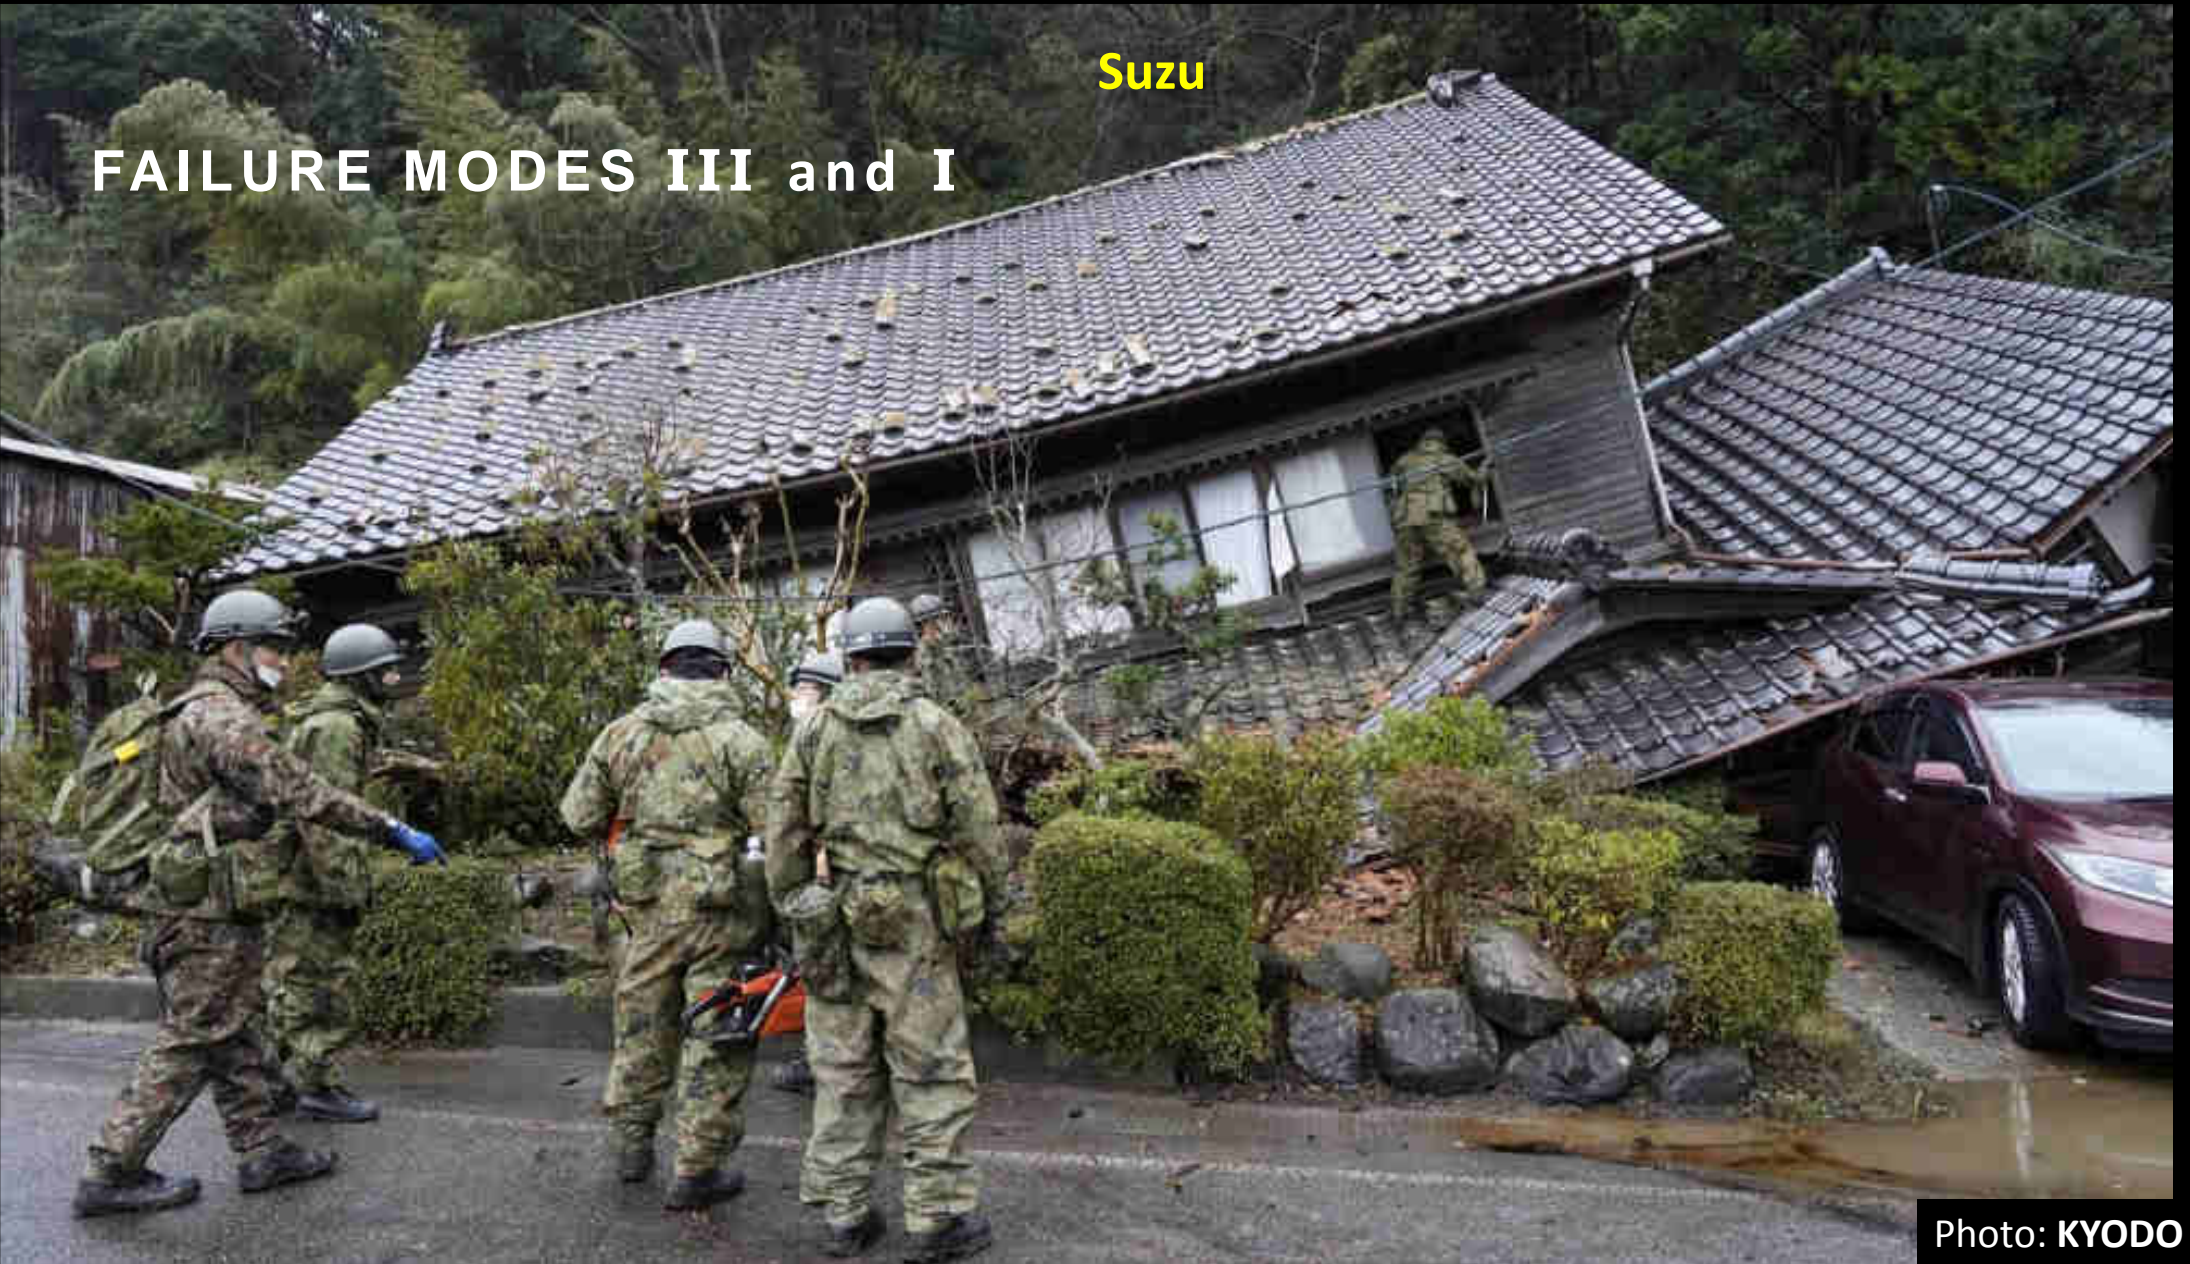
FAILURE MODES III and I

Suzu

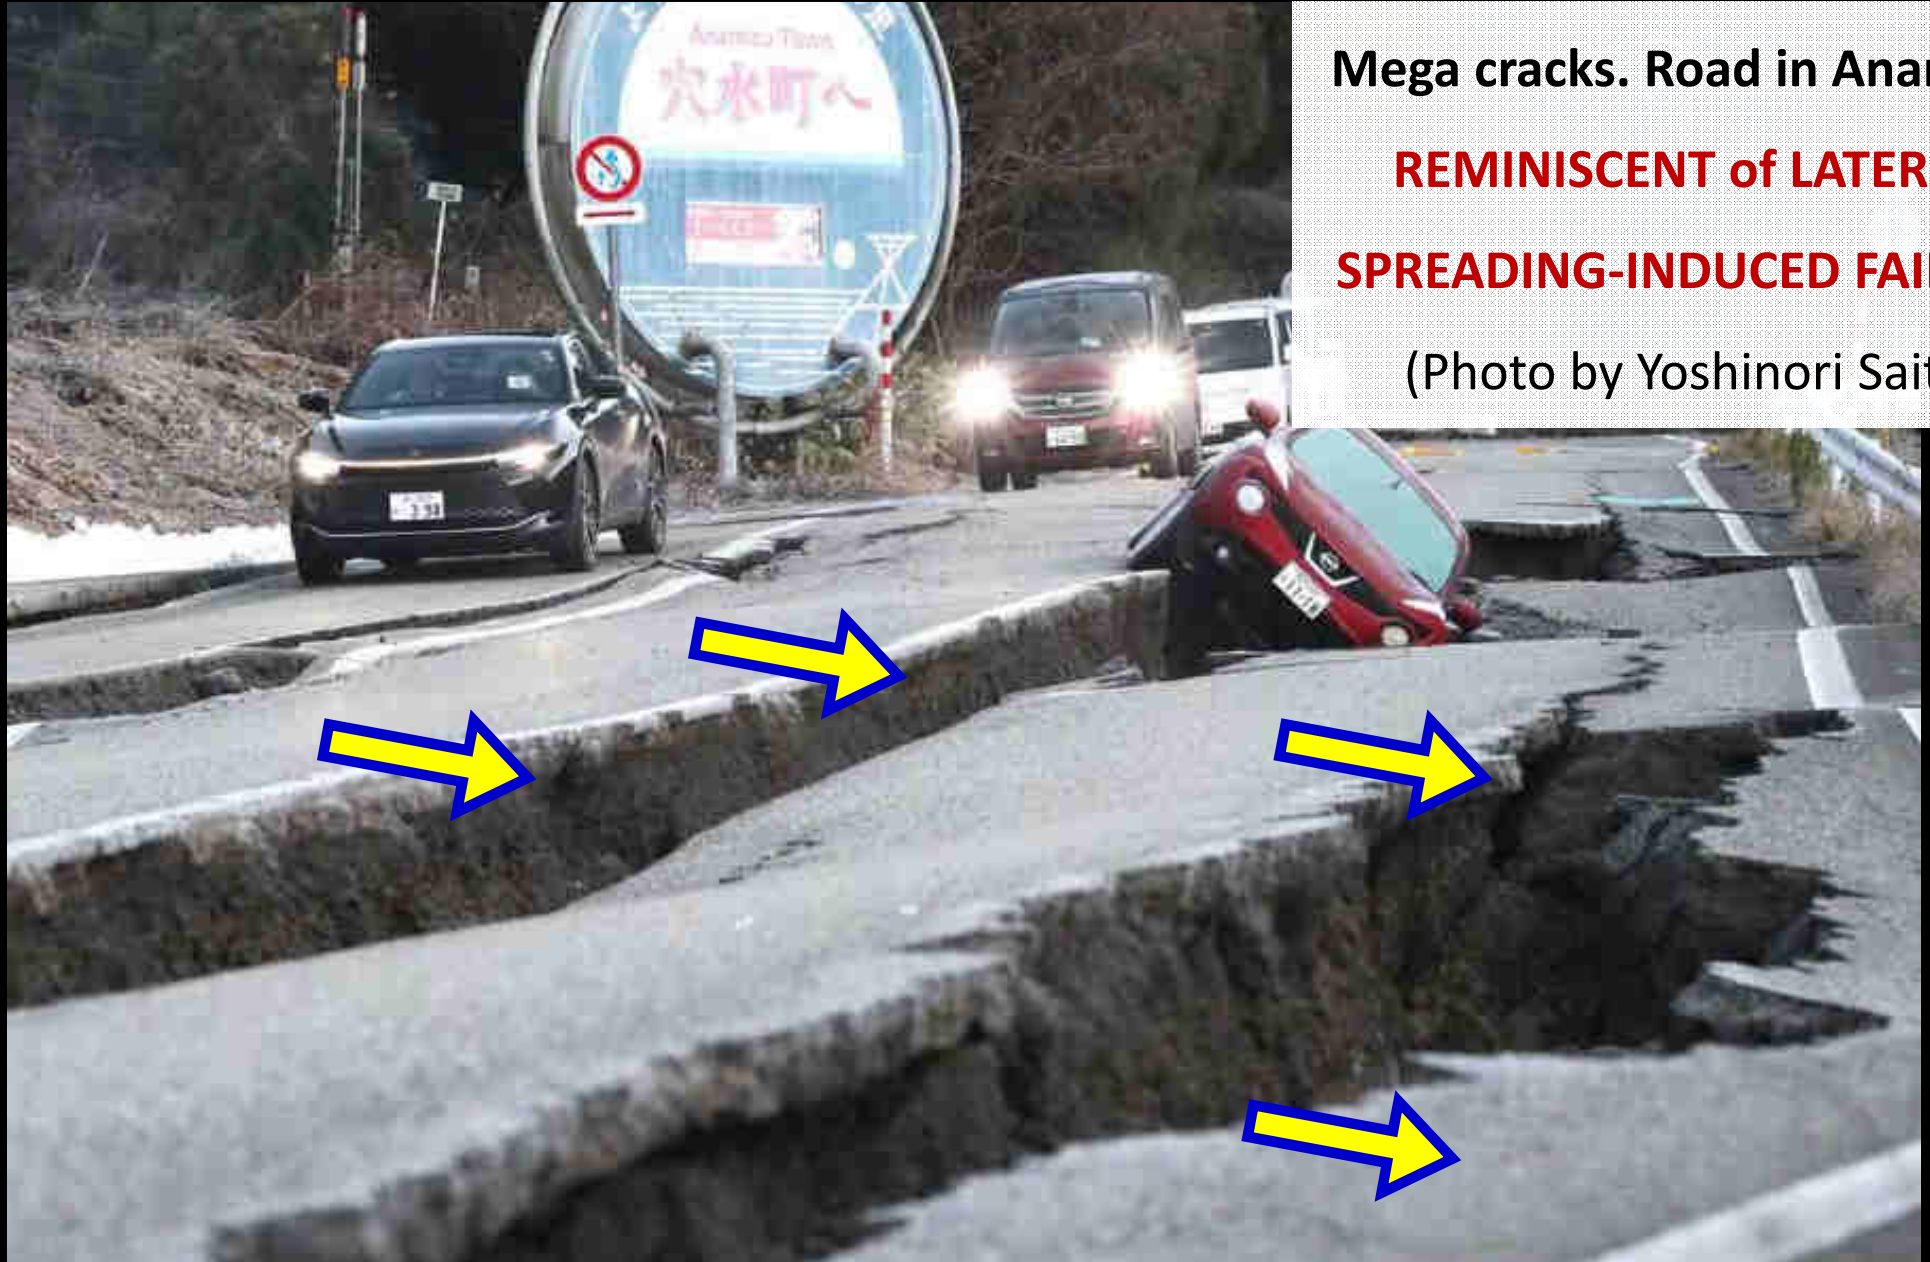
Mega cracks. Road in Anamizu.

**REMINISCENT of LATERAL  
SPREADING-INDUCED FAILURE**

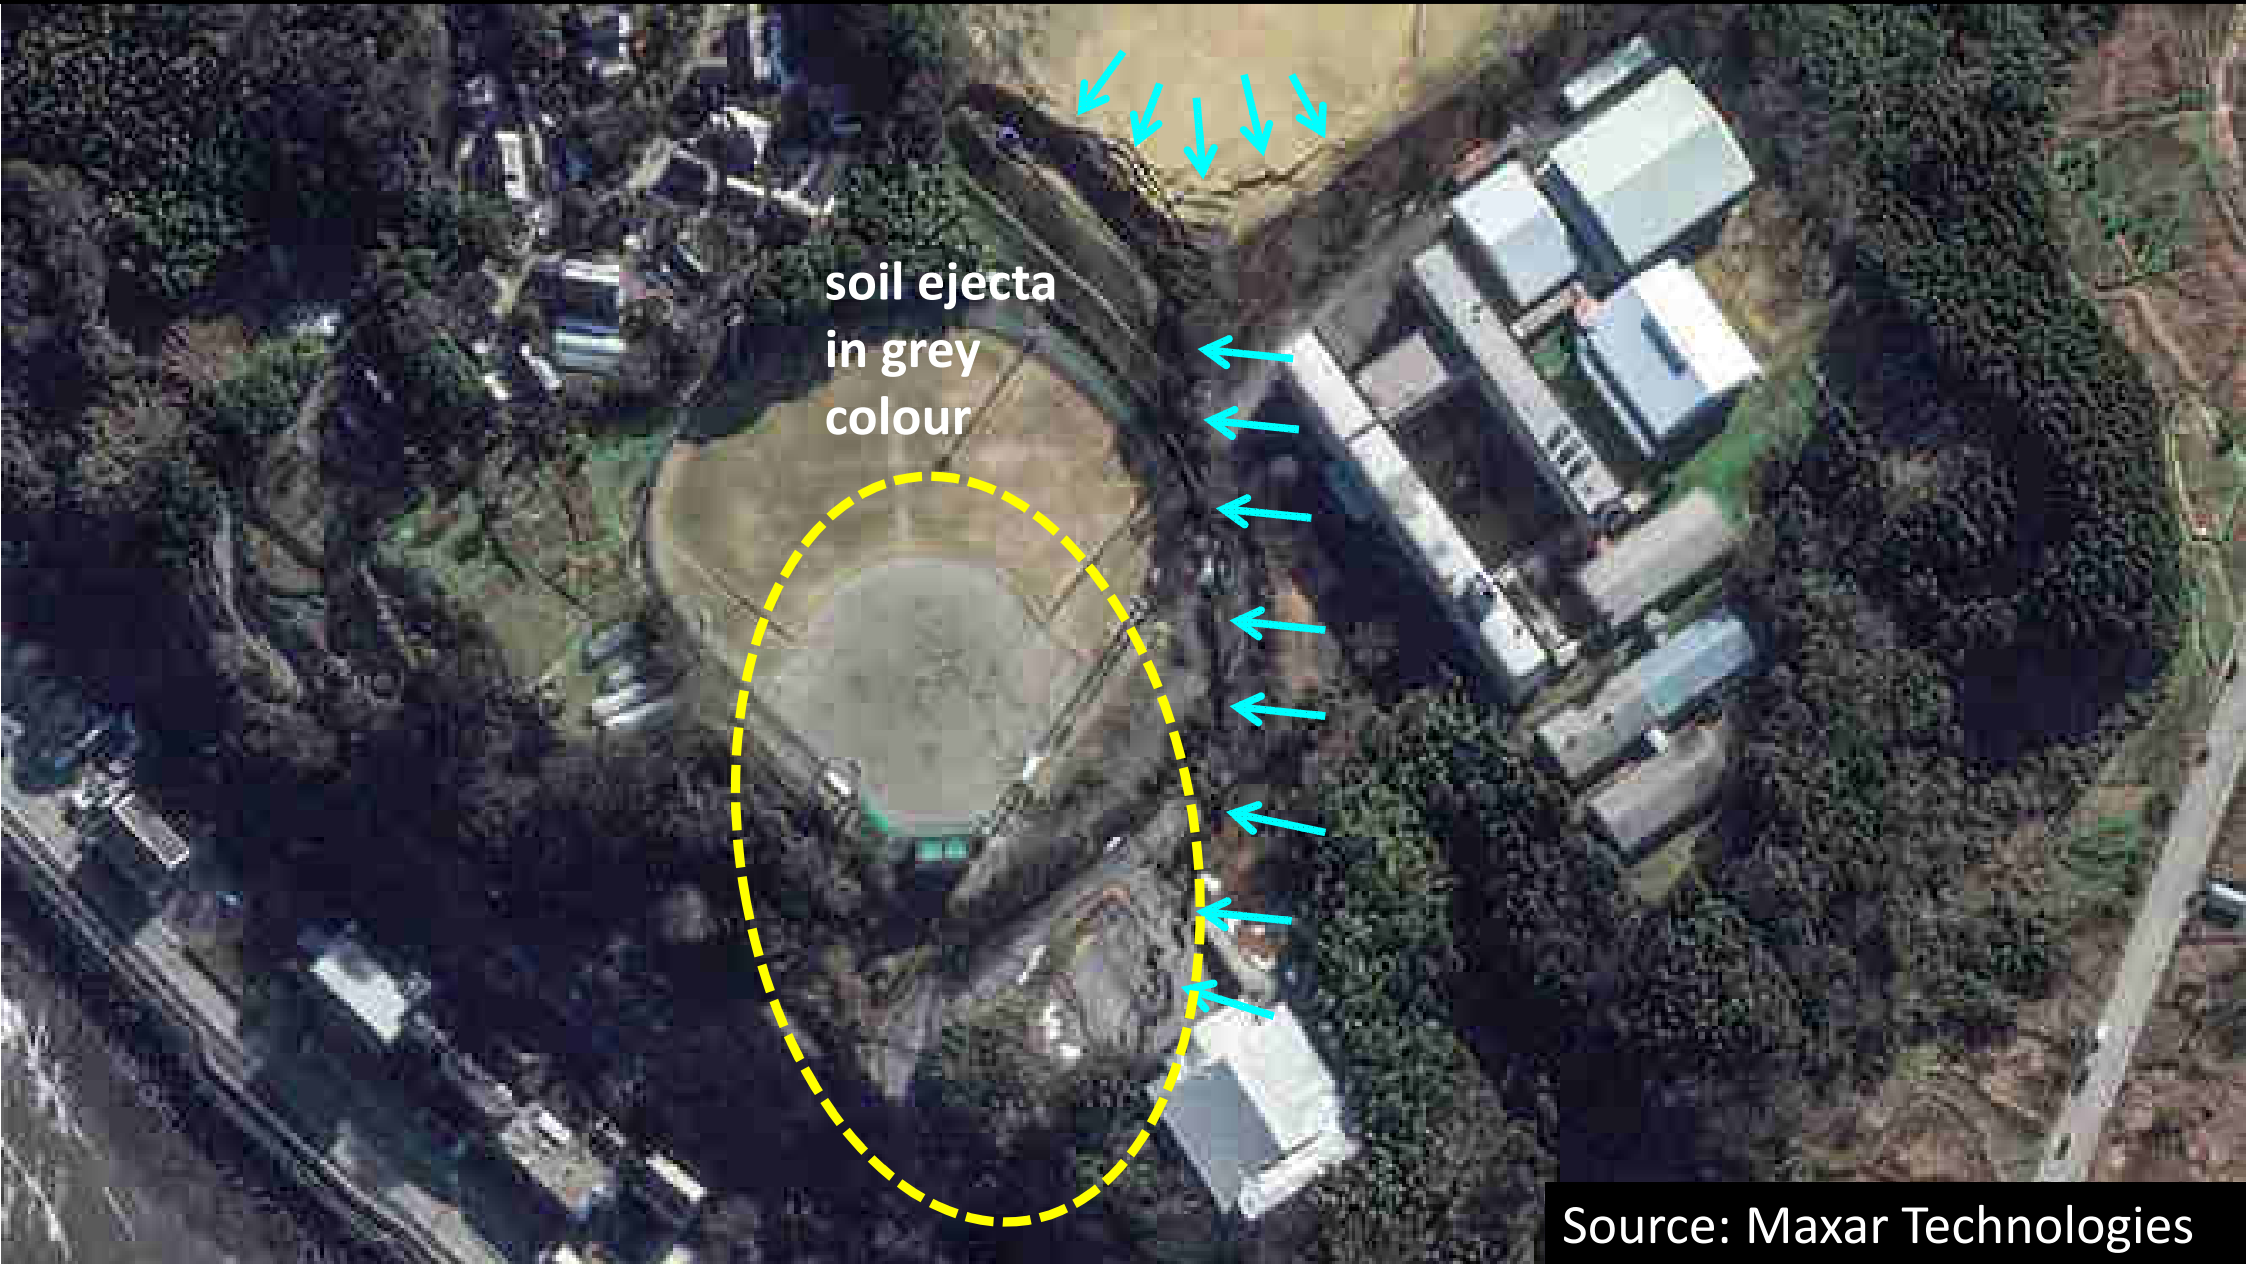
soil ejecta  
in grey  
colour
