## SEISMIC PERFORMANCE OF ROCK BLOCK STRUCTURES WITH OBSERVATIONS FROM THE OCTOBER 2006 HAWAII EARTHQUAKE

Edmund MEDLEY<sup>1</sup>, Dimitrios ZEKOS<sup>2</sup>

Keywords: rock block structures, Hawaii earthquakes, earthquake observations, geomechanical failures

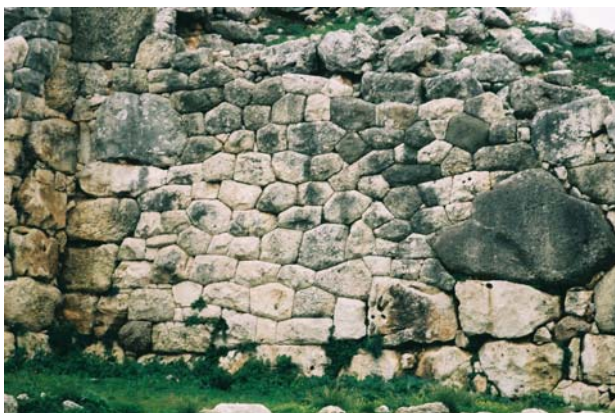
**Figure 1. Polygonal masonry construction (in the center) used to repair section of Cyclopean masonry (left and right) at Mycenae.**

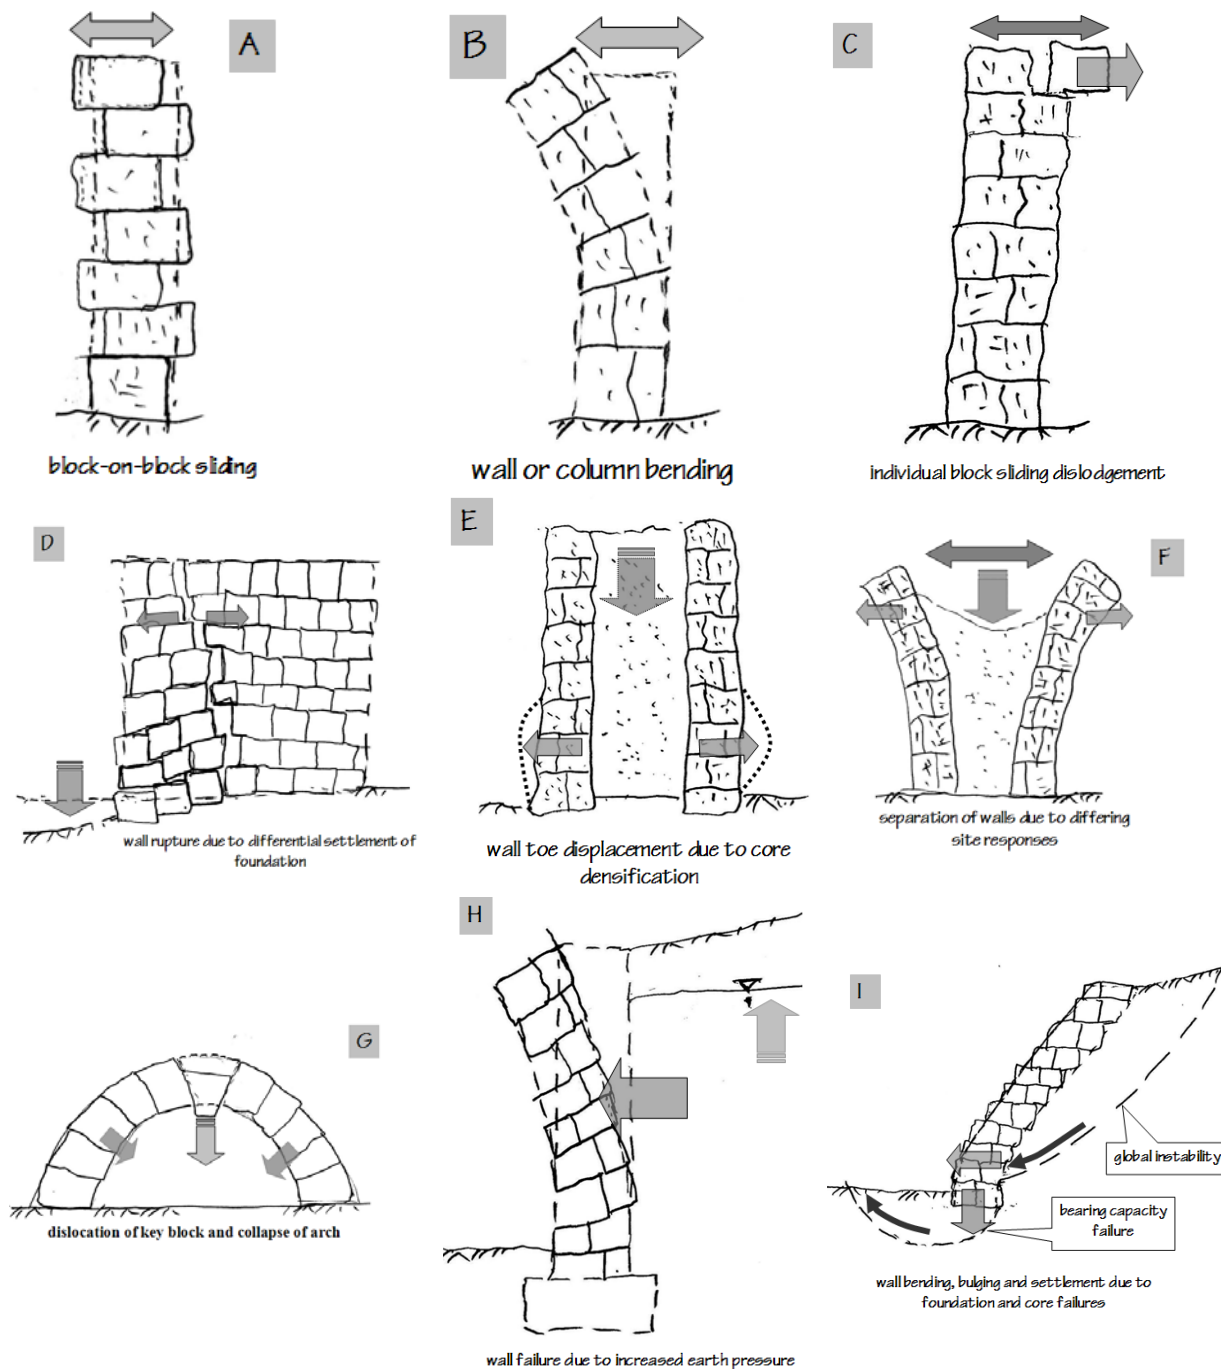
- A) Block-on-block sliding of columns: whereas stacked blocks of rocks, that could be for example part of a column of a temple, move relative to each other as a result of seismic excitation and exhibit permanent relative seismic displacement.
- B) Bending of a (generally mortared) wall or column during seismic loading as a result of the structural response of the column or the structure that the column supports.
- C) Sliding and dislodgement of blocks; that could occur during earthquake loading of the structure that has been exposed to centuries of weathering and erosion.

**Figure 10. (A-I) Failure modes of rock block structures.**

- D) Dislocation of walls due to differential settlement of foundation soils, which could take place under static or seismic conditions. An example of this mode for an Inca wall in Machu Pichu is presented by Wright and Zegarra (2000).

- E) Loss of strength of loose soil or rubble cores or backfill, and imposition of additional loading on walls; and (F) separation of block walls due to differing response of fill and exterior walls; Such modes of failure have been observed in shake table tests performed by Meyer et al. (2007) on brick and stone walls.

- G) Loss of arch key block and deformation of arch legs. Such failure modes have been observed on Mycenaean underground burial chambers known as “treasuries”.

- H) Increase in earth pressures of core or backfill, possibly by the elevation of water.
- I) Wall deformation due to global instability such as failure of the core or backfill; or a failure at the toe due to inadequate bearing capacity of the underlying soils.

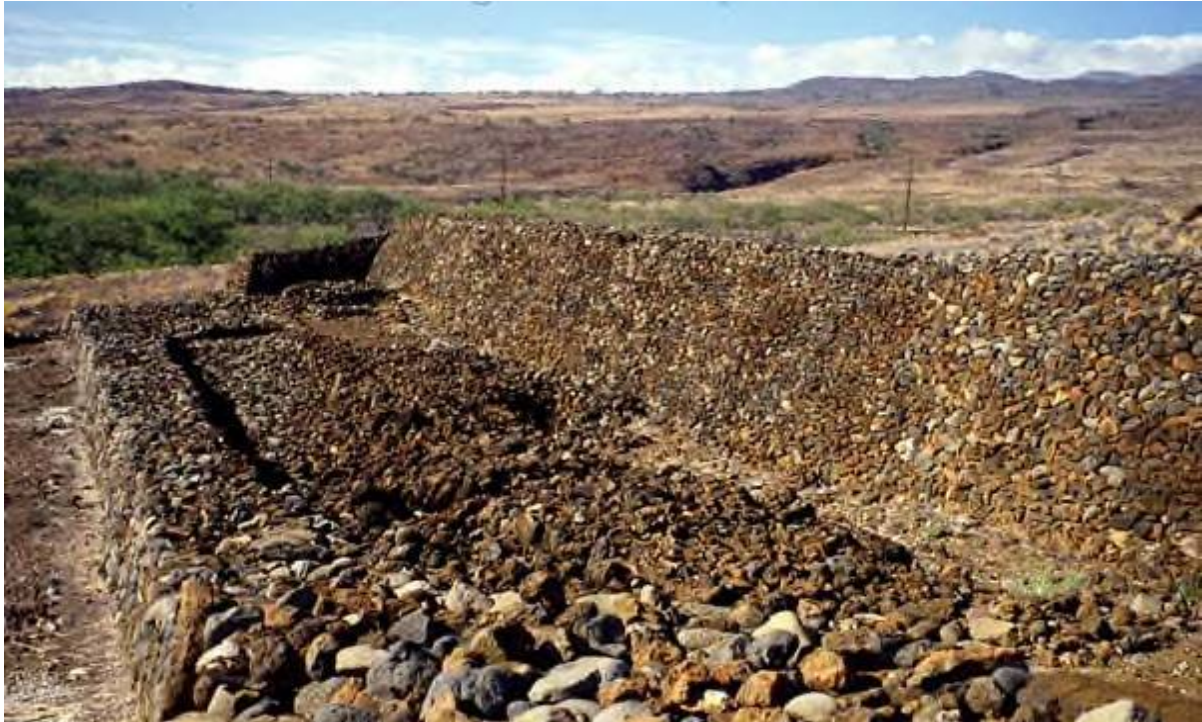
Figure 13. Mailekini Heiau, pre- earthquake (photo [www.pacificworlds.com/kawaihae](http://www.pacificworlds.com/kawaihae)).

The Pu'ukoholā and Mailekini Heiaus were both severely damaged by the October 15 2006 earthquakes, the epicenters of which were less than 50 km away (Figure 11). At the Mailekini heiau, much of the interior face of the east wall slumped and raveled (Figure 13 and Figure 14). The worst damage at the Pu'ukoholā Heiau was to high retaining walls bounding the sole access passage (Figure 15 and Figure 16). Many wall bulges were observed at originally steep wall faces (40 to 50 degrees) resulting in further steepening of the wall faces near the bottom of the edifice (Figure 17 and Figure 18), although it is likely that some bulging had occurred before the earthquakes. The bulging suggests that there are future vulnerabilities to increased rock face instability and possible eventual collapses from future earthquakes or creep deformation (Medley, 2006). Some slumps and ravel of the wall faces occurred where the bulges over-steepened and collapsed (Figure 19) apparently in much the same fashion as sketched in Figure 10J. The angle of repose for the slumps was about 30 degrees, with run-outs extending to more than 5 m from the original toe of the walls.

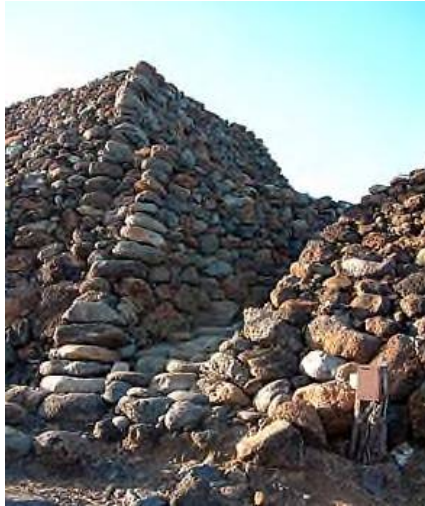
**Figure 15. Pre-earthquake view of entrance passageway into Pu'ukoholā**  
(Photo [www.pacificworlds.com/kawaohae](http://www.pacificworlds.com/kawaohae)).

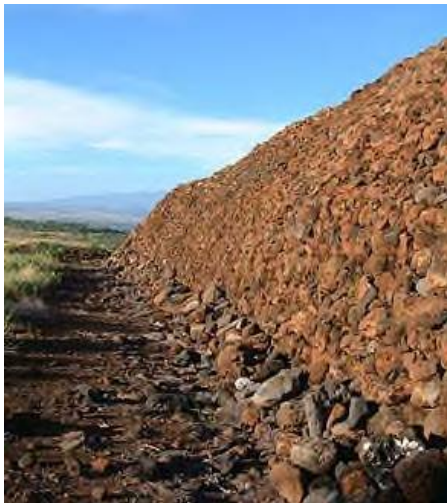
**Figure 17. Pre-earthquake condition of Pu'ukoholā Outer Wall, from near NE corner**  
(Photo: [www.pacificworlds.com/kawaihae](http://www.pacificworlds.com/kawaihae)).
