## SEISMIC PERFORMANCE OF ROCK BLOCK STRUCTURES WITH OBSERVATIONS FROM THE OCTOBER 2006 HAWAII EARTHQUAKE

Edmund MEDLEY<sup>1</sup>, Dimitrios ZEKOS<sup>2</sup>

Keywords: rock block structures, Hawaii earthquakes, earthquake observations, geomechanical failures

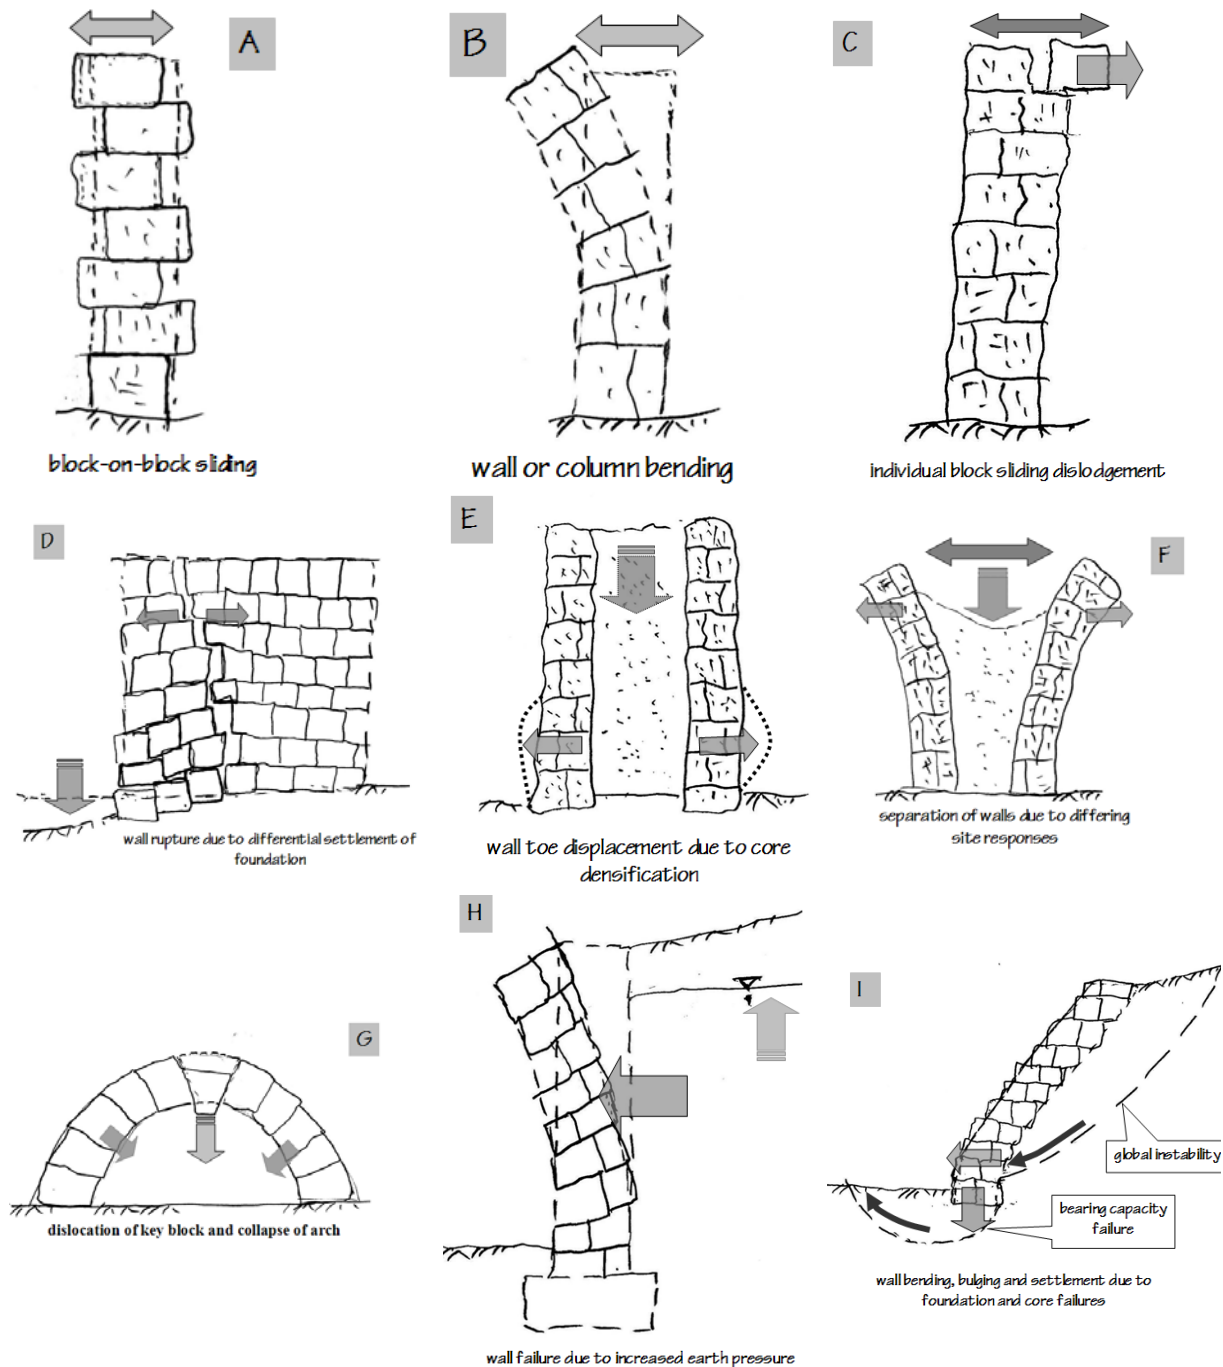
Figure 10 shows several modes of failure, which have been observed in the laboratory, on sites of culturally significant rock block structures or can be expected for rock block structures subjected to seismic loading. These modes are:

- A) Block-on-block sliding of columns: whereas stacked blocks of rocks, that could be for example part of a column of a temple, move relative to each other as a result of seismic excitation and exhibit permanent relative seismic displacement.
- B) Bending of a (generally mortared) wall or column during seismic loading as a result of the structural response of the column or the structure that the column supports.
- C) Sliding and dislodgement of blocks; that could occur during earthquake loading of the structure that has been exposed to centuries of weathering and erosion.

**Figure 10. (A-I) Failure modes of rock block structures.**

- D) Dislocation of walls due to differential settlement of foundation soils, which could take place under static or seismic conditions. An example of this mode for an Inca wall in Machu Pichu is presented by Wright and Zegarra (2000).

- E) Loss of strength of loose soil or rubble cores or backfill, and imposition of additional loading on walls; and (F) separation of block walls due to differing response of fill and exterior walls; Such modes of failure have been observed in shake table tests performed by Meyer et al. (2007) on brick and stone walls.

- G) Loss of arch key block and deformation of arch legs. Such failure modes have been observed on Mycenaean underground burial chambers known as “treasuries”.

- H) Increase in earth pressures of core or backfill, possibly by the elevation of water.
- I) Wall deformation due to global instability such as failure of the core or backfill; or a failure at the toe due to inadequate bearing capacity of the underlying soils.

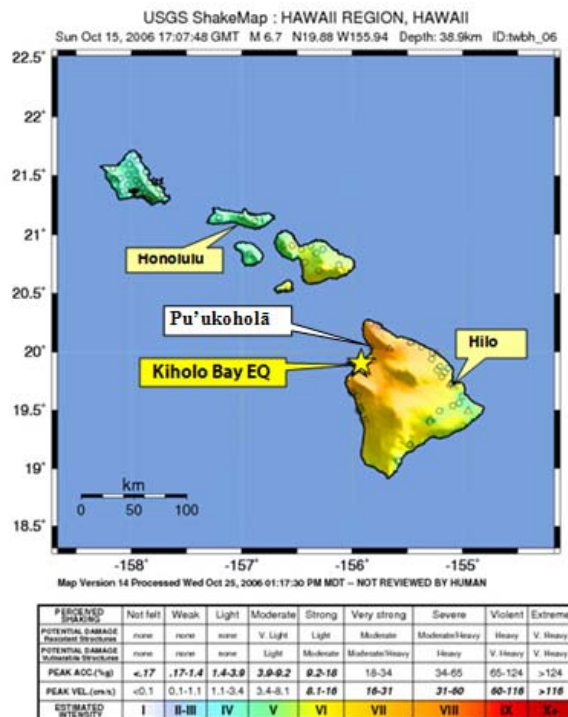
Figure 11. USGS ShakeMap for the M6.7 Kiholo Bay earthquake (after USGS).

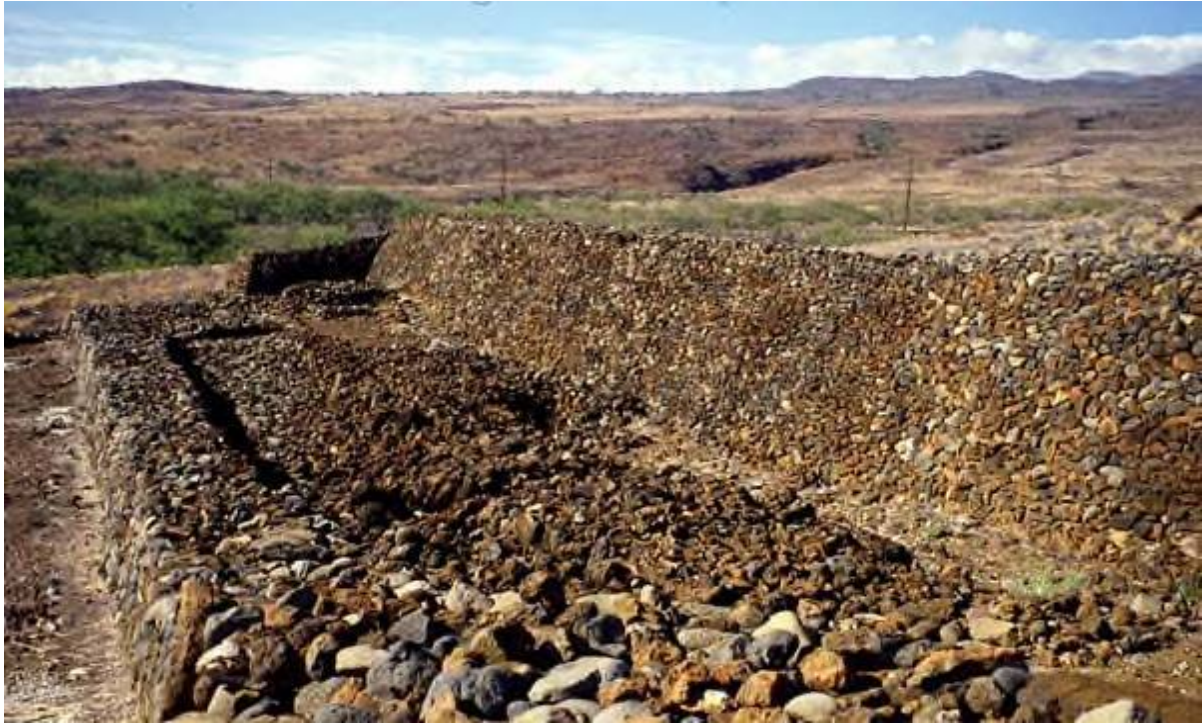
Figure 13. Mailekini Heiau, pre- earthquake (photo [www.pacificworlds.com/kawaihae](http://www.pacificworlds.com/kawaihae)).

The Pu'ukoholā and Mailekini Heiaus were both severely damaged by the October 15 2006 earthquakes, the epicenters of which were less than 50 km away (Figure 11). At the Mailekini heiau, much of the interior face of the east wall slumped and raveled (Figure 13 and Figure 14). The worst damage at the Pu'ukoholā Heiau was to high retaining walls bounding the sole access passage (Figure 15 and Figure 16). Many wall bulges were observed at originally steep wall faces (40 to 50 degrees) resulting in further steepening of the wall faces near the bottom of the edifice (Figure 17 and Figure 18), although it is likely that some bulging had occurred before the earthquakes. The bulging suggests that there are future vulnerabilities to increased rock face instability and possible eventual collapses from future earthquakes or creep deformation (Medley, 2006). Some slumps and ravel of the wall faces occurred where the bulges over-steepened and collapsed (Figure 19) apparently in much the same fashion as sketched in Figure 10J. The angle of repose for the slumps was about 30 degrees, with run-outs extending to more than 5 m from the original toe of the walls.

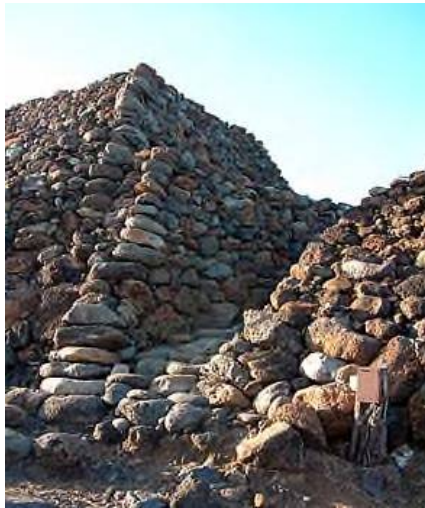
**Figure 15. Pre-earthquake view of entrance passageway into Pu'ukoholā**  
(Photo: [www.pacificworlds.com/kawaihae](http://www.pacificworlds.com/kawaihae)).

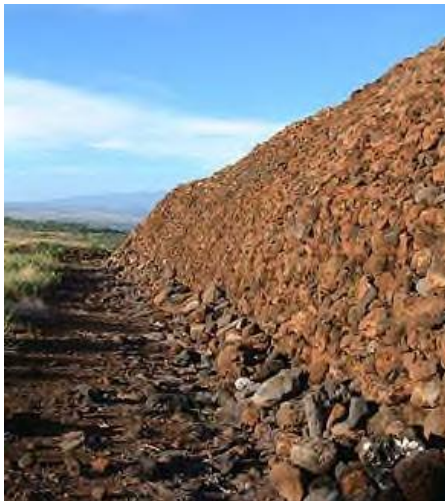
**Figure 17. Pre-earthquake condition of Pu'ukoholā Outer Wall, from near NE corner**  
(Photo: [www.pacificworlds.com/kawaihae](http://www.pacificworlds.com/kawaihae)).
