**FORENSIC INVESTIGATION OF THE FAILURE OF AN
INTERCEPTOR SEWER, SEA CLIFF AREA, SAN FRANCISCO,
CALIFORNIA**

Dr. Edmund W. Medley, P.E., C.E.G.

**Proceedings of WEFTEC 2000
Water Environment Federation
Anaheim, CA October 2000**

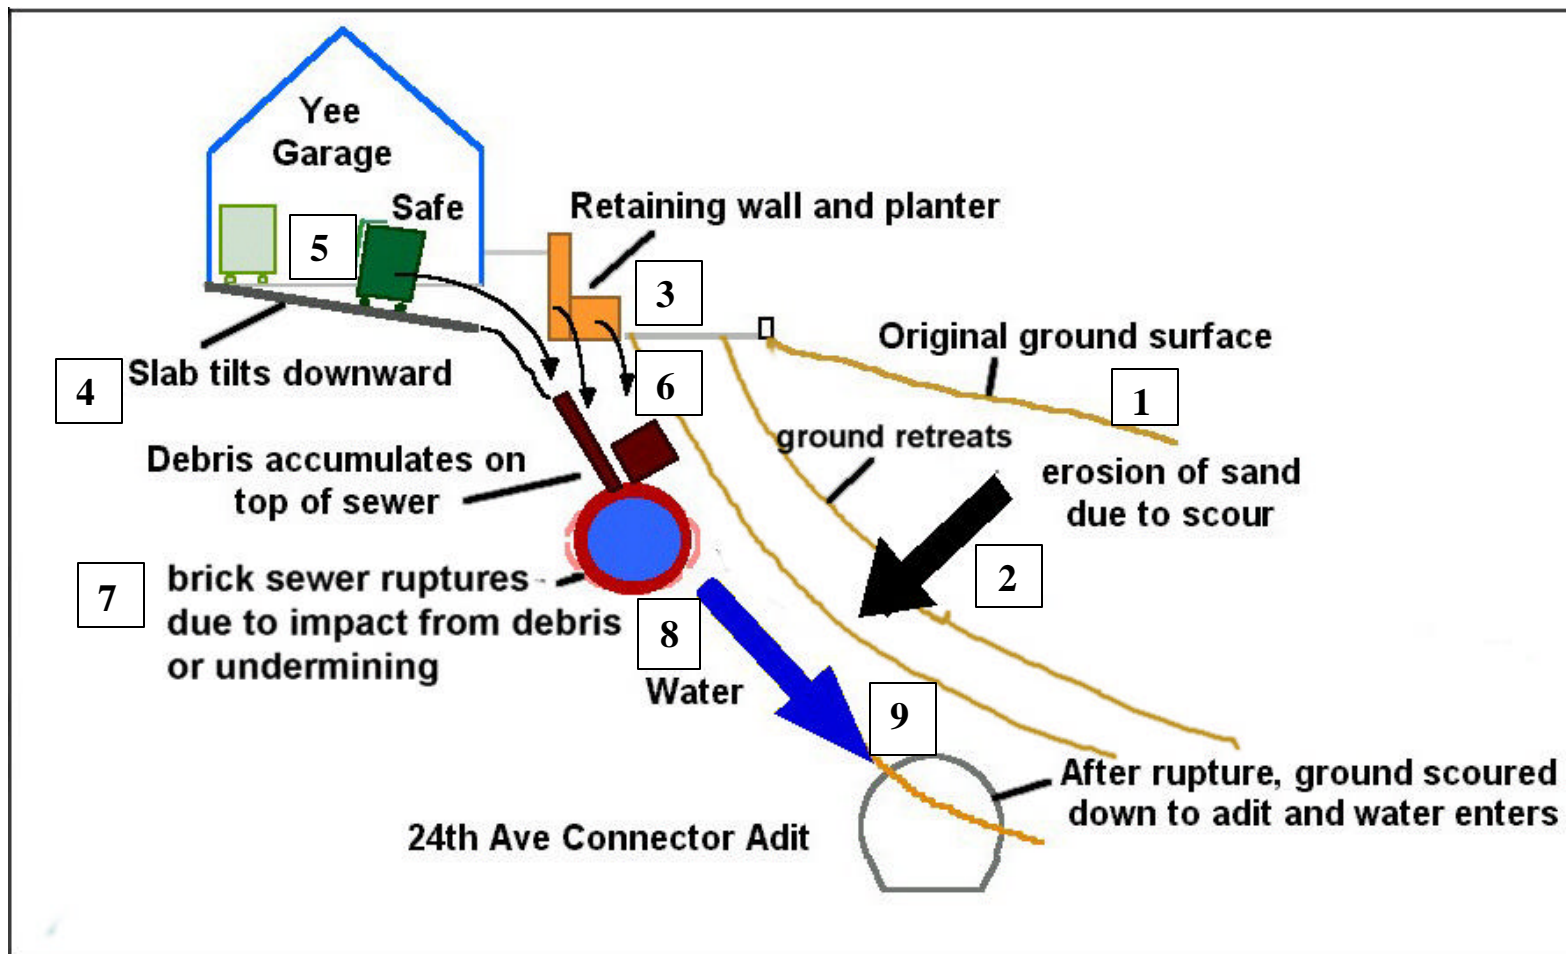
Once the sewer ruptured, the full force of the storm water was unleashed upon the sand soil supporting the sewer. Aggressive erosion resulted in northerly and downward scour toward Lobos Creek and the 24th Avenue Connector adit ([Figure 13](#)). As the water flowed north and downward toward the creek, erosion of the bottom of the south-facing slope of El Camino del Mar occurred, and a rapid series of small slope failures resulted. At about 0245 to 0250, water eventually breached the thin temporary ground support inside the 24th Avenue Connector adit. Once the water had entered the adit, it flowed unimpeded down the Richmond Transport, to reach the surveyors, about 9000 feet away, some 15 to 20 minutes later.

Figure 13 Cross-Section adjacent Yee Residence showing most likely scenario of sewer collapse. Events are: 1: original ground; 2: ground starts to erode; 3: brick retaining wall is undermined and starts to tilt toward driveway; 4: garage slab moves downward as retaining wall moves; 5: heavy 6-foot high safe rolls down tilted slab and falls into pit; 6: safes; gateposts and other heavy object fall onto sewer; 7: sewer breaks; 8: full force of storm water flow is unleashed from broken sewer and rapidly scours downward through sand toward Lobos Creek; 9: discharge from sewer breaches adit and drains to Richmond Transport.
