**January 24, 2020 Elazığ-Sivrice Earthquake ($M_w=6.8$)
Reconnaissance Study Report**

**MIDDLE EAST TECHNICAL UNIVERSITY
EARTHQUAKE ENGINEERING RESEARCH CENTER**

REPORT NO: METU/EERC 2020-01

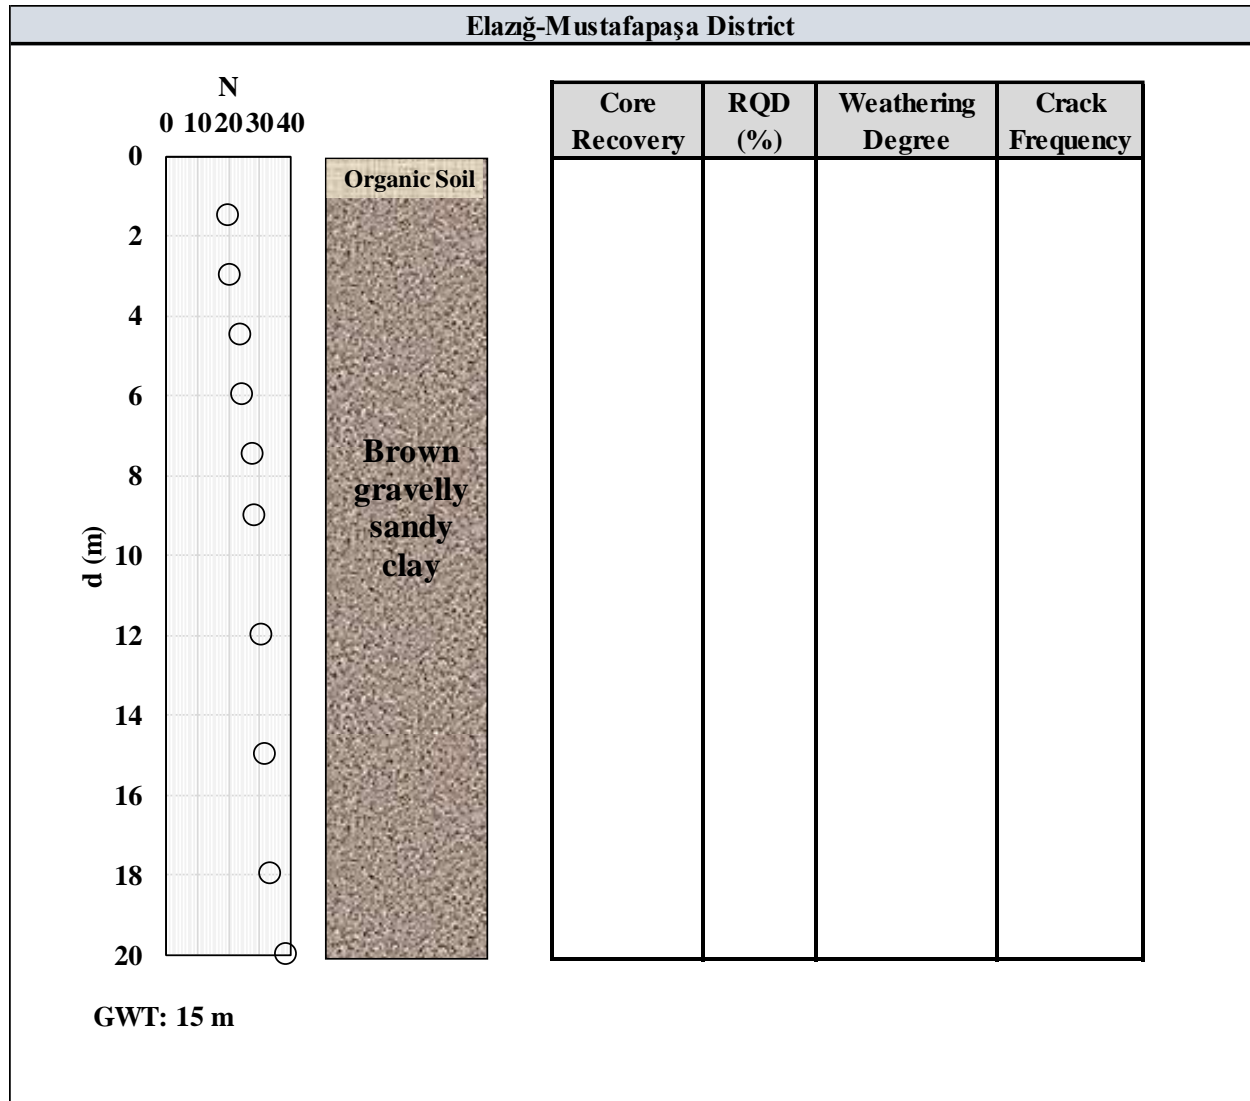
Figure 4.1. Typical Borelog for Elazığ-Mustafapaşa District

Several structurally damaged residential buildings were mapped in Elazığ-Mustafapaşa district, which is located in the city center of Elazığ city. Mustafapaşa district consists of Plio-Quaternary aged young sediments. Typical soil type observed in the district is classified as brown gravelly sandy clay. Groundwater table is typically observed at 15 meters. A representative lithology is presented in Figure 4.1. Shear wave velocity of the upper 30 m ($V_{s,30}$) for the region is estimated as 300-350 m/s by Multi-Channel Surface Wave Analysis Method (MASW). Note that the borelog given in Figure 4.1 reflects idealized soil conditions, which may not representative for the whole district.

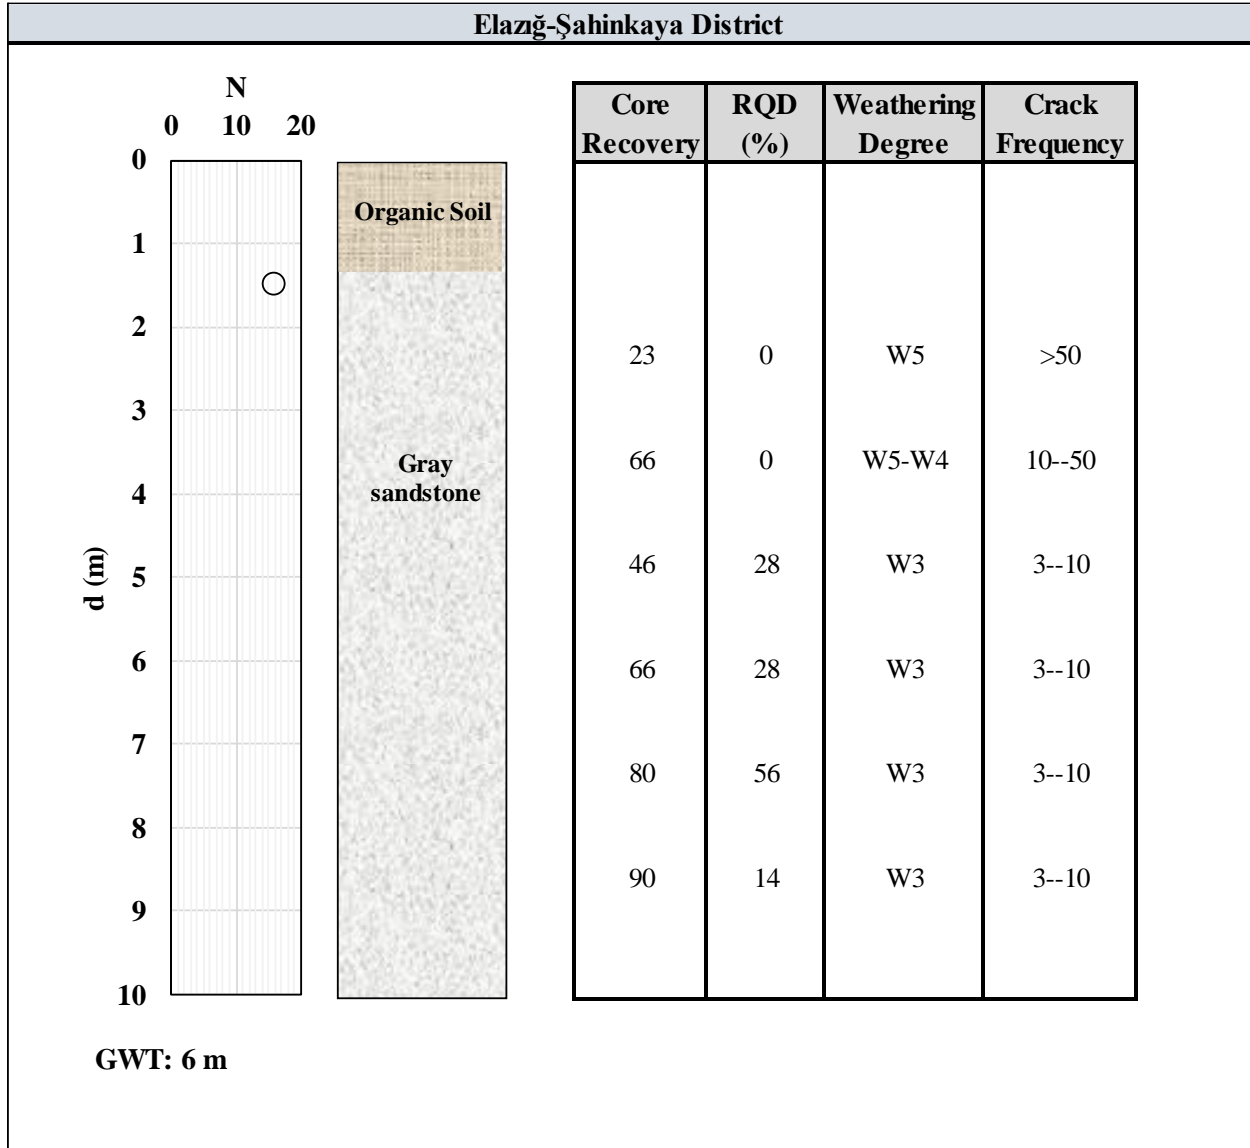
Figure 4.2. Typical Borelog for Elazığ-Şahinkaya District

In Şahinkaya district, again a concentration of structural damage has been observed. The district foundation soil/rock profile is composed of mostly weathered sandstone. The weathering and fracturing decreases with depth. Groundwater table is located at 6 meters. A representative soil/rock profile is presented in Figure 4.2. Shear wave velocity of the upper 30 m ($V_{s,30}$) for the district is estimated as 400-500 m/s by Multi-Channel Surface Wave Analysis Method (MASW).

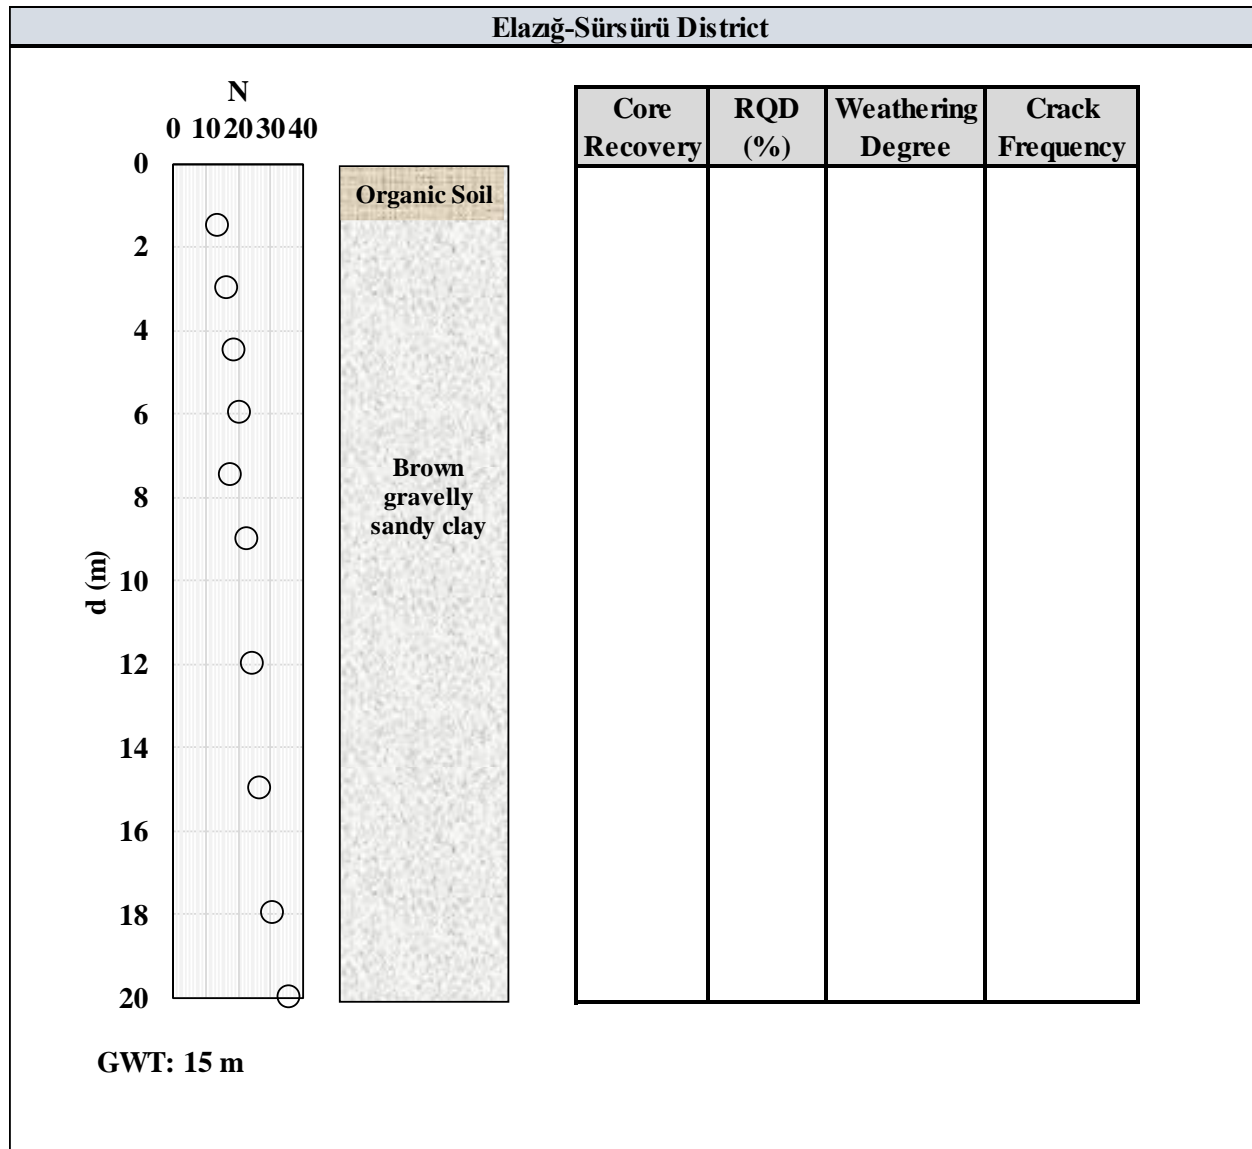
Figure 4.3. Typical Borelog for Elazığ-Sürsürü

The most of the structural damage had been concentrated in Elazığ-Sürsürü district, where Plio-Quaternary aged young sediments dominate foundation profiles. The upper surficial layers are classified as brown gravelly sandy clay. Groundwater table is located below 15 m depth. Two representative lithology are presented in Figure 4.3. Shear wave velocity of the upper 30 m ($V_{s,30}$) for the region is estimated as 350-400 m/s by Multi-Channel Surface Wave Analysis Method (MASW).

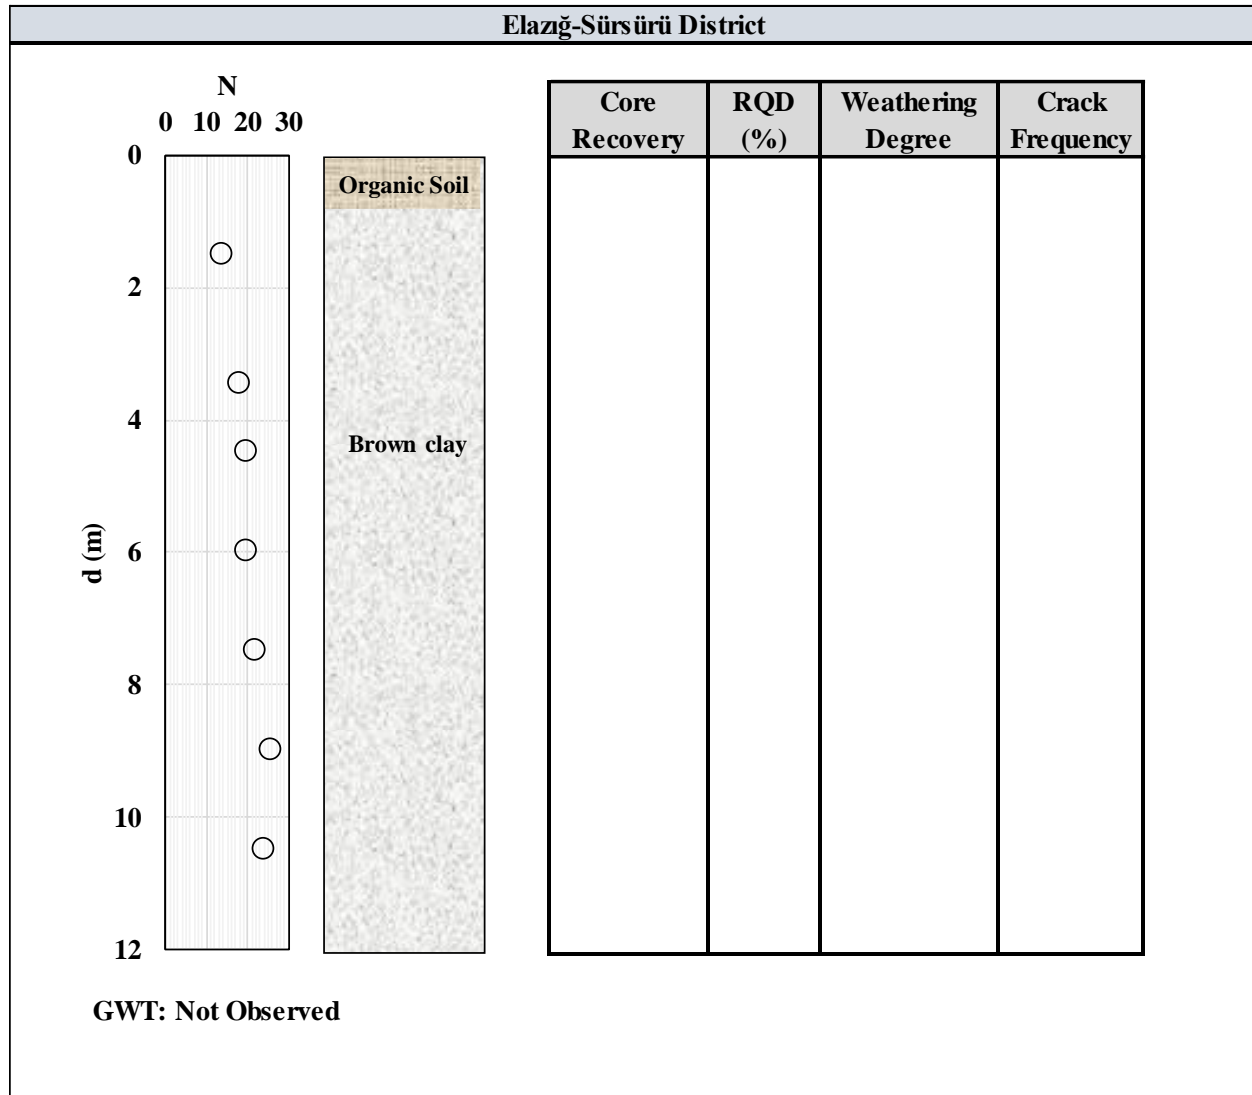
Figure 4.4. Typical Borelog for Elazığ-Sürsürü District

During the site visit, a field investigations study including borehole drilling, undisturbed and disturbed soil sampling with SPT measurements, was witnessed. The borelog of this study is retrieved by personal communication and is presented in Figure 4.4.

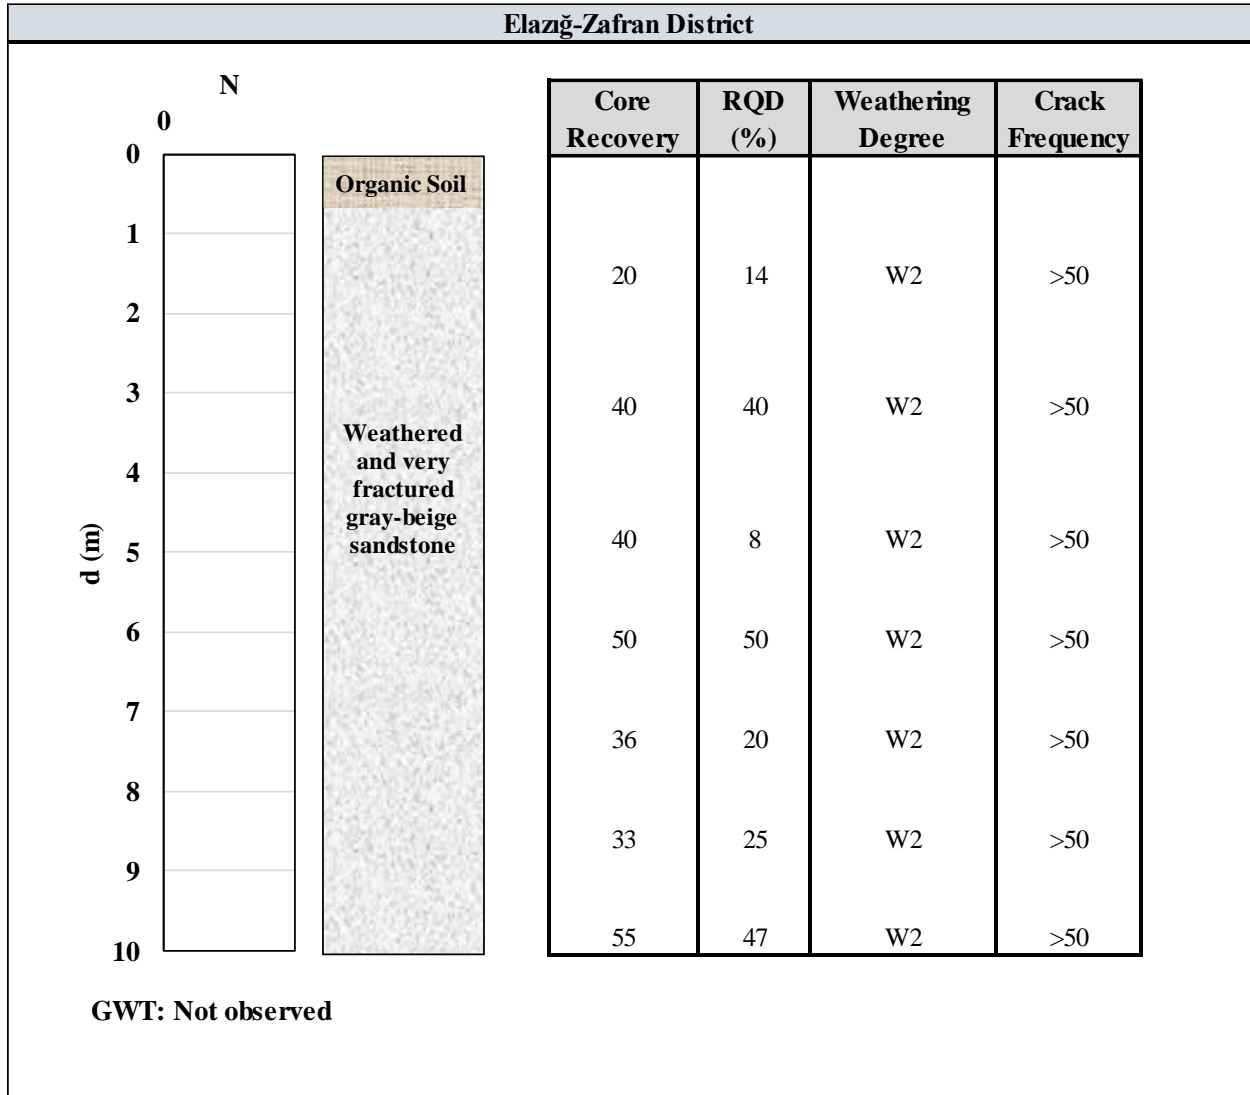
Figure 4.5. Typical Borelog for Elazığ-Zafran District

Mainly weathered and fractured gray-beige sandstone is observed in Elazığ-Zafran District. The rock becomes relatively intact with depth. Groundwater table is observed to be deeper than 10 meters. A representative soil/rock profile is presented in Figure 4.5. Shear wave velocity for the upper 30 m ($V_{s,30}$) is estimated as 650-700 m/s by Multi-Channel Surface Wave Analysis Method (MASW). The structural damage patterns specific for the district are not available yet, and will be the scope of future studies.

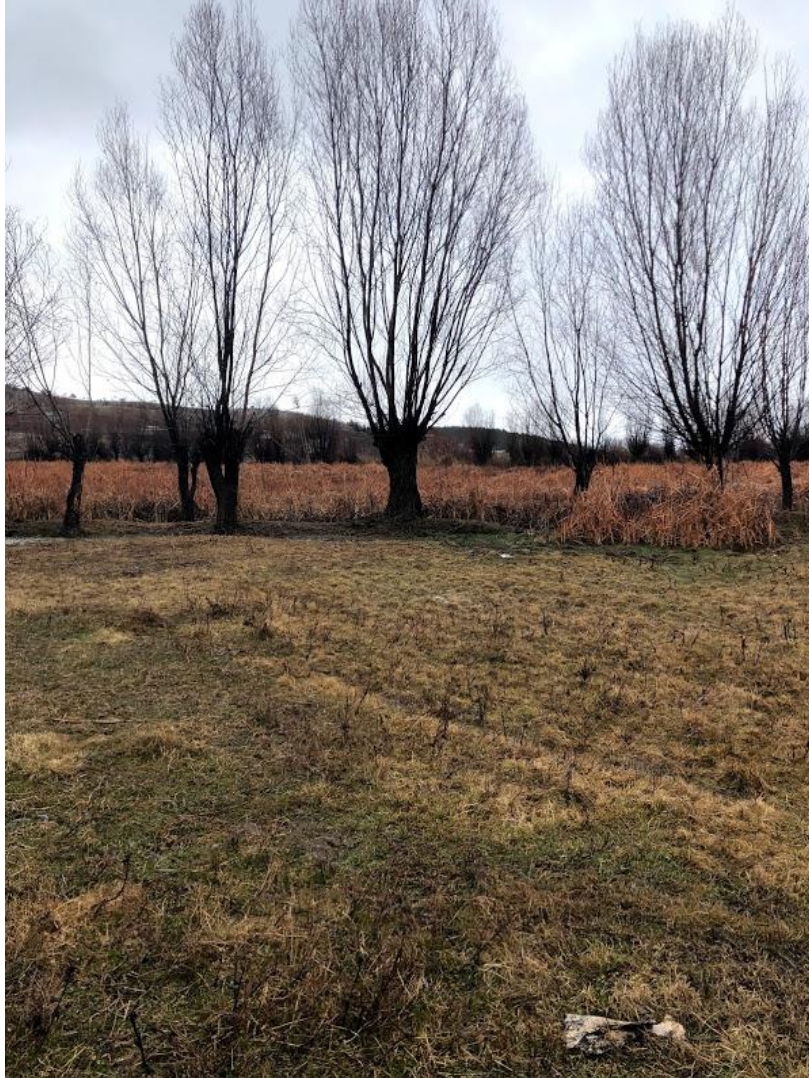
The surficial soils and the alluvial geological setting are concluded to be suitable for liquefaction triggering. However, no signs of liquefaction in the form of sand boils, lateral spread, excessive settlements, etc. were observed at the first stop, as shown in Figure 4.8.

Figure 4.8. A view of the site taken by Sivrice road
(38°28'08.6"N 39°16'40.2"E / 31.01.2020 / 11:47)

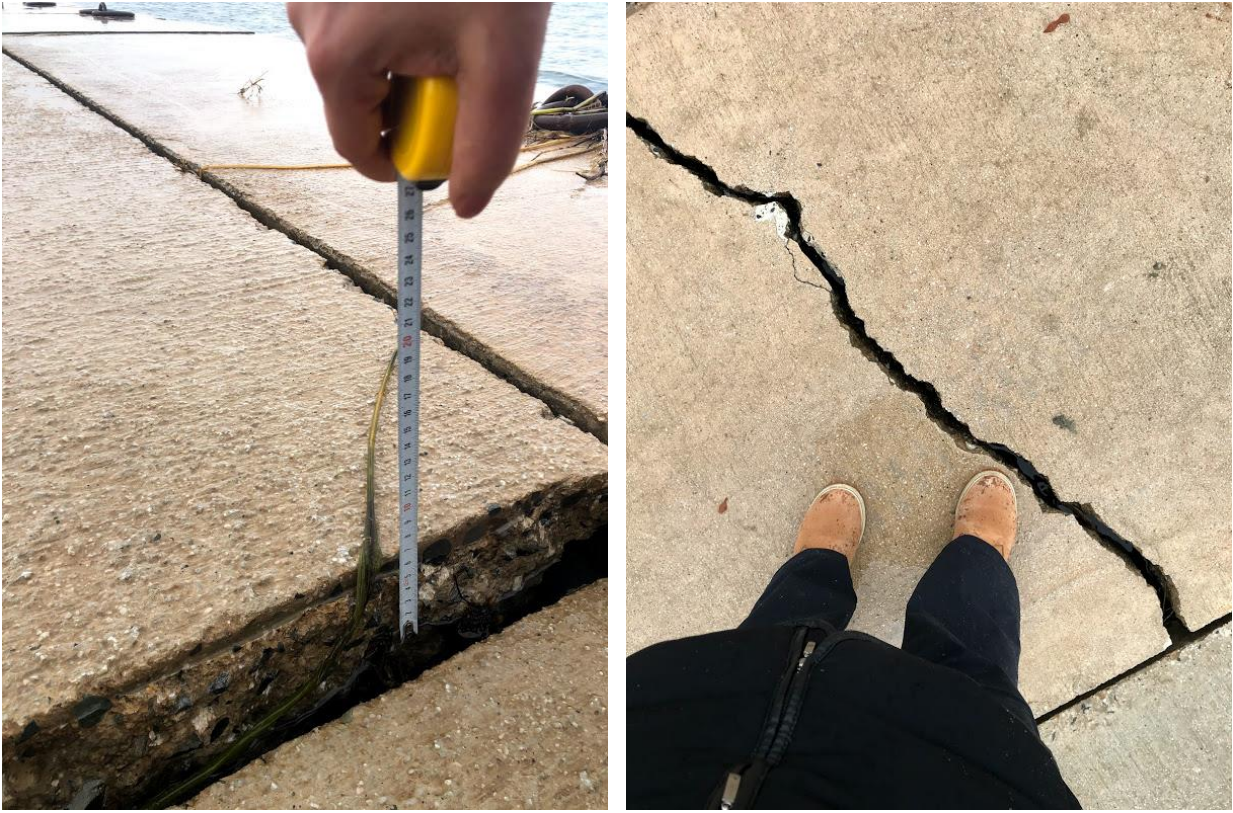
Seismically-induced lateral spreading and volumetric settlements were observed on the natural beach of Hazar Lake shoreline and Sivrice dock. Observed ground failure was mapped and discussed in a detailed manner in Section 4.7. Distribution of volumetric settlement and lateral displacements are mapped as shown in Figures 4.12 to 4.19, respectively. Next to the lake beach, where liquefaction manifestation is observed, a neighboring beach has exhibited no signs of ground failure, as given in Figure 4.20 and 4.21.

Figure 4.13. Measurements of seismically-induced volumetric settlement in the dock of
Hazar Lake
($38^{\circ}26'53.1''N$ $39^{\circ}18'53.6''E$ / 31.01.2020 / 12:16 & $38^{\circ}26'53.2''N$ $39^{\circ}18'52.9''E$ / 31.01.2020 / 12:13)

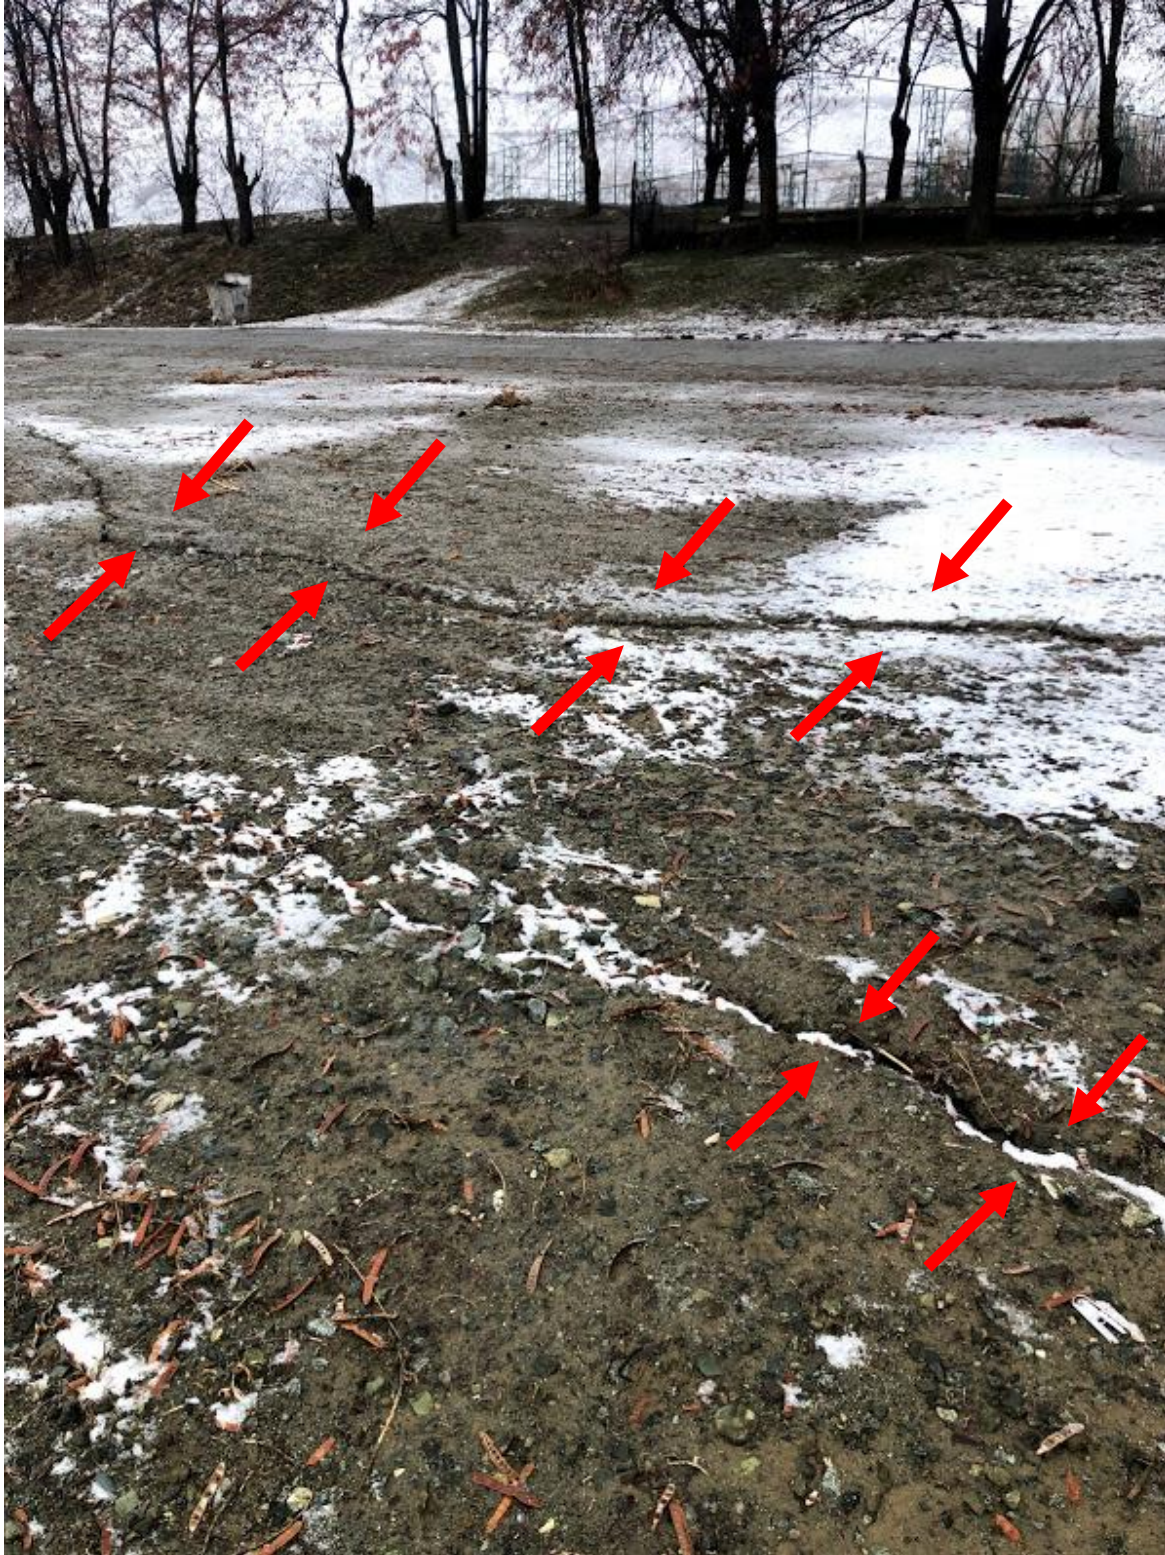
Figure 4.16. Seismically-induced lateral spreading ground deformations mapped on the beach of Hazar Lake
(38°26'50.7"N 39°18'56.7"E / 31.01.2020 / 12:28)

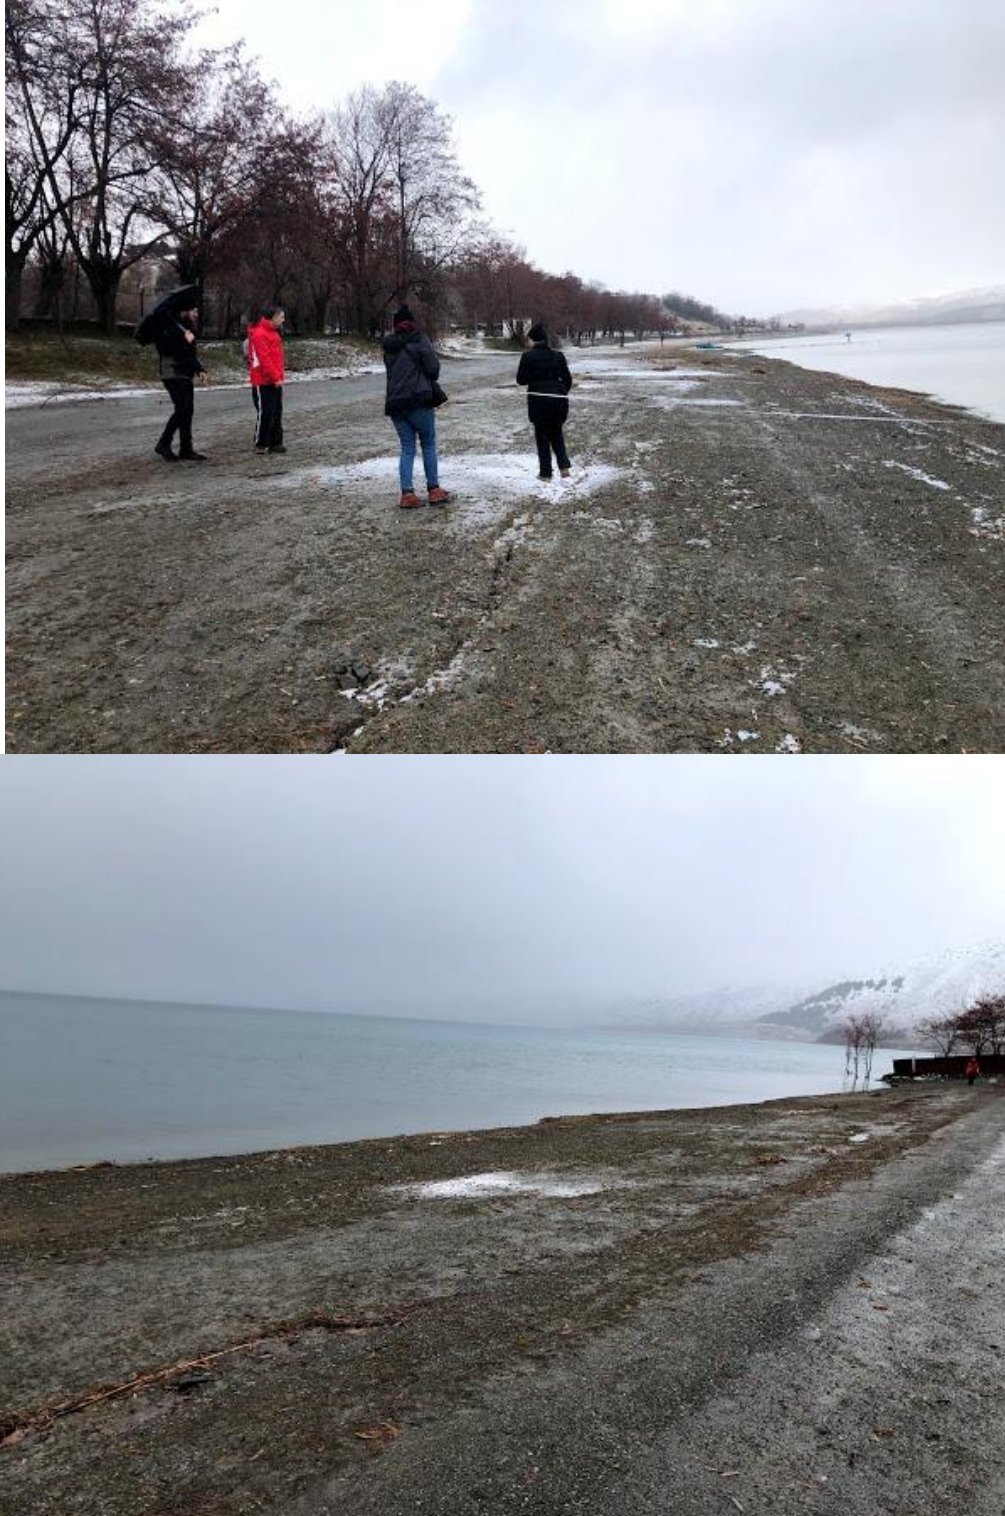
Figure 4.17. Seismically-induced lateral spreading on the beach of Hazar Lake
($38^{\circ}26'48.4''N$ $39^{\circ}18'57.4''E$ / 31.01.2020 / 12:31 & $38^{\circ}26'50.1''N$ $39^{\circ}18'57.2''E$ / 31.01.2020 / 12:54)

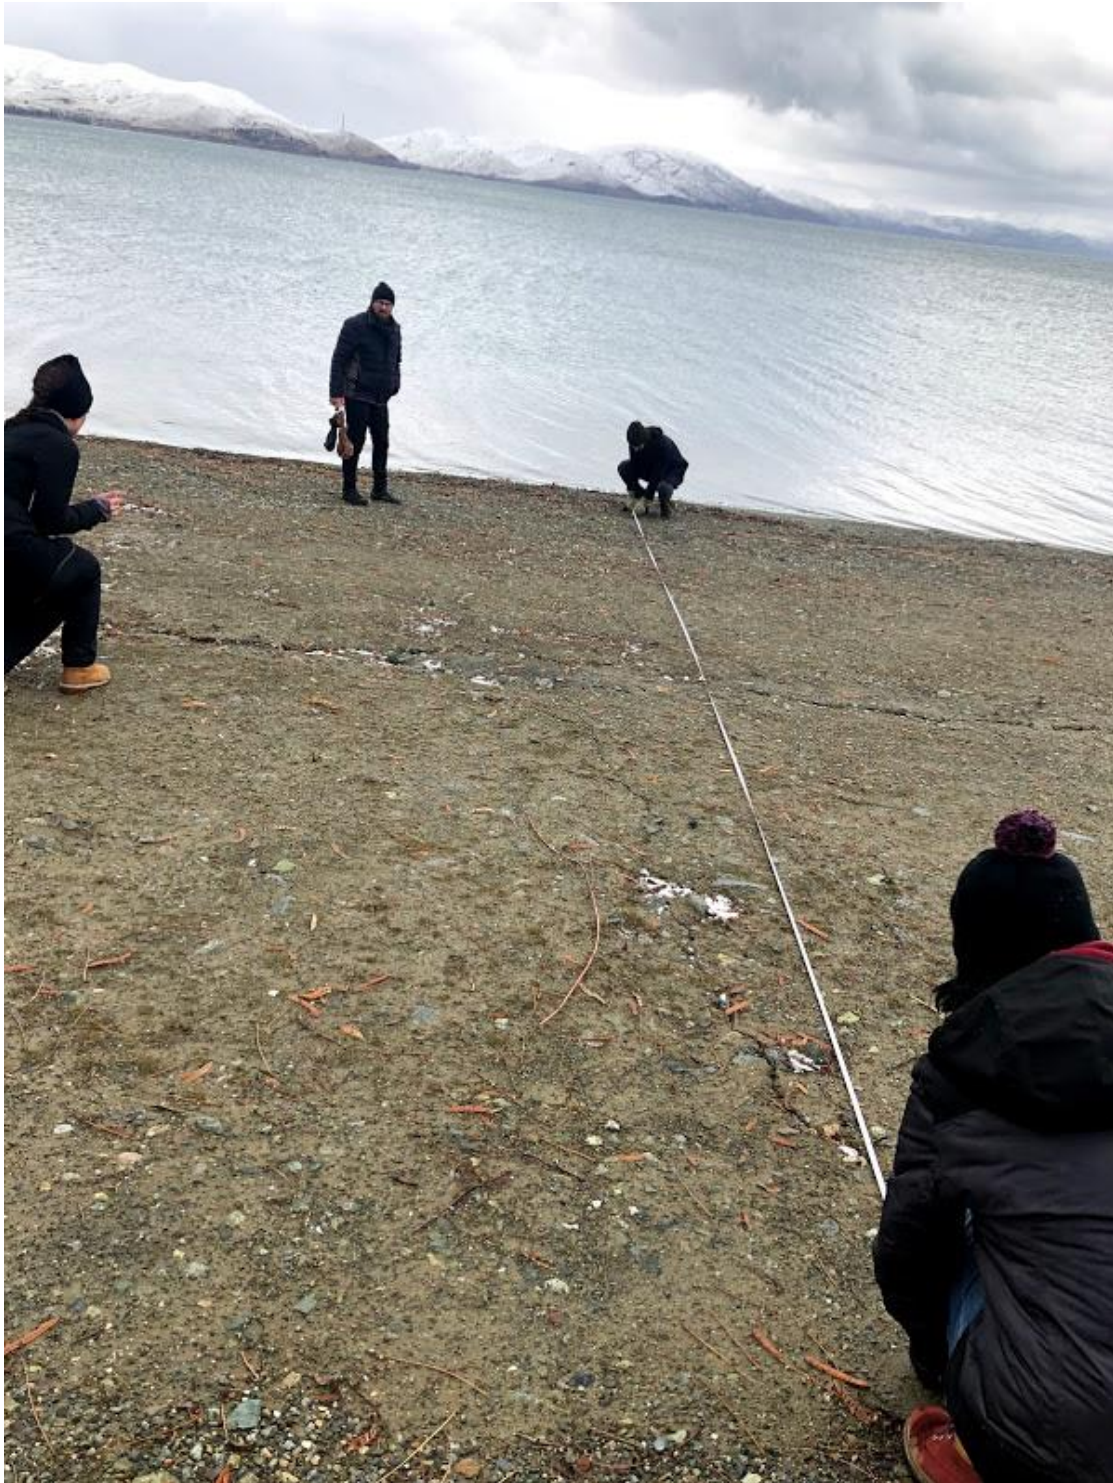
Figure 4.19. Mapping efforts of seismically-induced lateral spreading on the beach of Hazar Lake
($38^{\circ}26'50.0''N$ $39^{\circ}18'57.2''E$ / 31.01.2020 / 13:14)

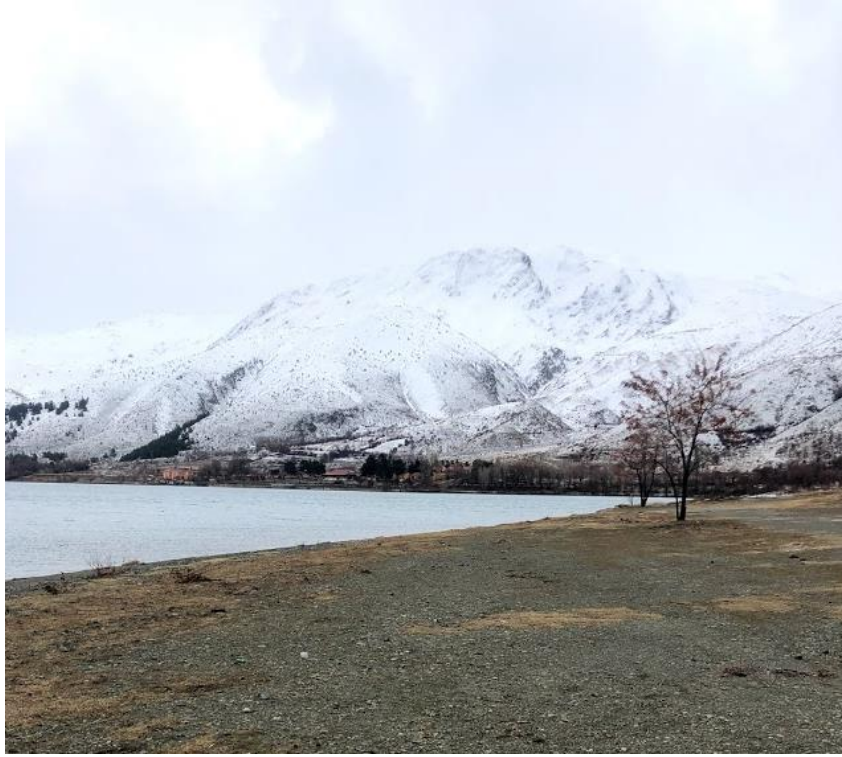
Figure 4.20. No ground failure on a neighboring beach of Hazar Lake
($38^{\circ}26'48.9''N$ $39^{\circ}18'59.4''E$ / 31.01.2020 / 13:08)

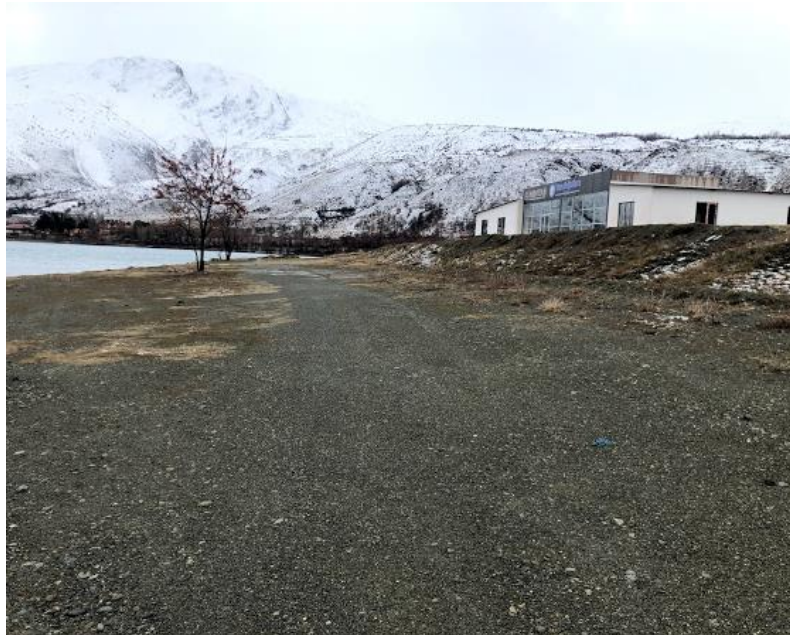
Figure 4.21. No ground failure on a neighboring beach of Hazar Lake
($38^{\circ}26'48.9''N$ $39^{\circ}18'59.4''E$ / 31.01.2020 / 13:08)

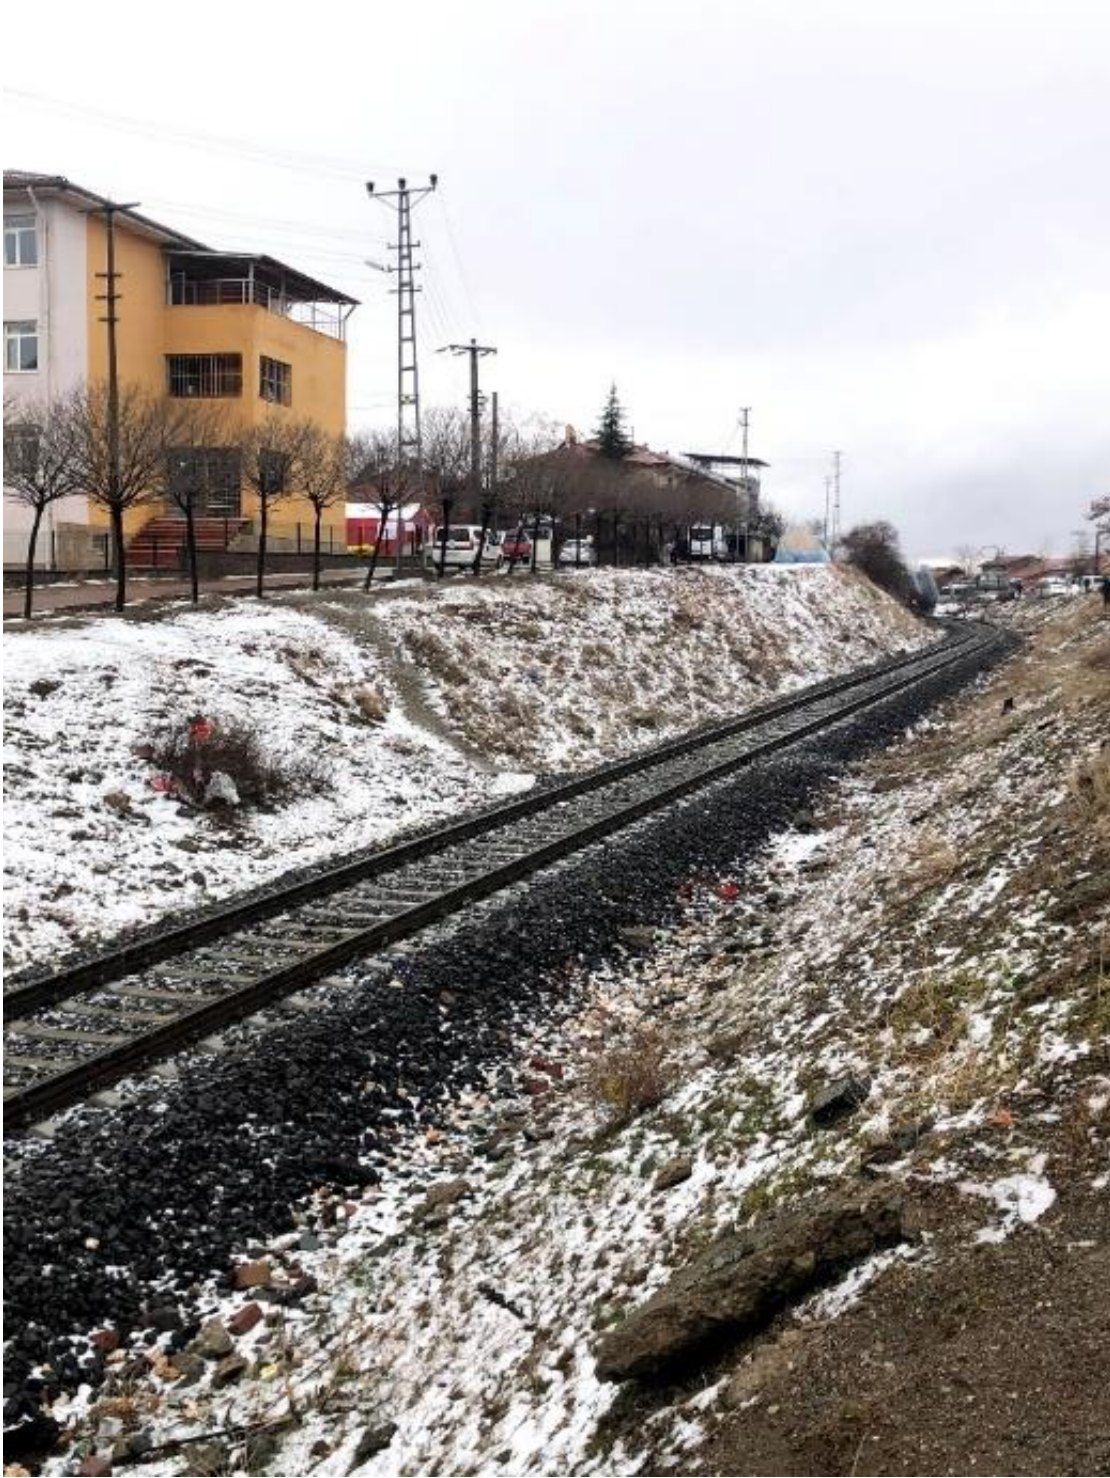
Moreover, the railway tracks were observed to experience no damage, as shown in Figure 4.23.

Figure 4.23. A view of railway tracks without any damage at Sivrice
(38°26'49.5"N 39°18'33.4"E / 31.01.2020 / 13:29)

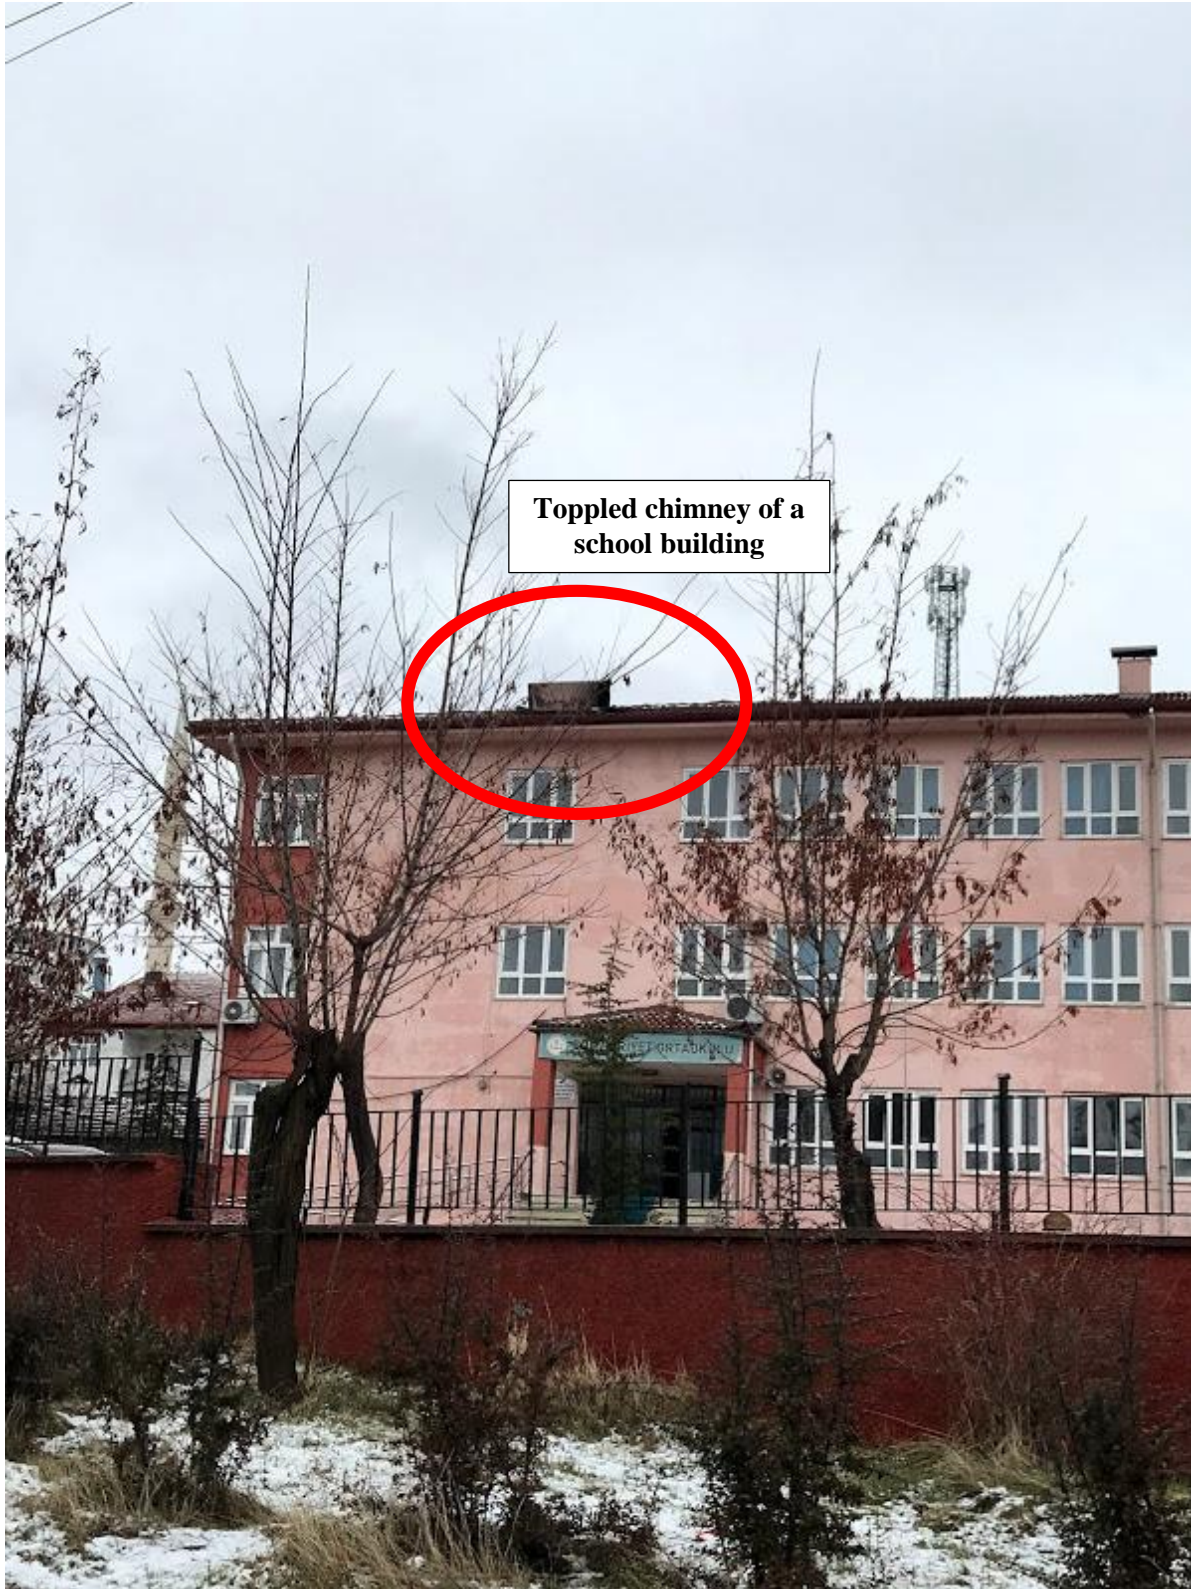
Toppled chimneys were observed as presented in Figure 4.24 and Figure 4.25. These failures show the intensity of shaking observed at the site, indicating a Mercalli intensity scale of VIII.

Figure 4.25. Topped chimney in Sivrice
(38°26'49.7"N 39°18'33.0"E / 31.01.2020 / 13:30)

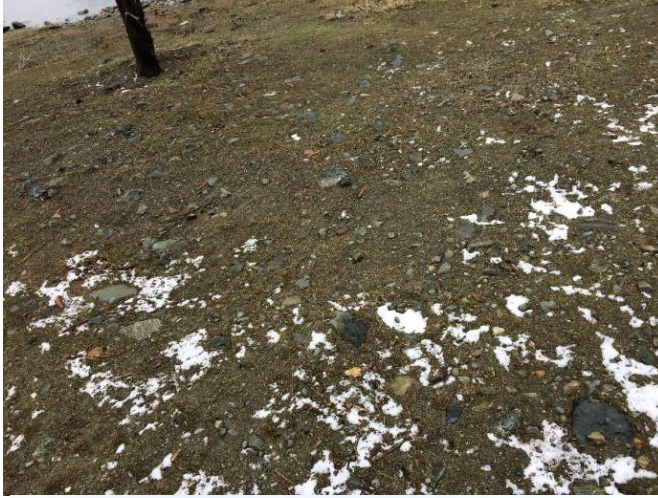
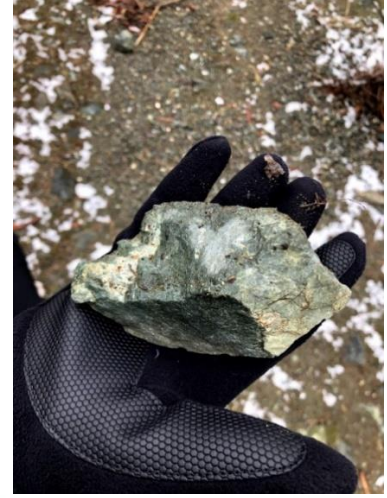
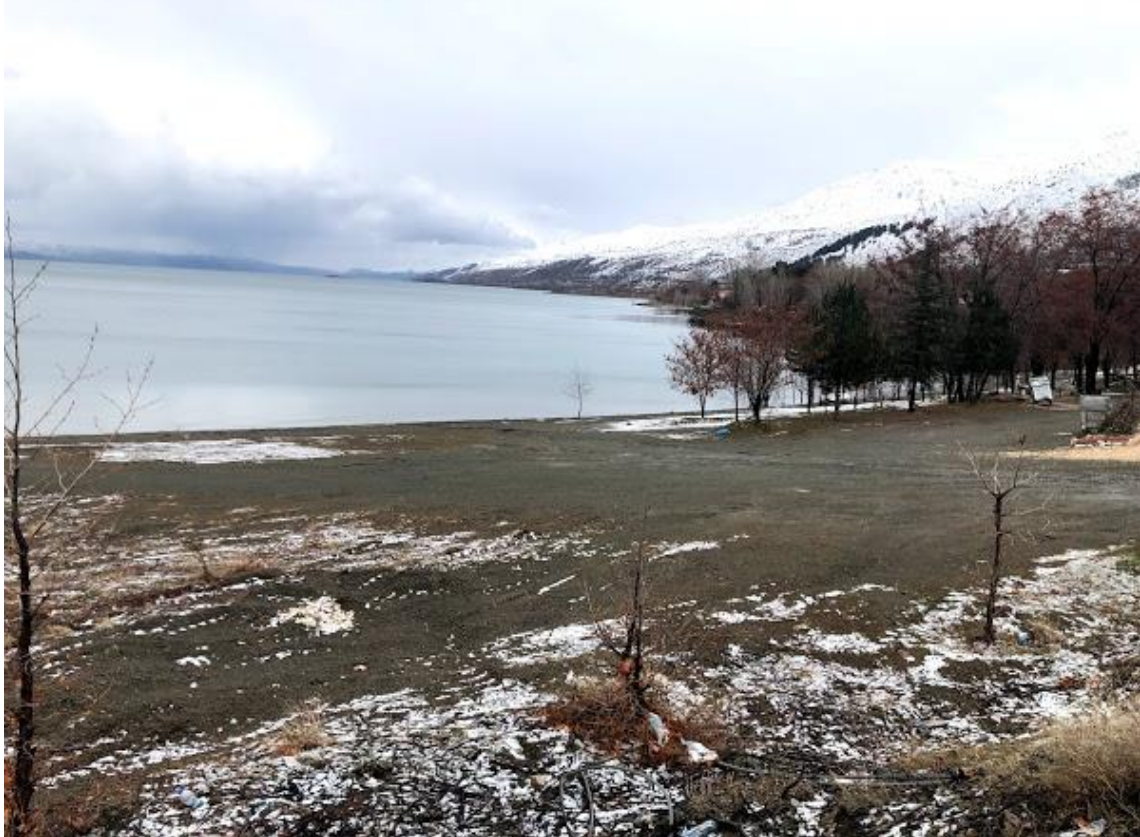
In the fourth stop, surface geology has changed to volcanic rocks, as shown in Figure 4.26. No ground failure was observed due to earthquake.

Figure 4.26. No signs of ground failure
(38°26'32.0"N 39°19'11.4"E / 31.01.2020 / 13:42 & 38°26'33.2"N 39°19'10.0"E / 31.01.2020 / 13:42 &
38°26'31.9"N 39°19'04.4"E / 31.01.2020 / 13:34)

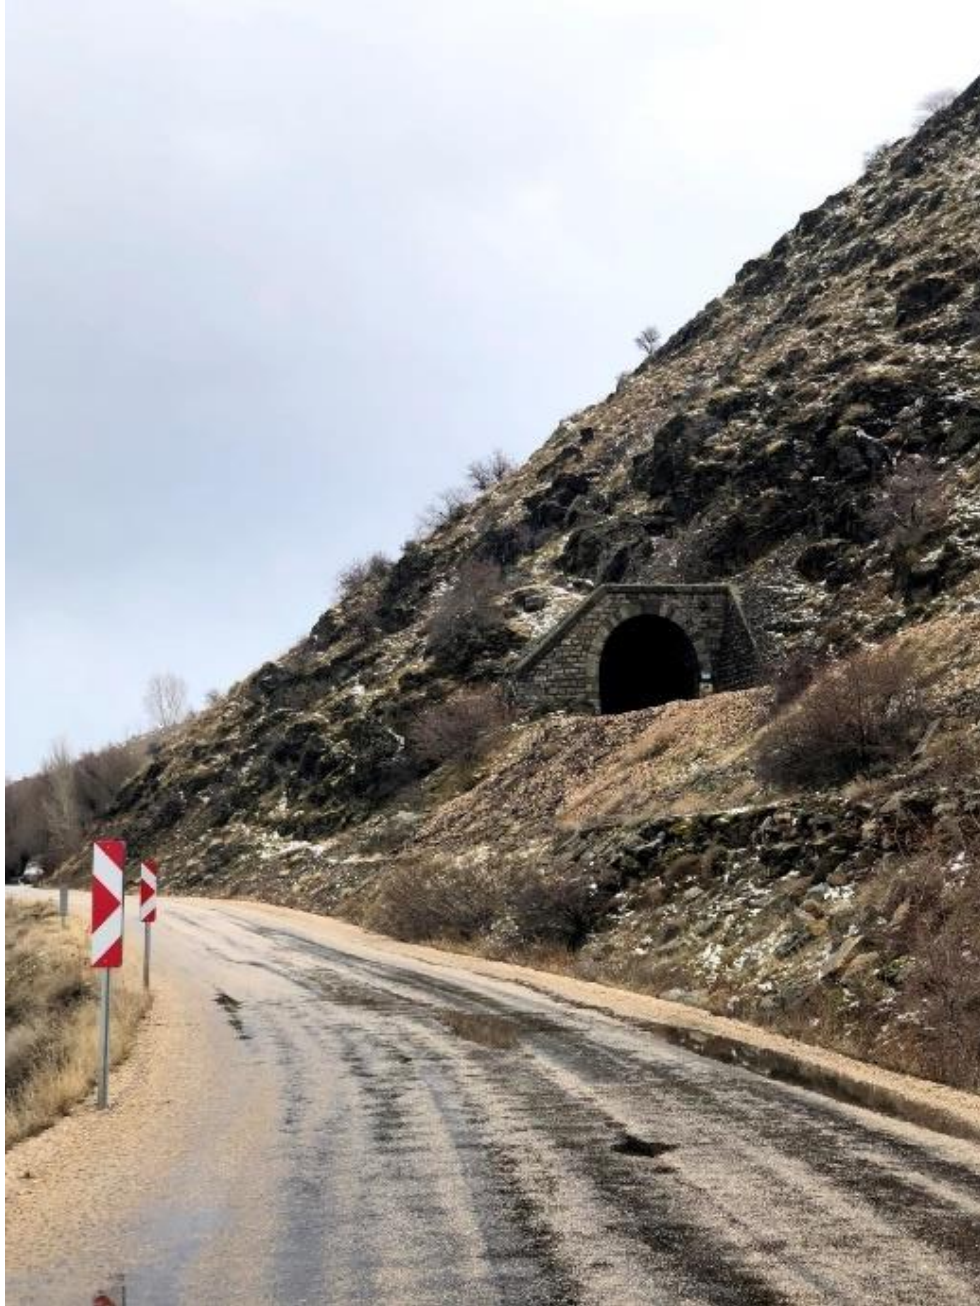
No damage was observed on the railway tunnel. Railway tunnel is open to service and Guney Kurtalan Express Train was serving, as documented in Figures 4.27 and 4.28 along with the coordinates of the pictures taken.

Figure 4.27. A view of the tunnel in Stop 5
(38°26'43.7"N 39°20'40.8"E / 31.01.2020 / 13:54)
