**January 24, 2020 Elazığ-Sivrice Earthquake ($M_w=6.8$)
Reconnaissance Study Report**

**MIDDLE EAST TECHNICAL UNIVERSITY
EARTHQUAKE ENGINEERING RESEARCH CENTER**

REPORT NO: METU/EERC 2020-01

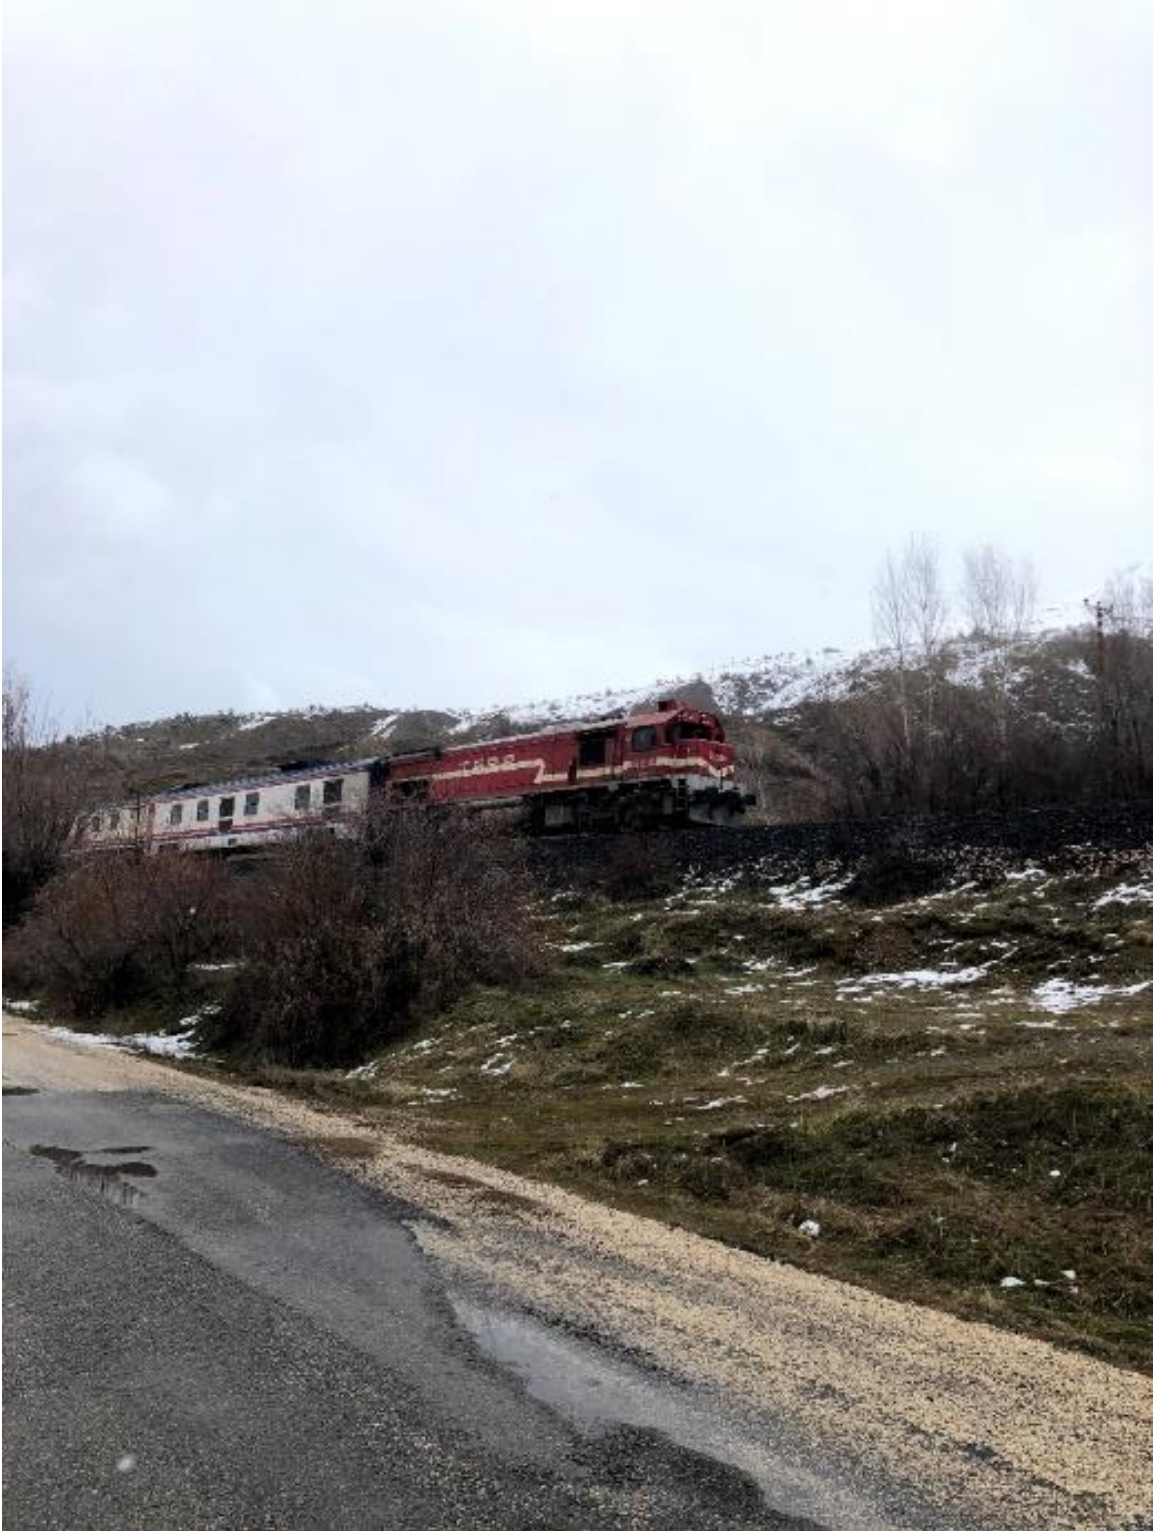
Figure 4.28. Guney Kurtalan Express Train passing by
($38^{\circ}26'56.9''N$ $39^{\circ}21'16.7''E$ / 31.01.2020 / 13:59)

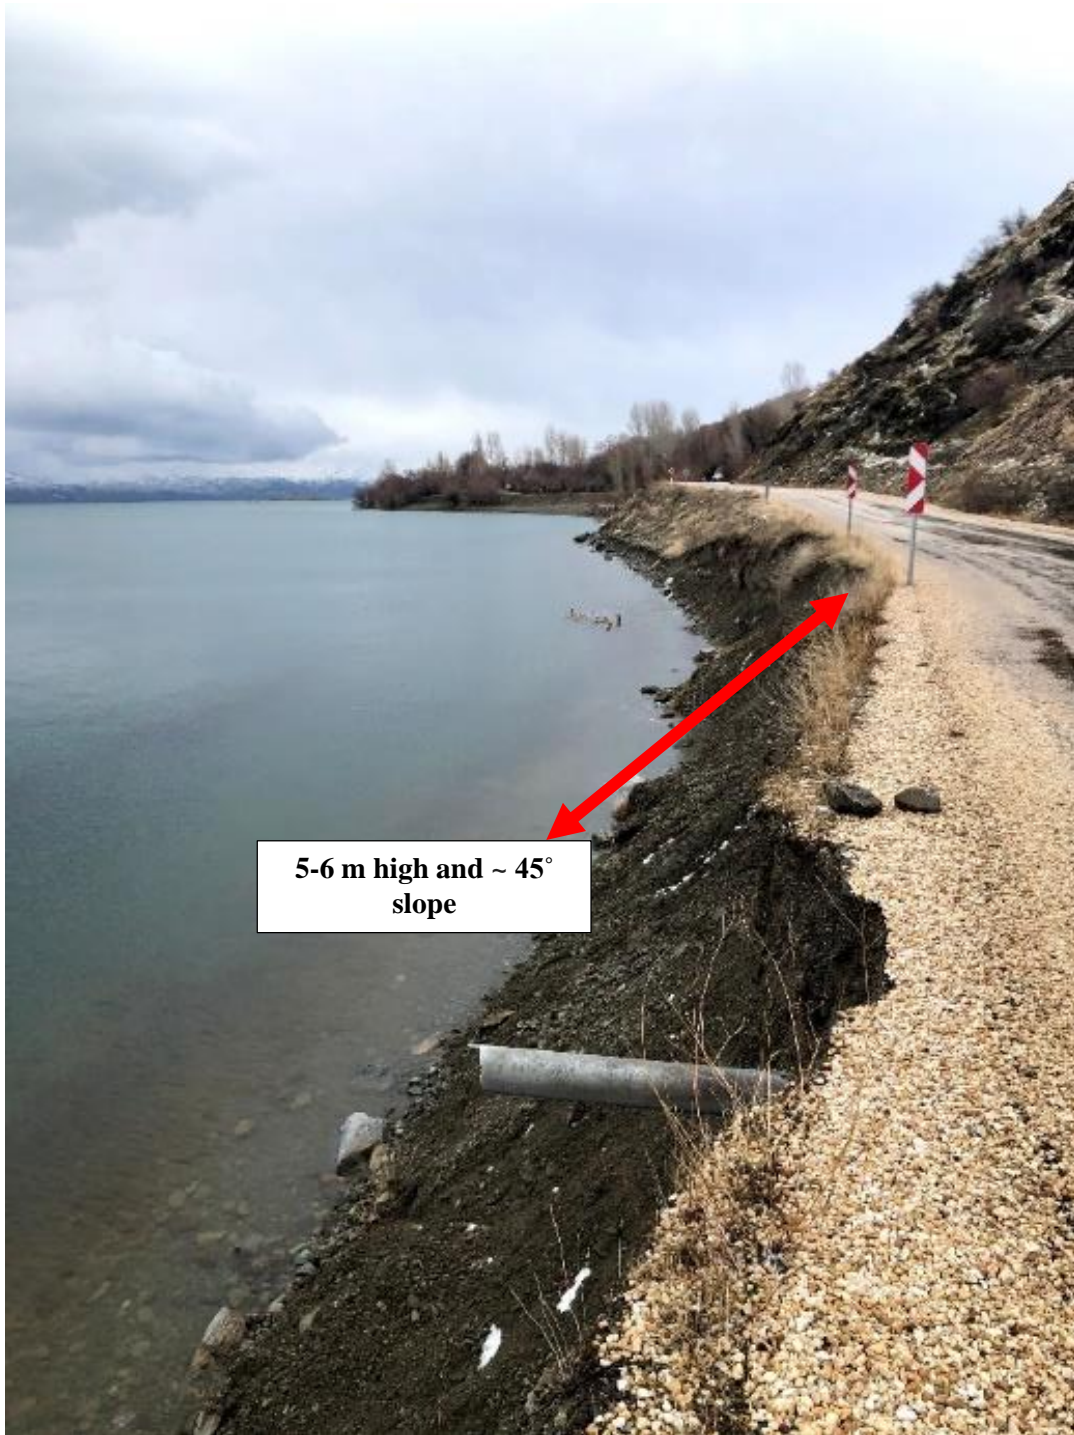
The shoreline by the railway tunnel was also visited. The road embankment has relatively steep slopes (nearly 45°); however, no ground failure was observed along this shoreline (Figure 4.29).

Figure 4.29. No failure on the road embankment
($38^\circ 26' 43.7''$ N $39^\circ 20' 40.7''$ E / 31.01.2020 / 13:54)

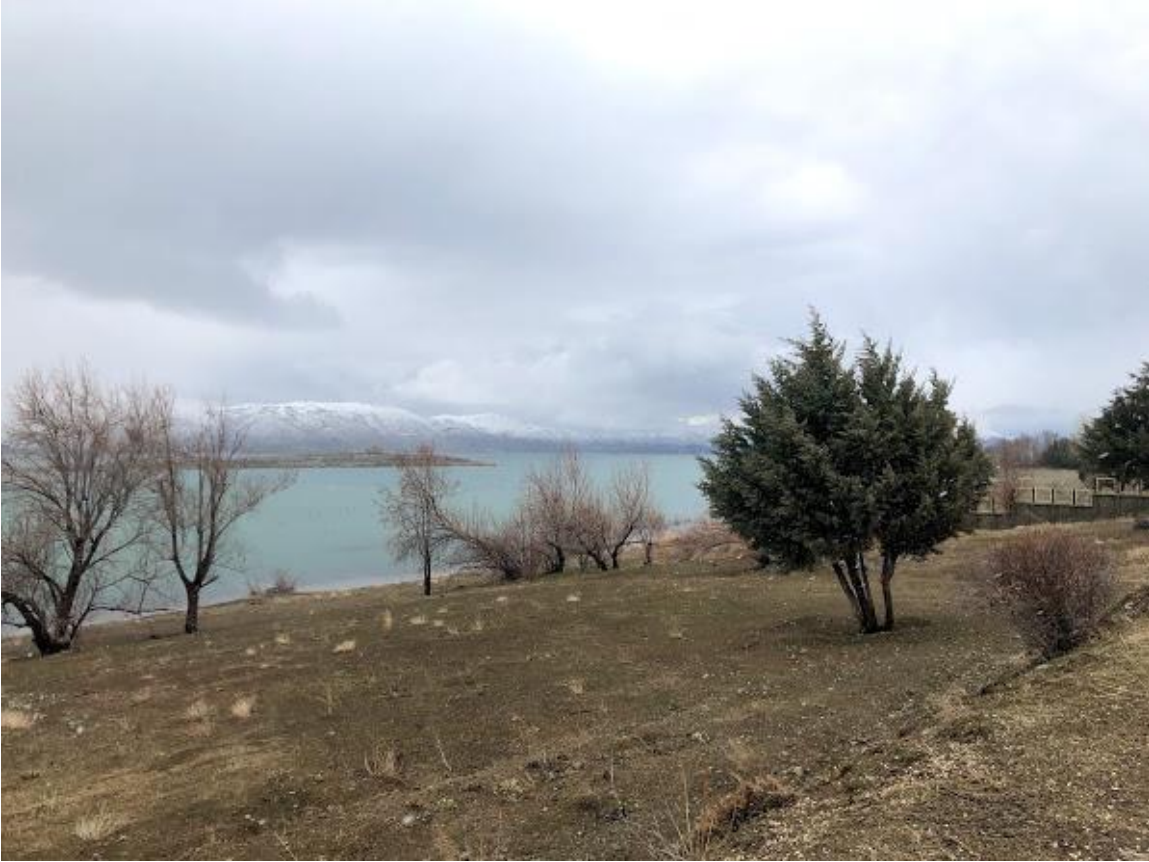
The surficial soil layers are composed of low plasticity clays as shown in Figure 4.30. No signs of ground failure were observed.

Figure 4.30. No ground failure at the 6th stop
(38°27'17.1"N 39°21'49.3"E / 31.01.2020 / 14:03)

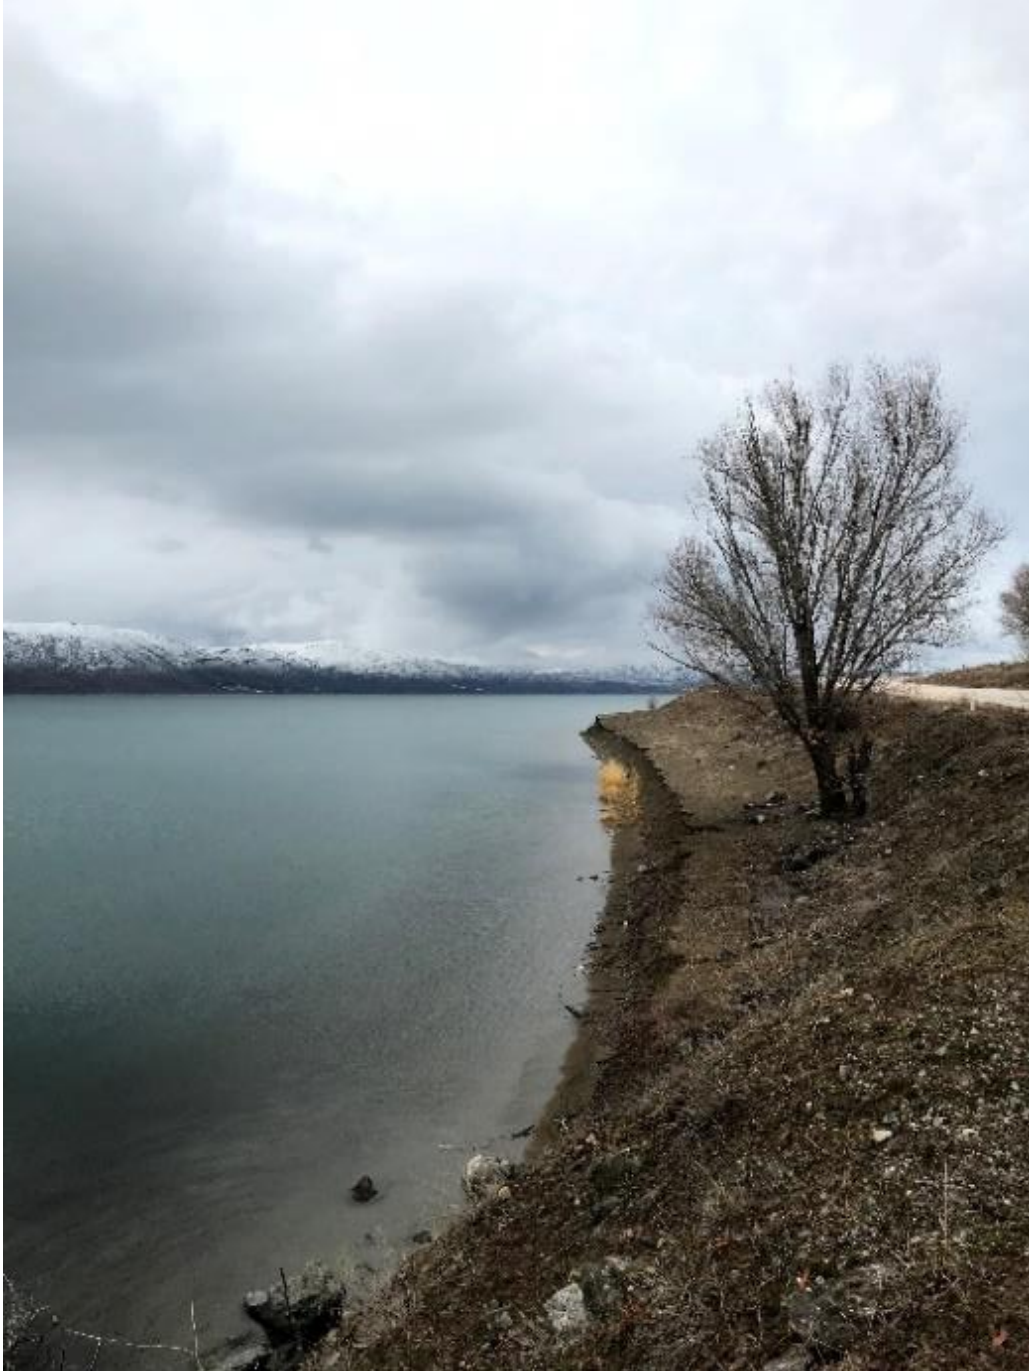
No ground failure was observed at steep slopes of the 7th stop, as shown in Figure 4.31.

Figure 4.31. No ground failure was observed at the shores of 7th stop
(38°27'31.0"N 39°22'55.9"E / 31.01.2020 / 14:08)

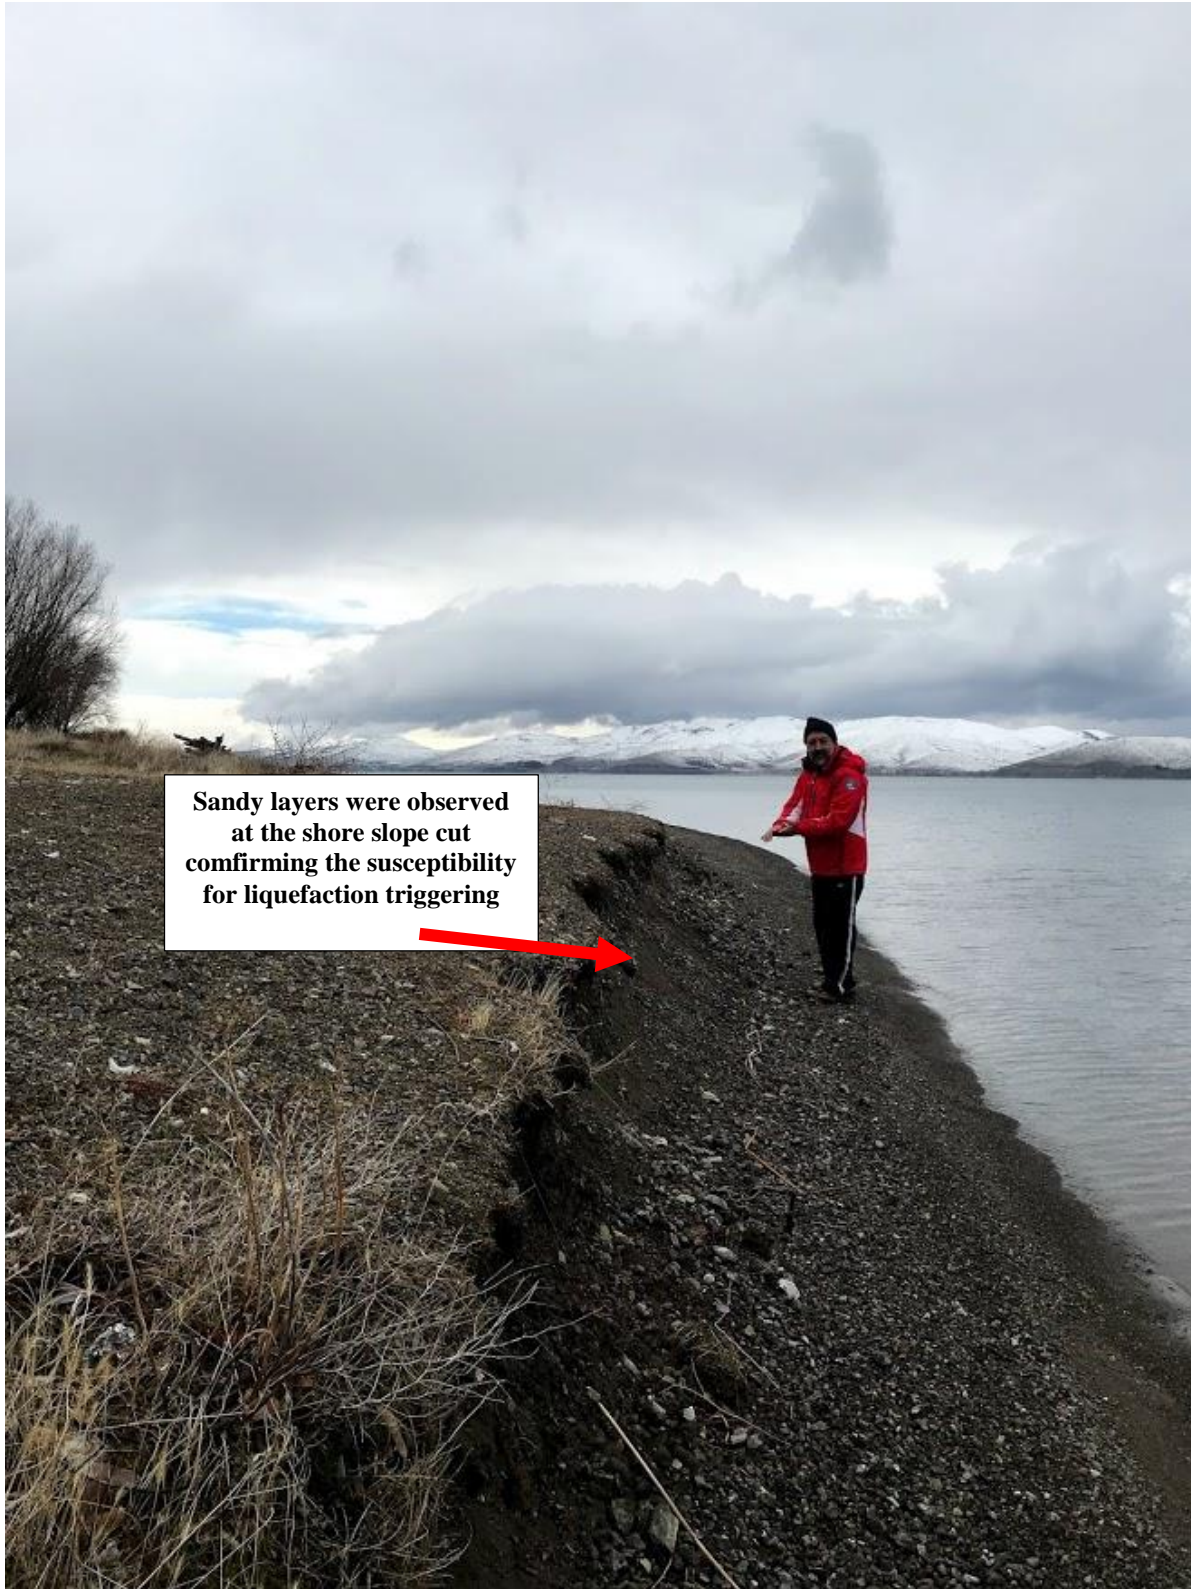
Seismically-induced liquefaction failure was observed in the form of sand boils as shown in Figures from 4.32 to 4.38.

Figure 4.35. Sandy soil layers observed in Stop 8
(38°27'50.3"N 39°24'02.1"E / 31.01.2020 / 14:21)

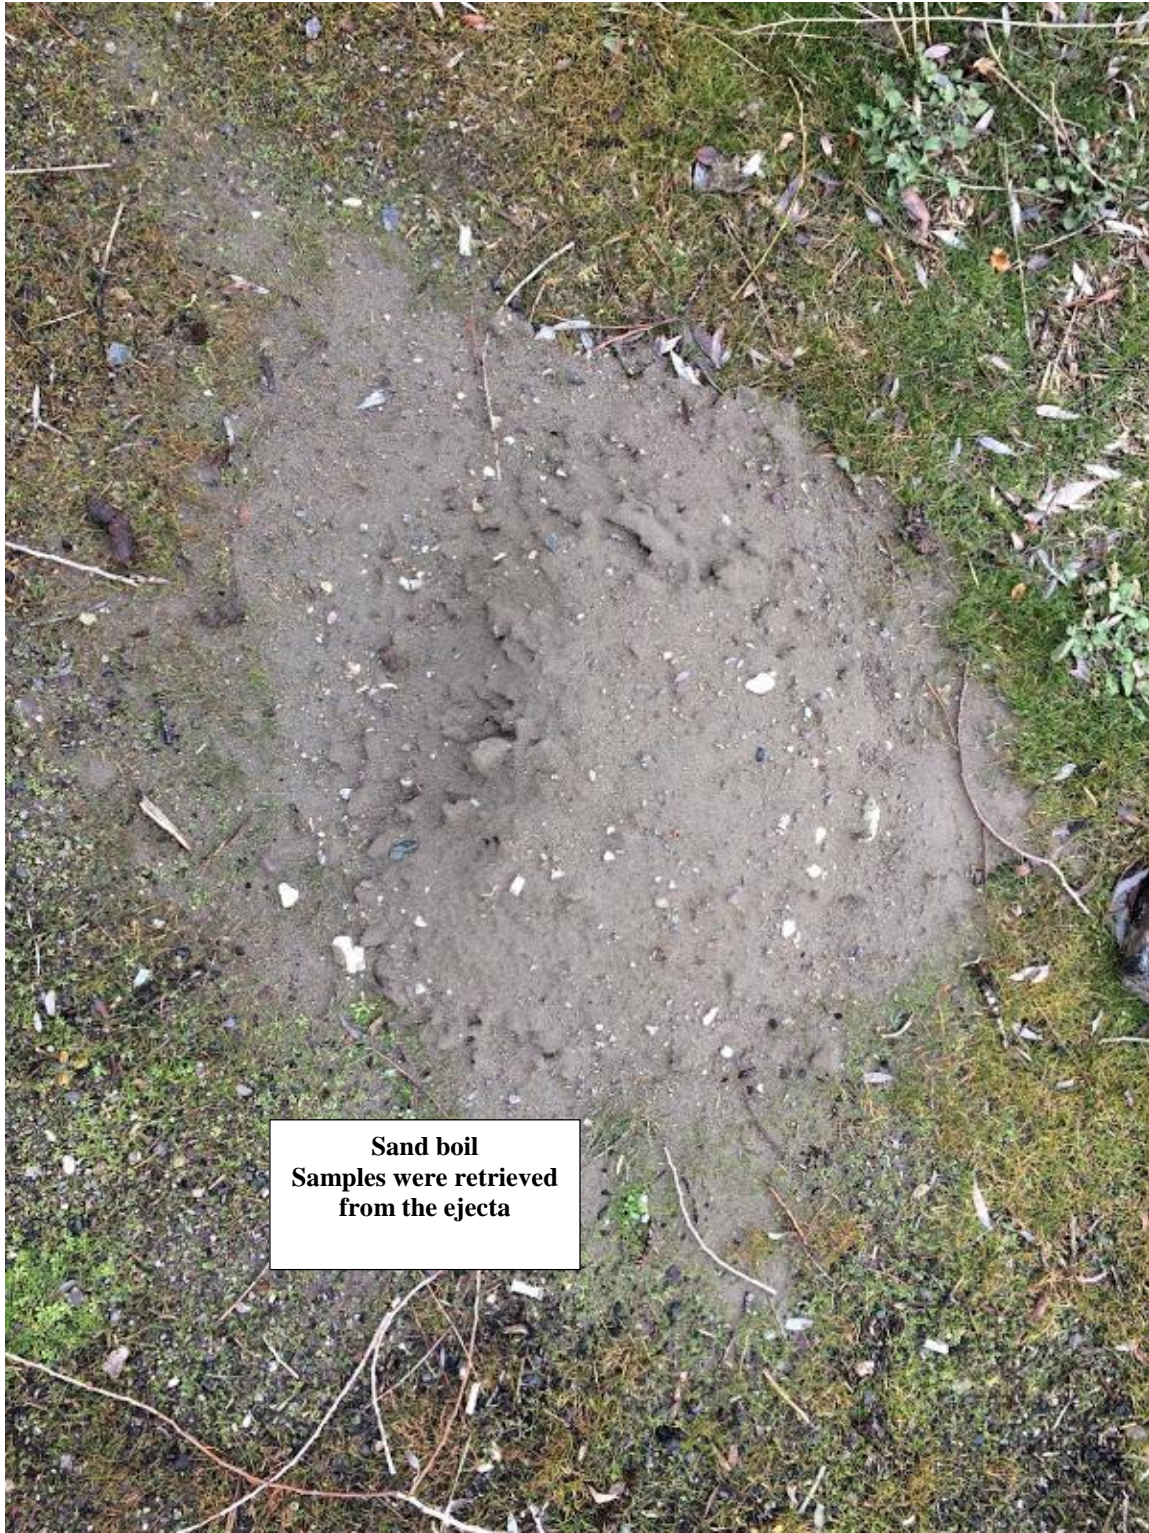
Sand boil
Samples were retrieved
from the ejecta

Figure 4.38. Sand boil observed in Stop 8
(38°27'50.1"N 39°24'01.3"E / 31.01.2020 / 14:43)

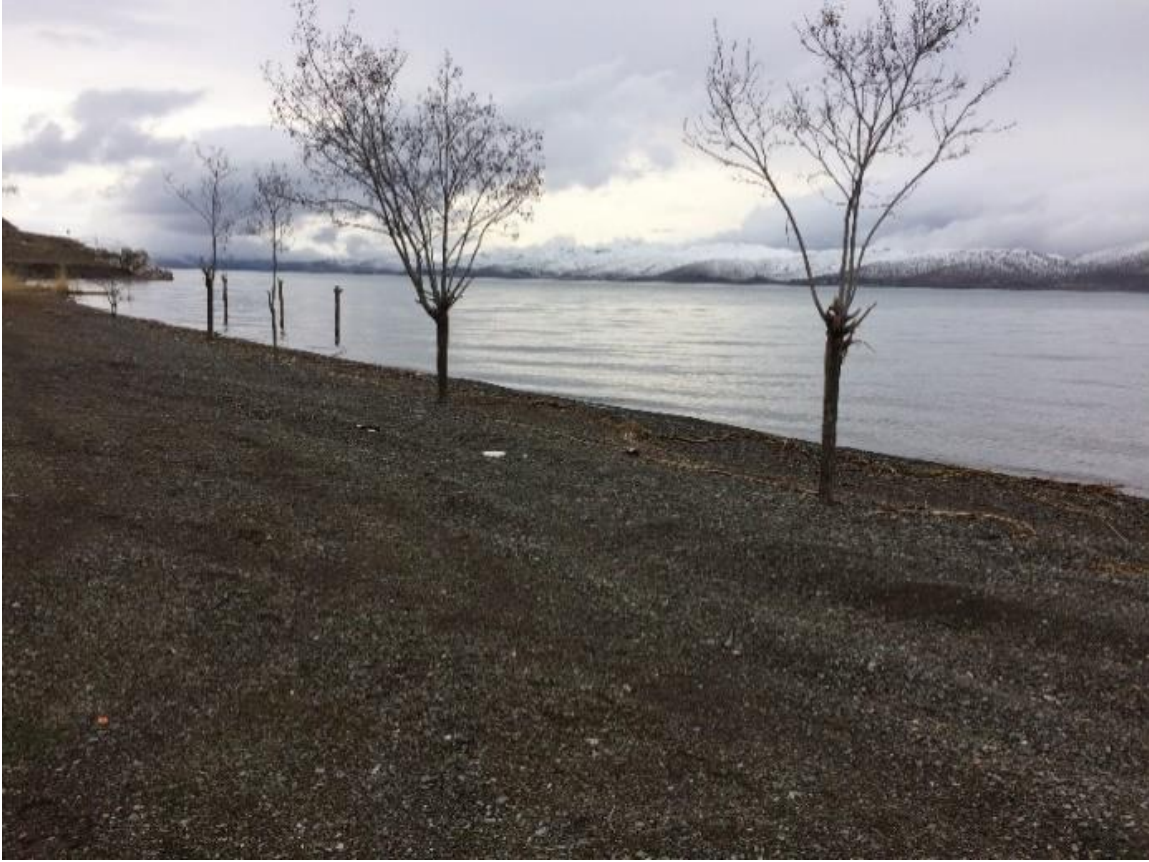
No ground failure was observed at this site, as presented in Figure 4.39.

Figure 4.39. No ground failure was observed at shore of 9th stop
(38°28'22.2"N 39°25'24.9"E / 31.01.2020 / 14:53)

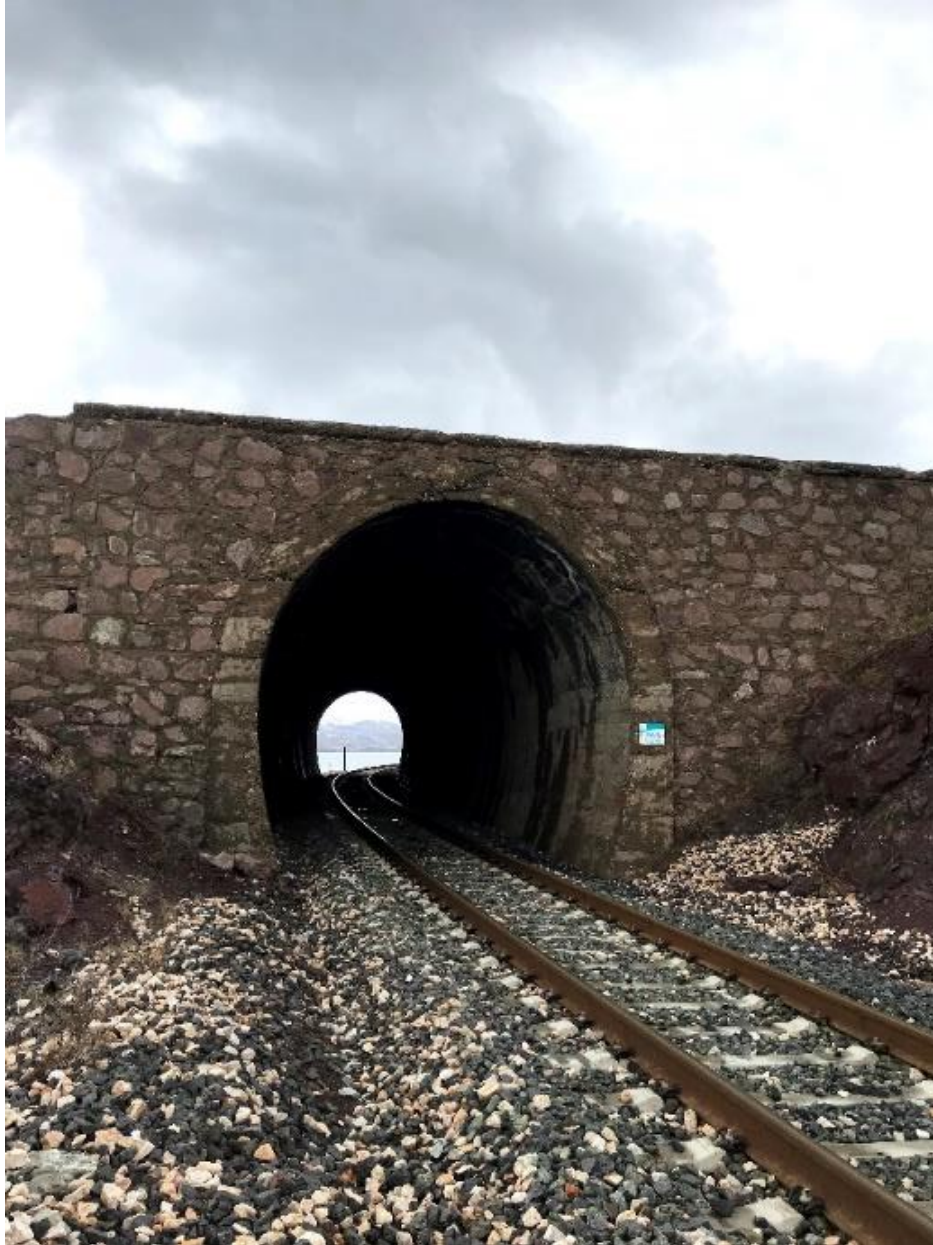
A relatively very short (~15 m long) railway tunnel was constructed at the toe of a highly weathered rock steep slope. Tunnel has been possibly designed to eliminate toe excavations, which may trigger slope instability problems. No damage was observed, as also presented in Figures 4.40 to 4.43. Additionally, no slope failure was observed near Hazar Lake, as presented in Figure 4.44.

Figure 4.40. A railway tunnel and rails exhibiting no damage
(38°28'52.8"N 39°27'18.2"E / 31.01.2020 / 15:08)

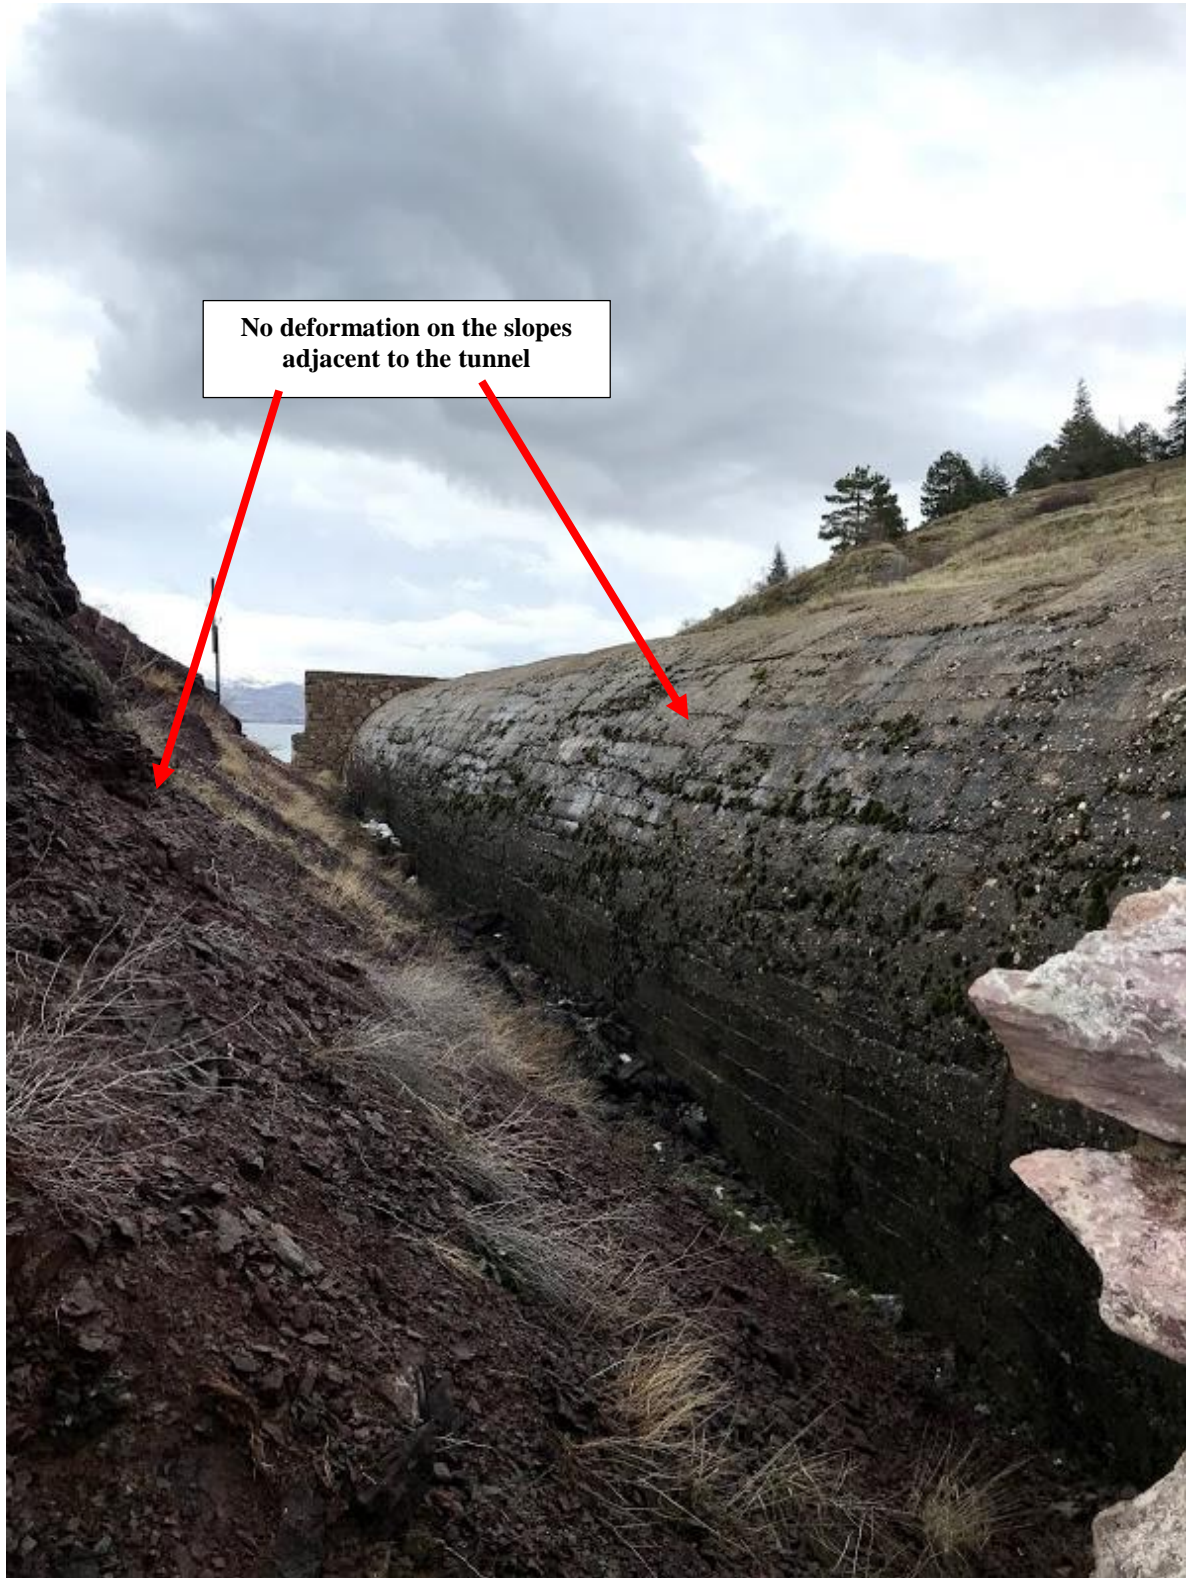
Figure 4.41. A view of tunnel body at Stop 10
(38°28'53.2"N 39°27'18.4"E / 31.01.2020 / 15:09)

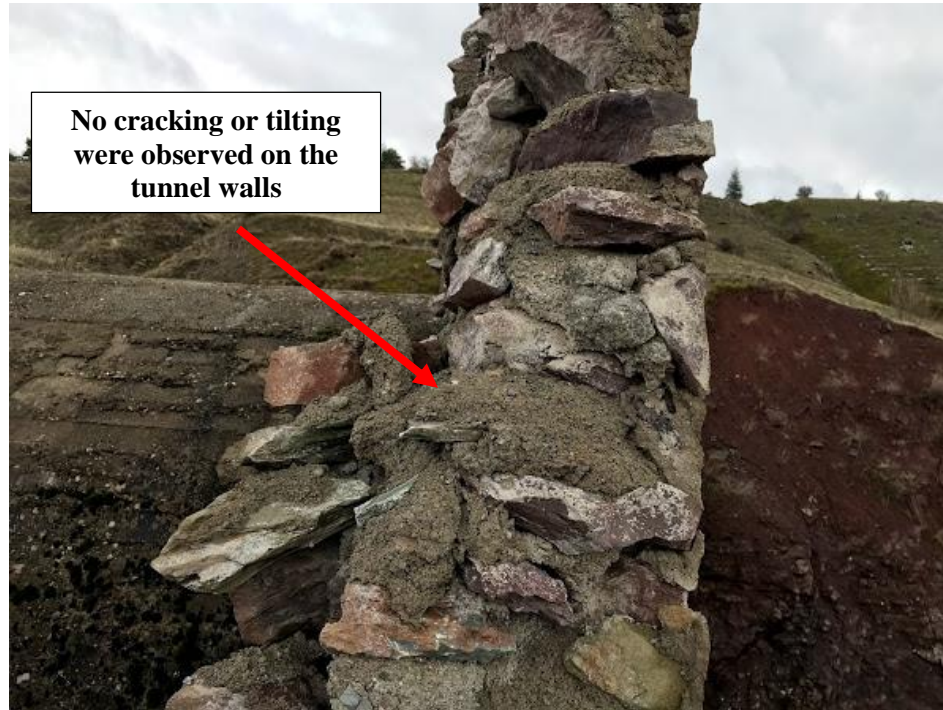
Figure 4.42. Side view of tunnel wall at Stop 10
(38°28'53.2"N 39°27'18.4"E / 31.01.2020 / 15:09)

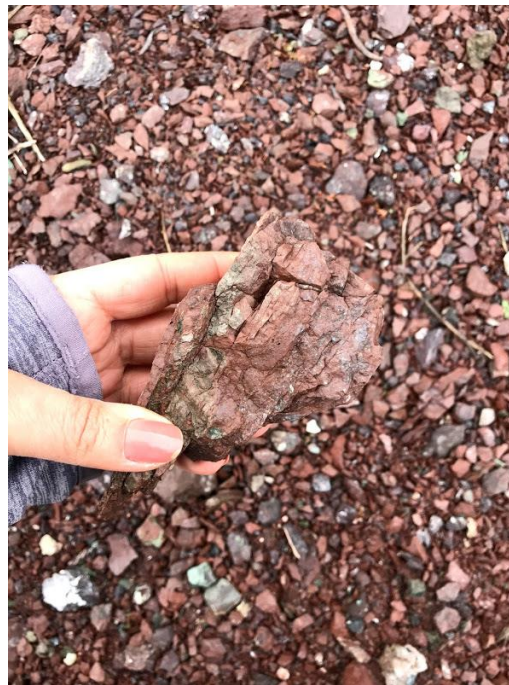
Figure 4.43. Interbeddings observed in volcanic rocks
(38°28'53.2"N 39°27'17.9"E / 31.01.2020 / 15:08)

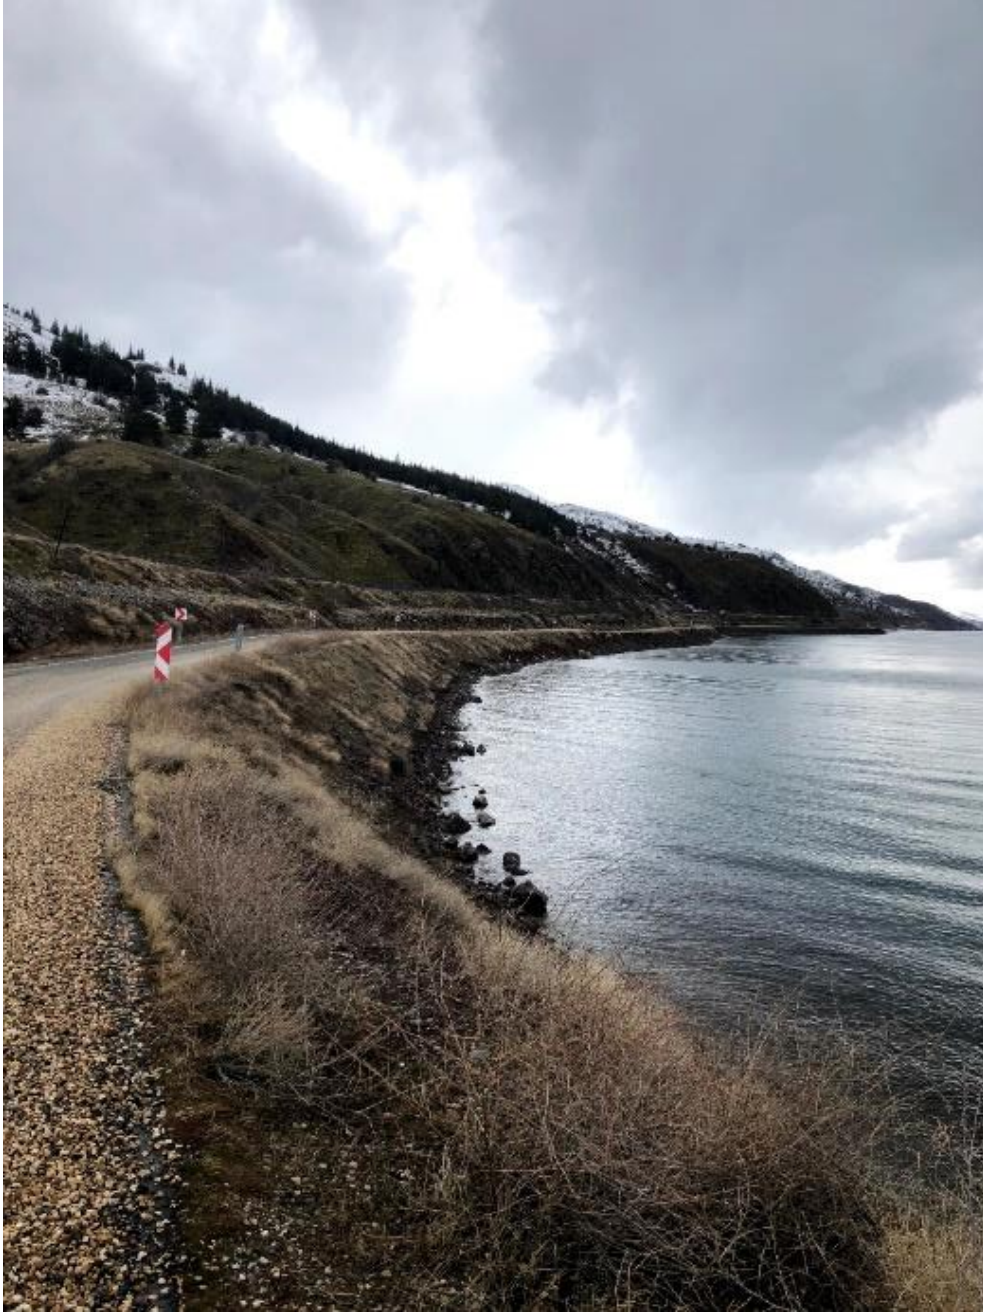
Figure 4.44. No ground failure was observed at shore of 10th stop
(38°28'52.6"N 39°27'16.9"E / 31.01.2020 / 15:04)

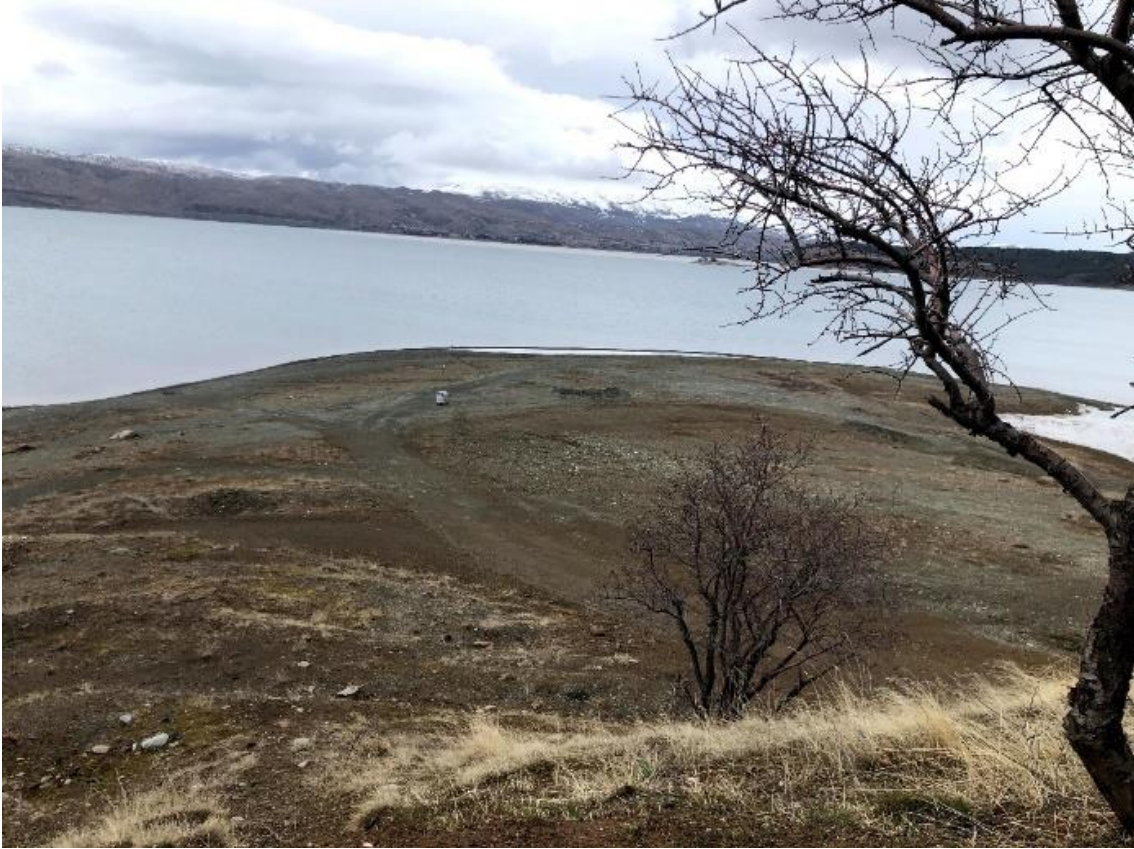
At 11th stop, no ground failure was observed as shown in Figure 4.45.

Figure 4.45. No ground failure was observed at shore of 11th stop
(38°29'37.1"N 39°29'02.3"E / 31.01.2020 / 15:18)

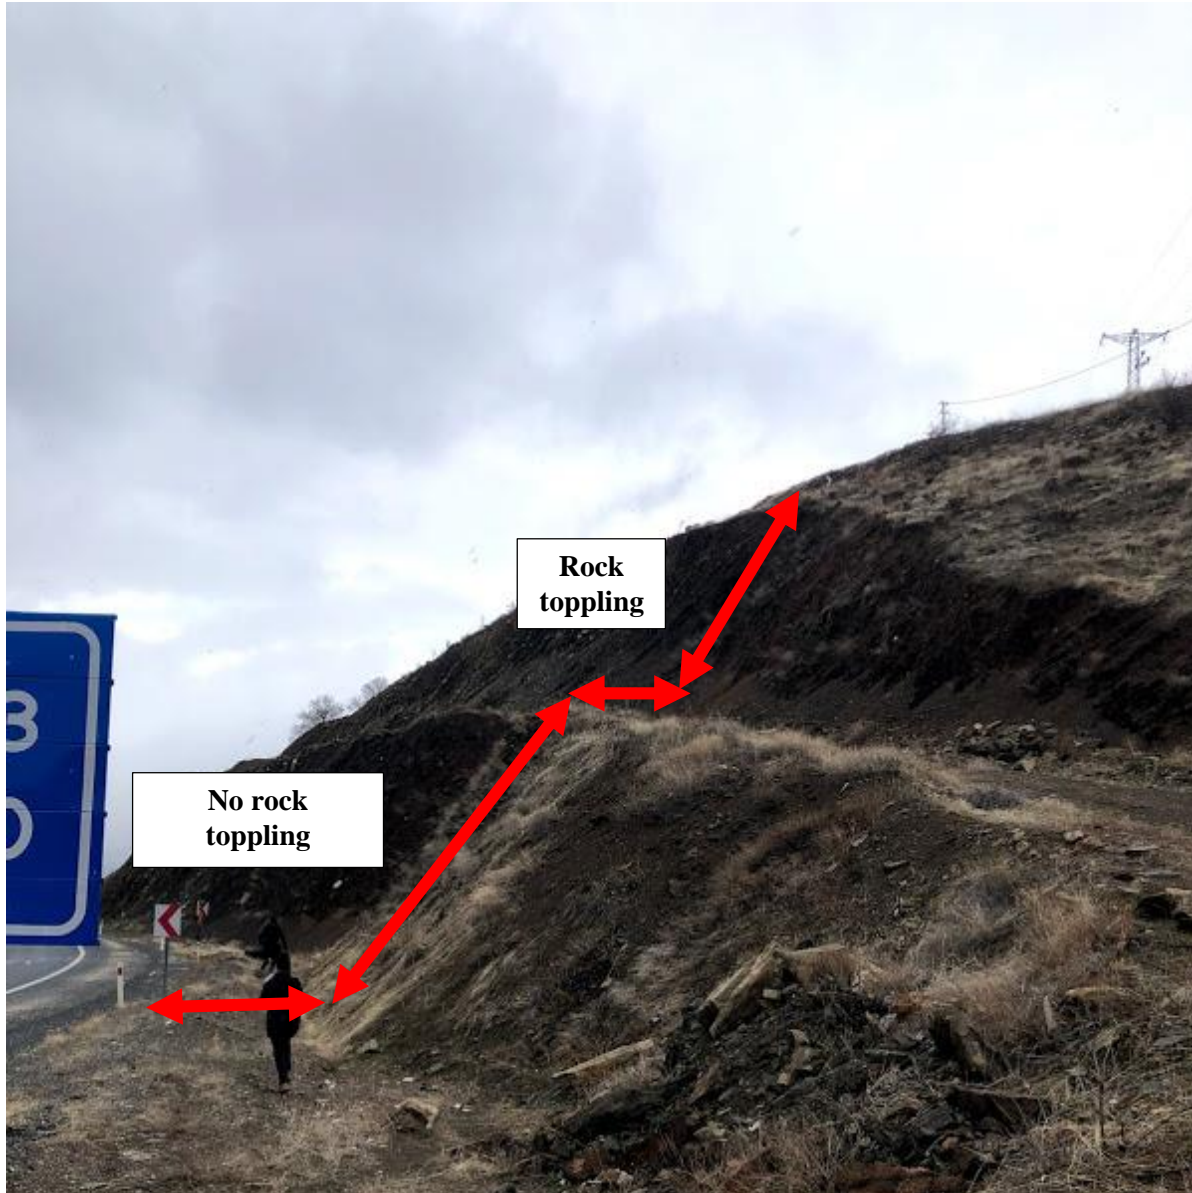
Rock falls were mapped at 13th stop as shown in Figures 4.47 to 4.51. Approximate dimensions (length, width, height) of the rocks are measured in the field. A simulation of the rock fall mechanism suggested a peak ground velocity of 4-6 m/s at the region as will be discussed later in the report. Fallen rock blocks horizontal distances from the toe of the first bench were measured as 3-5 m. The details of rockfall assessments will be presented later in the report.

Figure 4.47. Rockfall at 13th stop (general view)
(38°31'40.3"N 39°28'02.9"E / 31.01.2020 / 16:20)

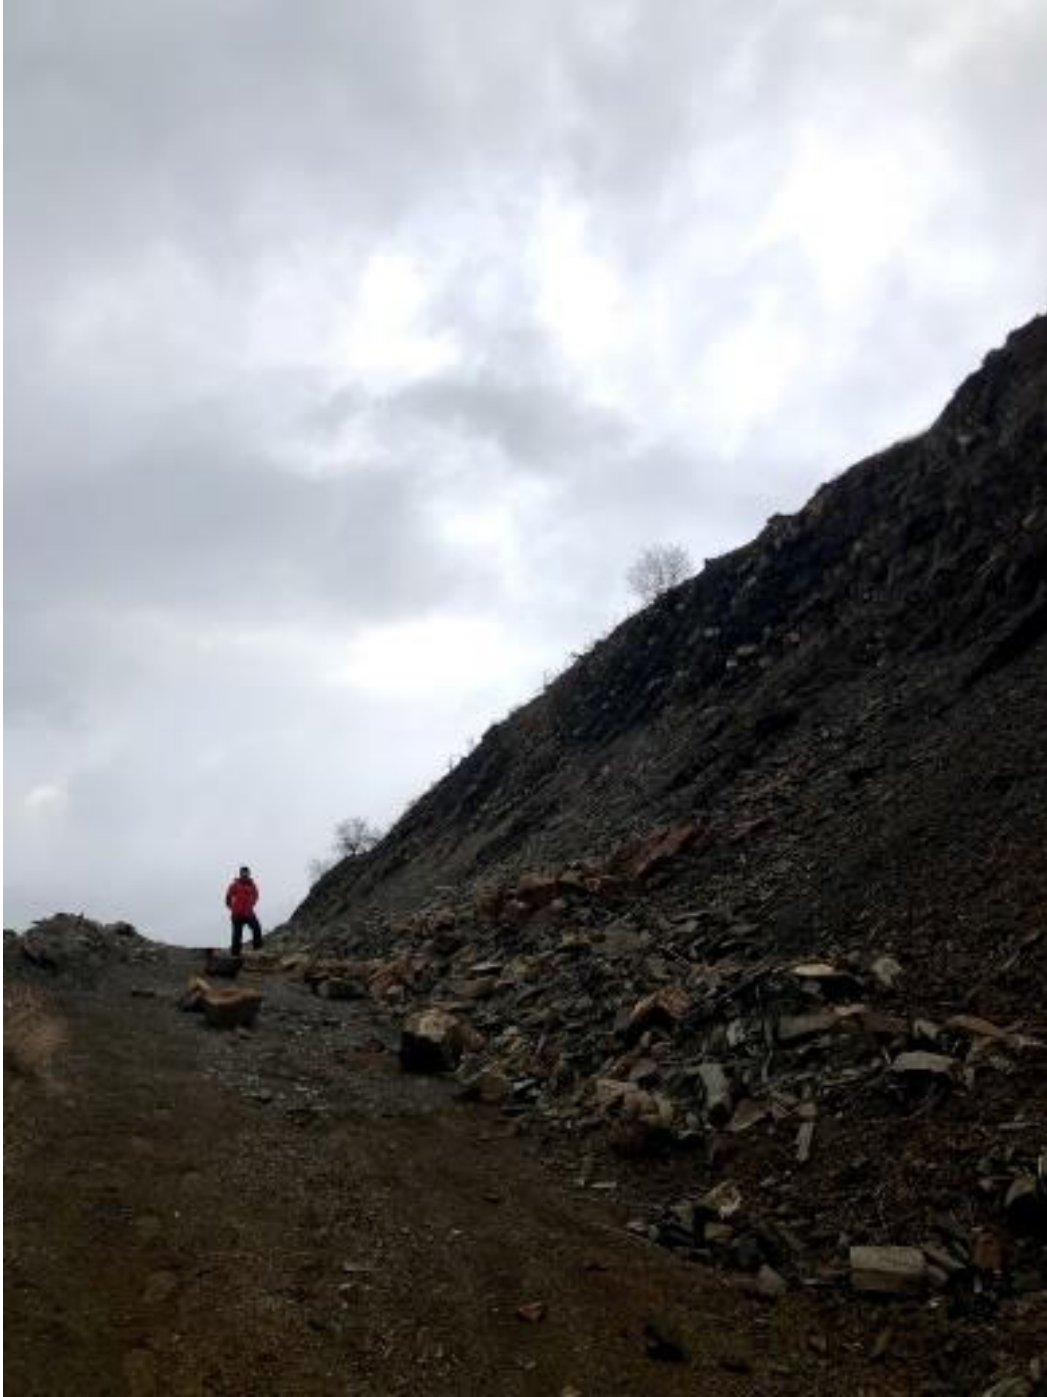
Figure 4.48. Rockfall at 13th stop (upper bench)
(38°31'41.5"N 39°27'60.0"E / 31.01.2020 / 16:10)

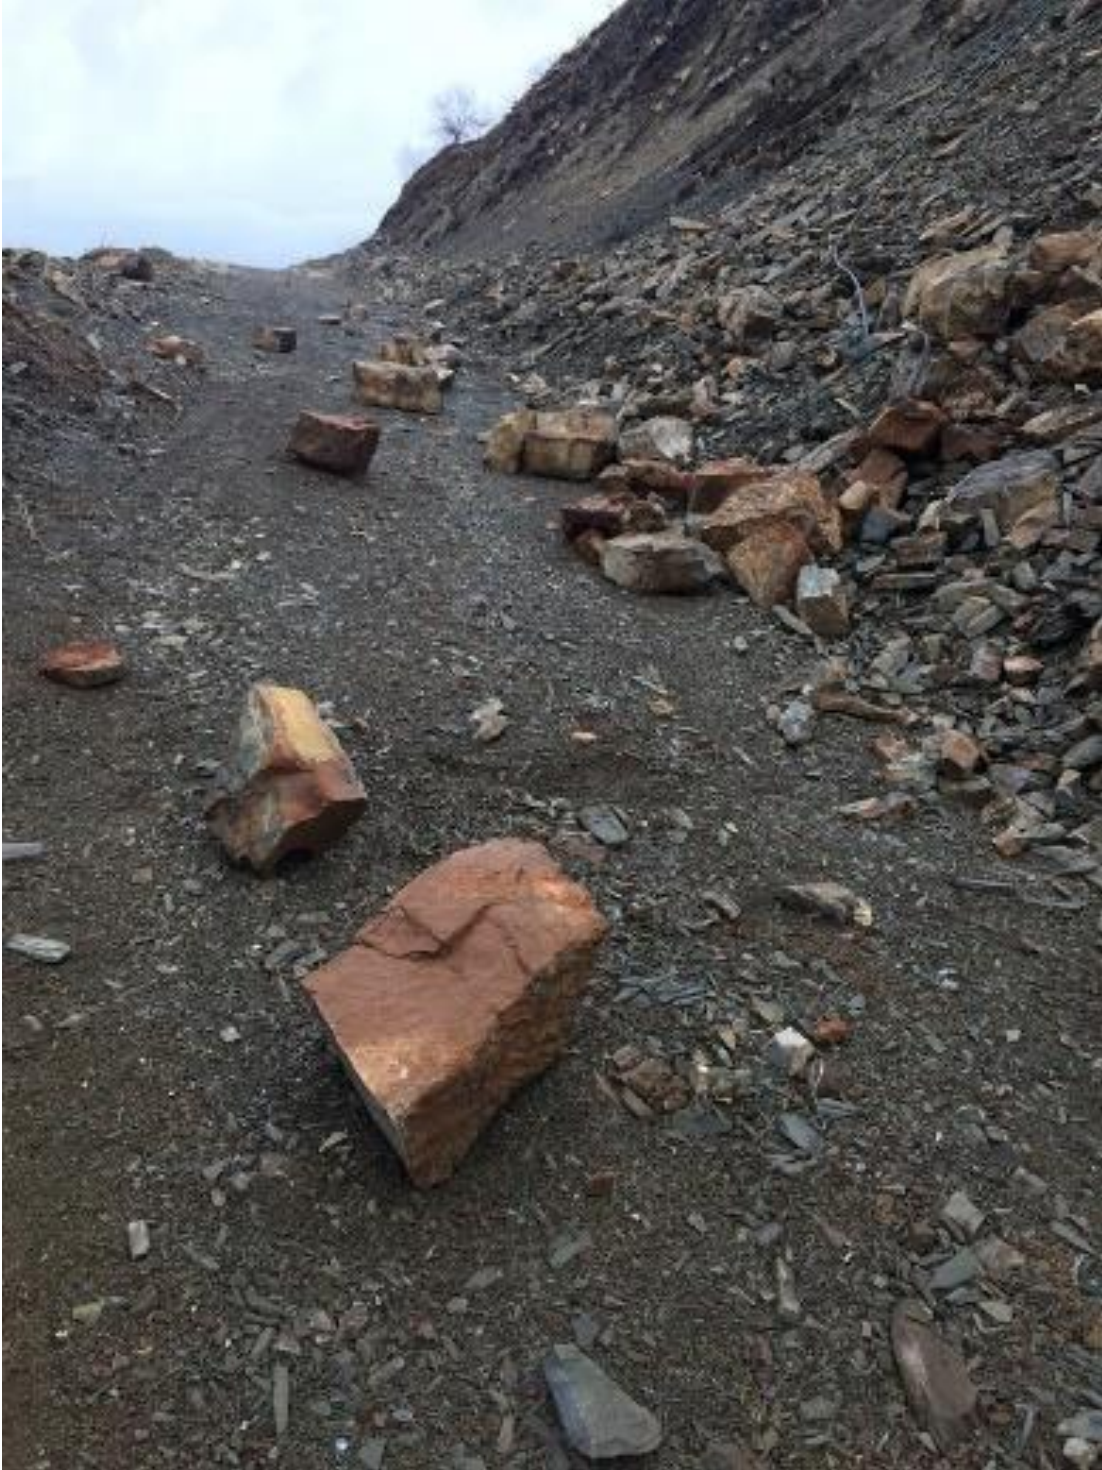
Figure 4.49. Rockfalls at 13th stop
(38°31'41.0"N 39°27'59.6"E / 31.01.2020 / 16:13)

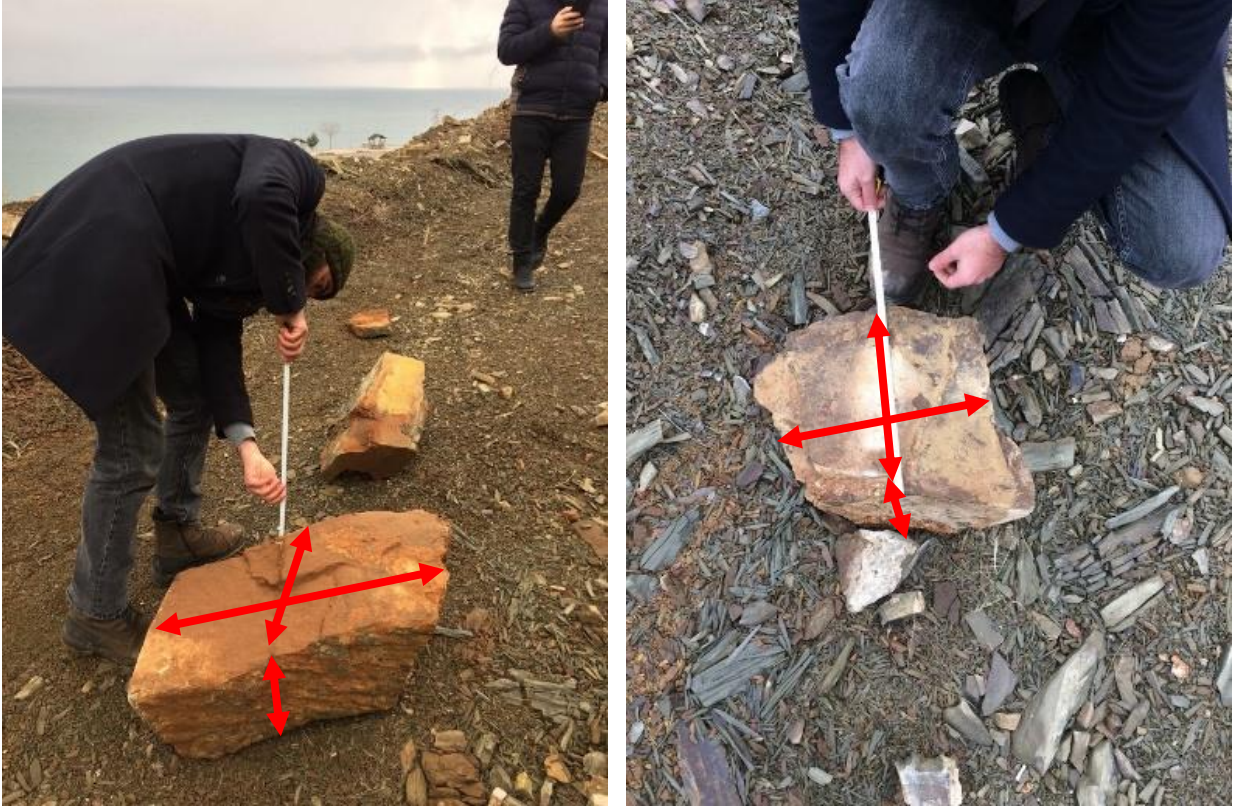
Figure 4.50. Measurement of rockfalls' dimensions at 13th stop.
(38°31'41.3"N 39°27'59.5"E / 31.01.2020 / 16:15 & 38°31'41.5"N 39°27'59.0"E / 31.01.2020 / 16:16)
