**January 24, 2020 Elazığ-Sivrice Earthquake ($M_w=6.8$)
Reconnaissance Study Report**

**MIDDLE EAST TECHNICAL UNIVERSITY
EARTHQUAKE ENGINEERING RESEARCH CENTER**

REPORT NO: METU/EERC 2020-01

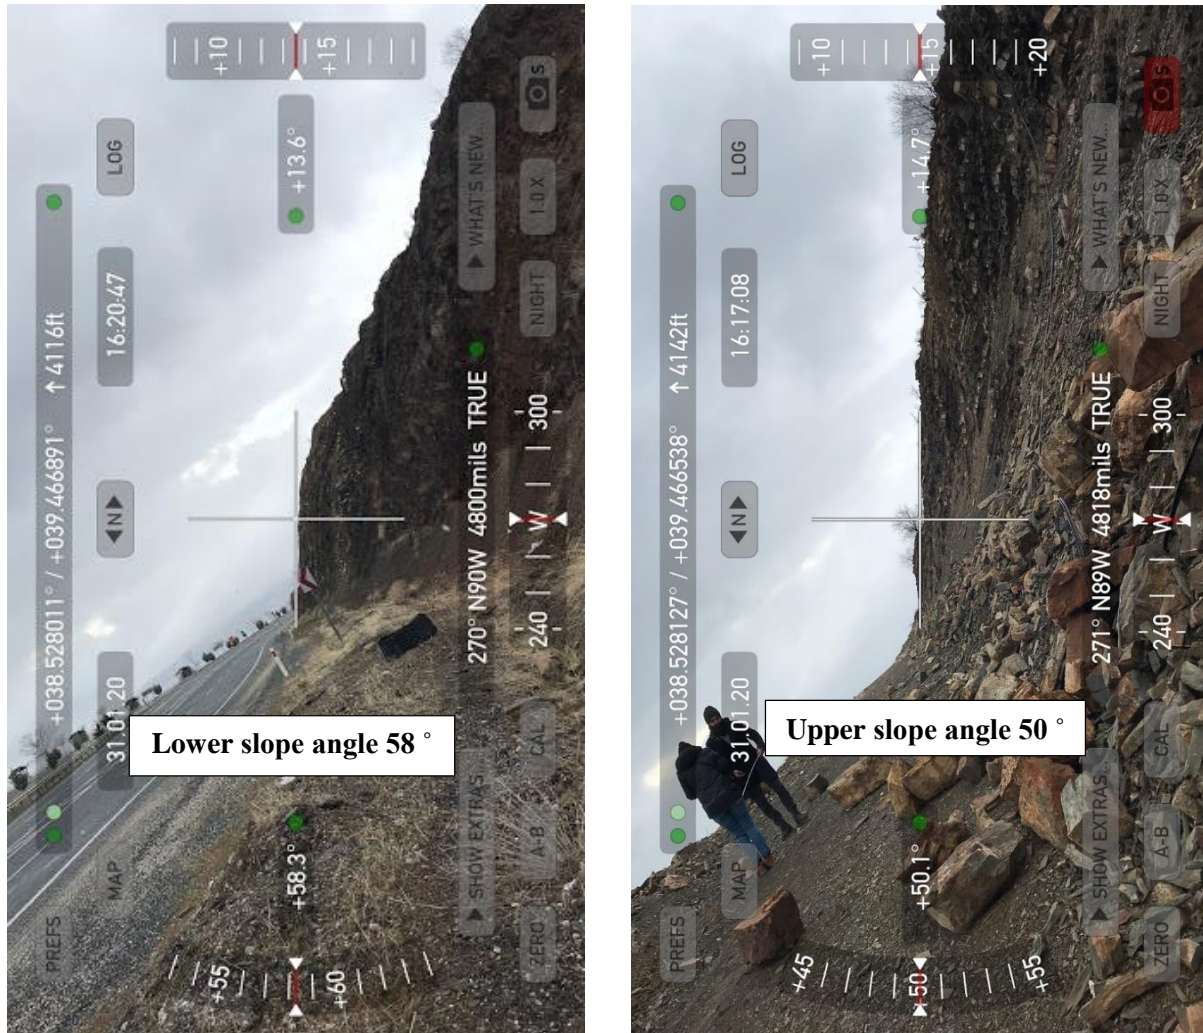
Figure 4.51. Rockfalls at 13th stop (Slope angle determination)
(38°31'40.8"N 39°28'00.8"E / 31.01.2020 / 16:20 & 38°31'41.3"N 39°27'59.5"E / 31.01.2020 / 16:17)

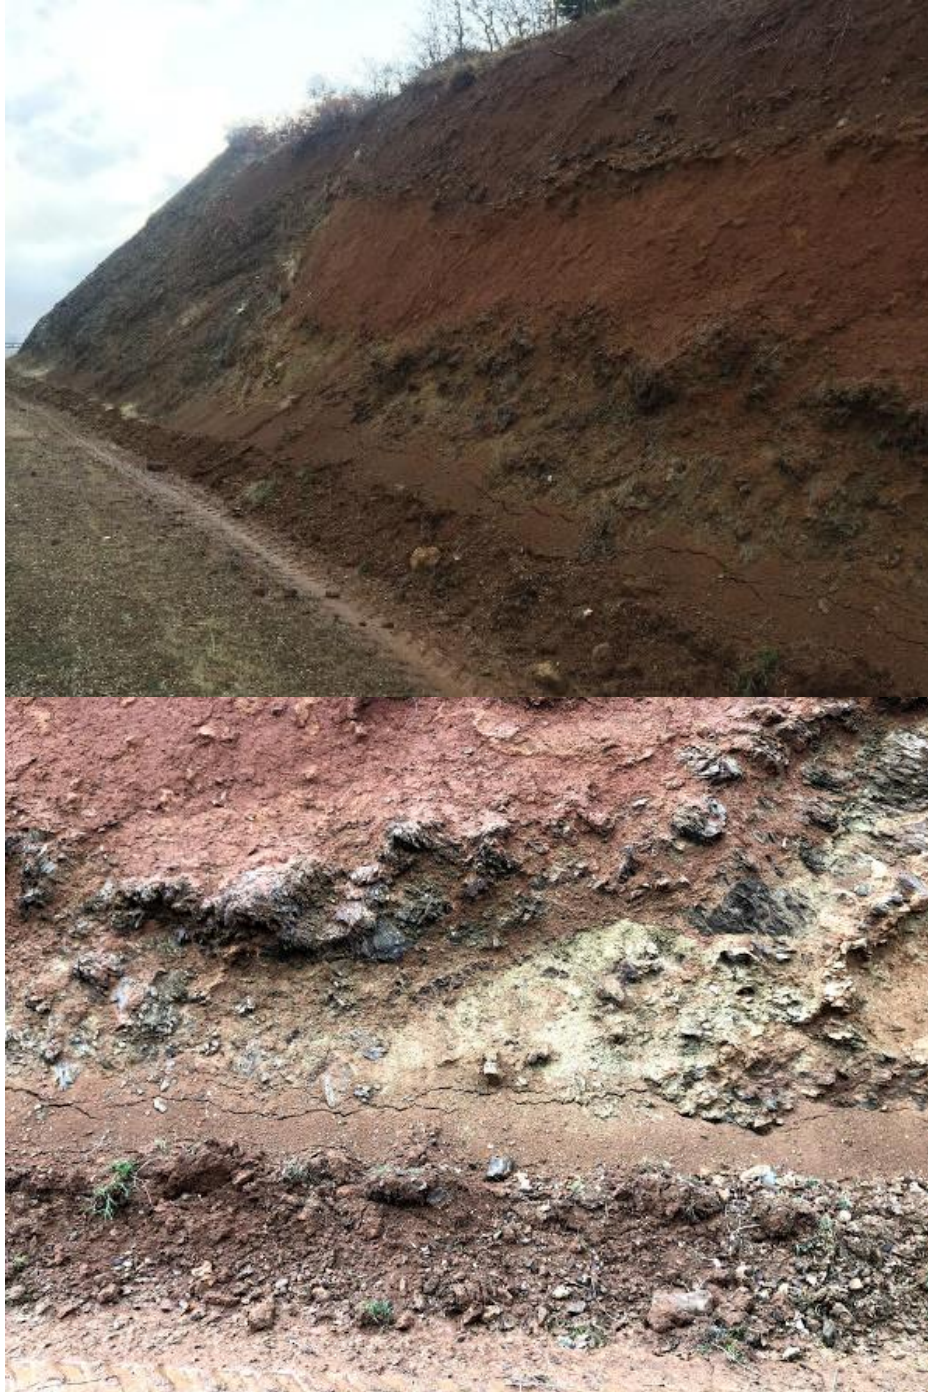
A 65° slope was documented to be stable as shown in Figures 4.52 and 4.53.

Figure 4.52. Side view of the slope
(38°30'11.7"N 39°23'33.4"E / 31.01.2020 / 16:34 & 38°30'11.8"N 39°23'33.3"E / 31.01.2020 / 16:34)

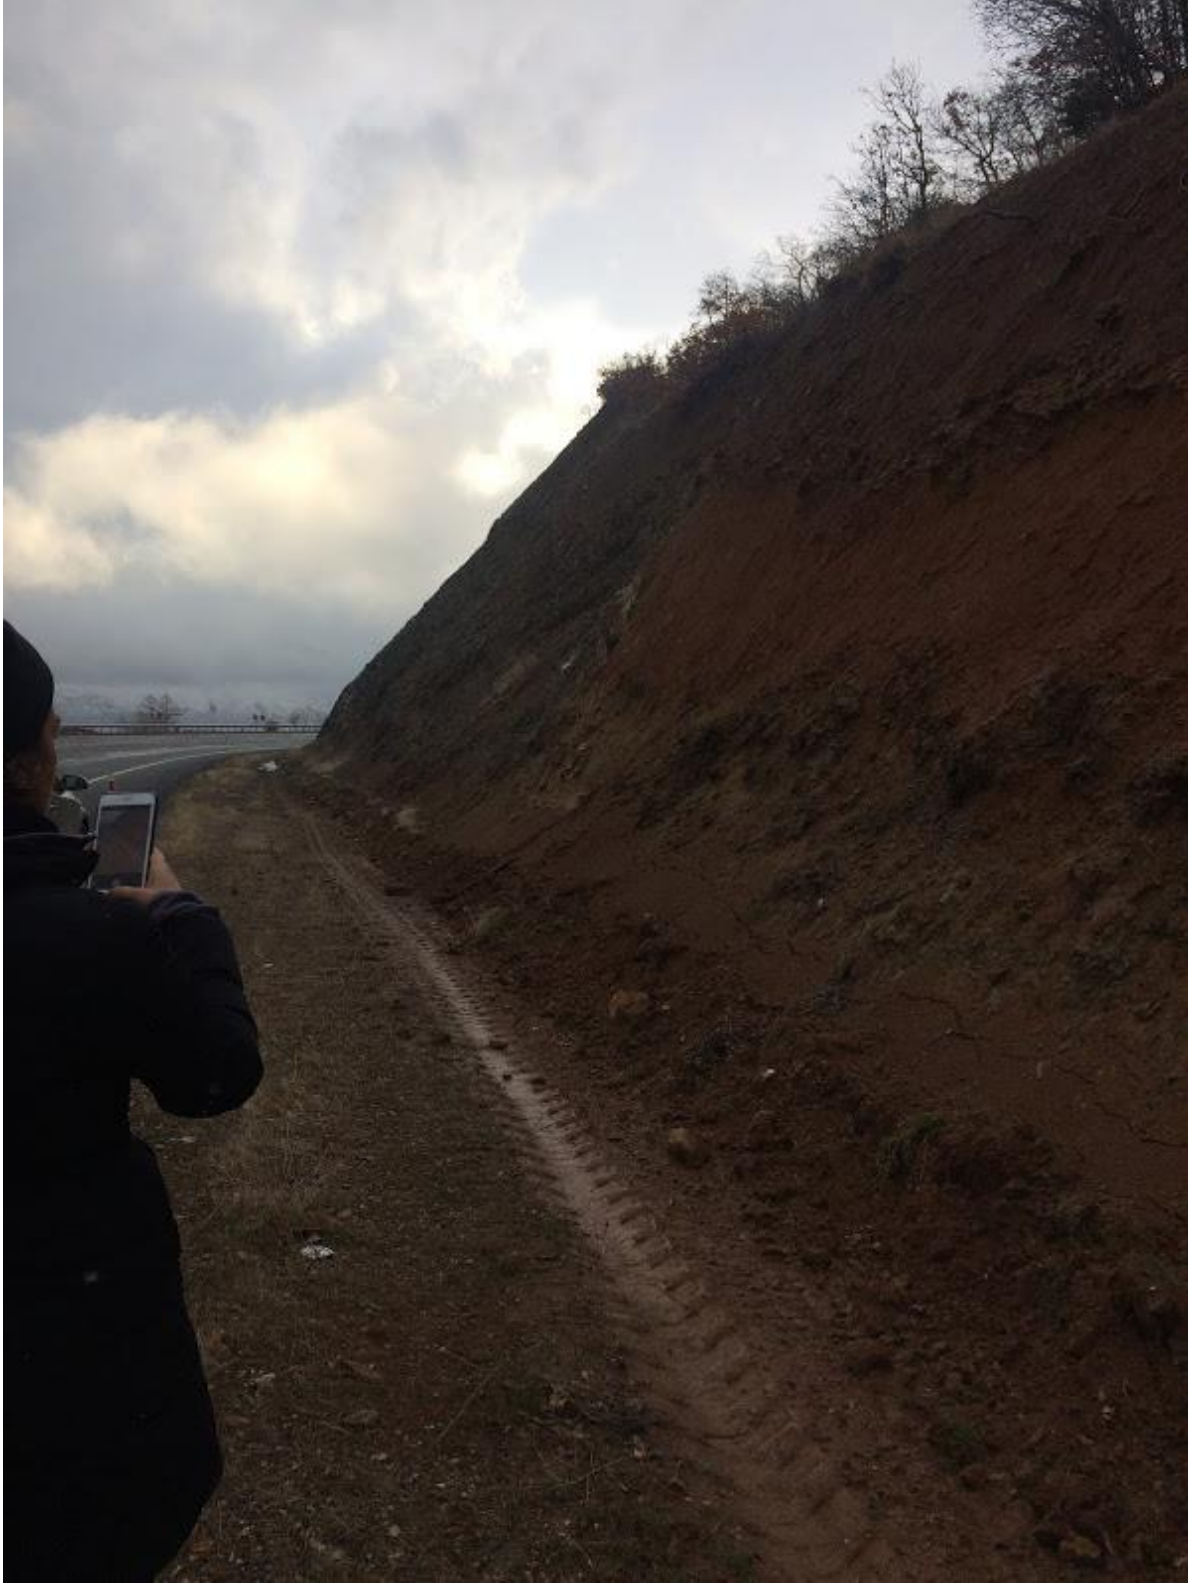
Figure 4.53. Side view of the slope
($38^{\circ}30'11.6''N$ $39^{\circ}23'33.7''E$ / 31.01.2020 / 16:34)

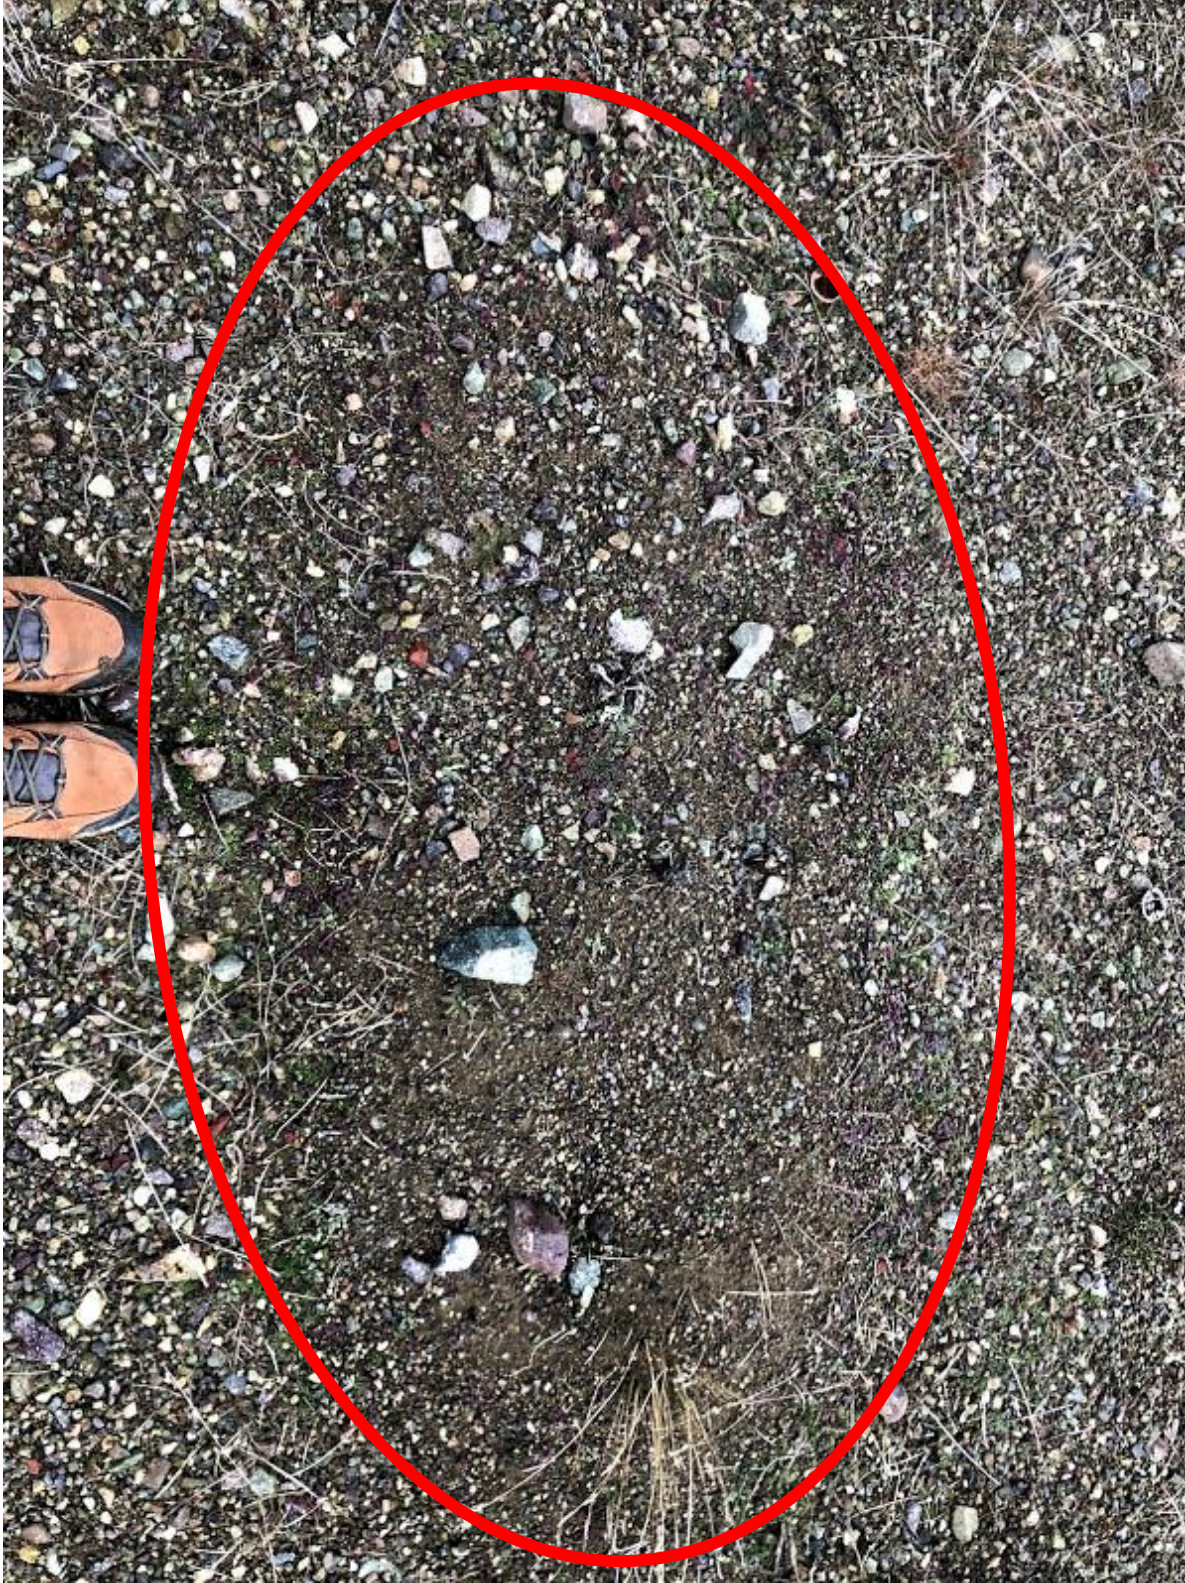
Seismically-induced liquefaction failure was observed in the form of sand boils at the 15th stop. Examples of sand boils in different forms are presented in Figures 4.55 to 4.57. Note that the plane tree leaves were covered by the sand boils in Figure 4.55.

Figure 4.56. Seismic soil liquefaction-induced sand boils
(38°29'32.1"N 39°21'02.0"E / 31.01.2020 / 16:58)

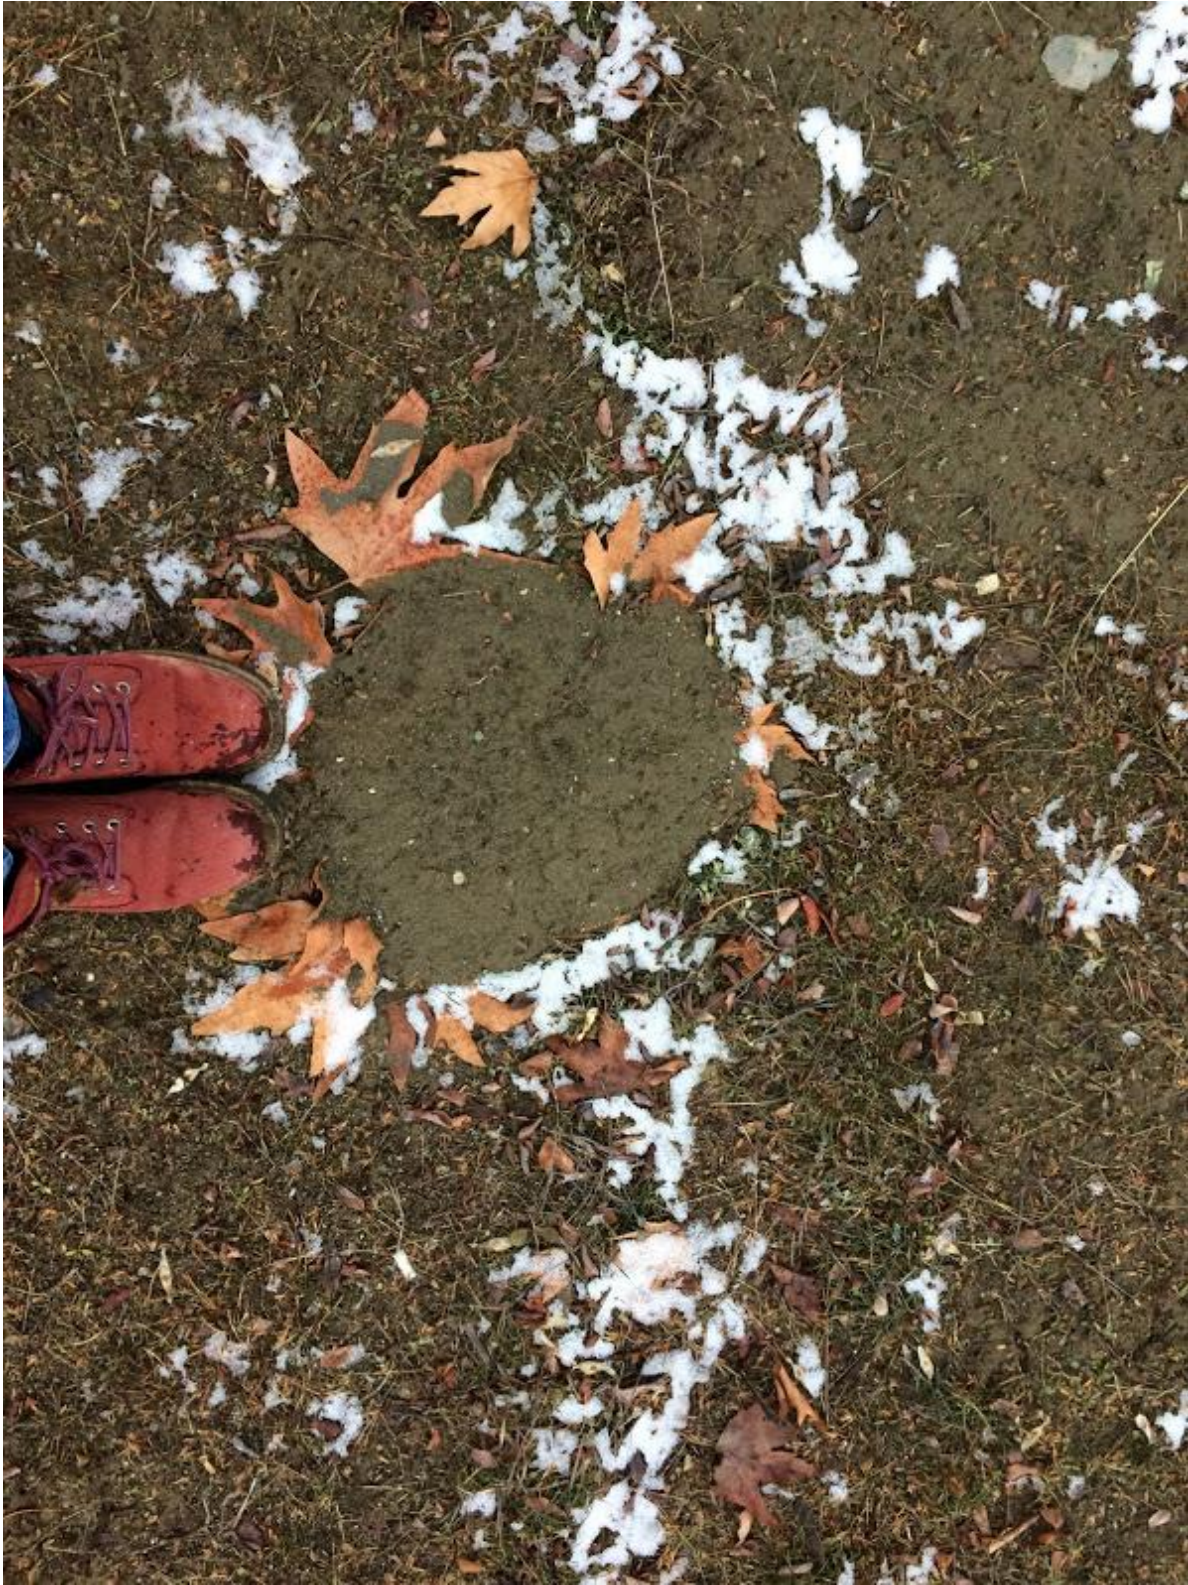
Figure 4.57. Seismic soil liquefaction-induced sand boils
(38°29'34.5"N 39°21'03.7"E / 31.01.2020 / 17:12)

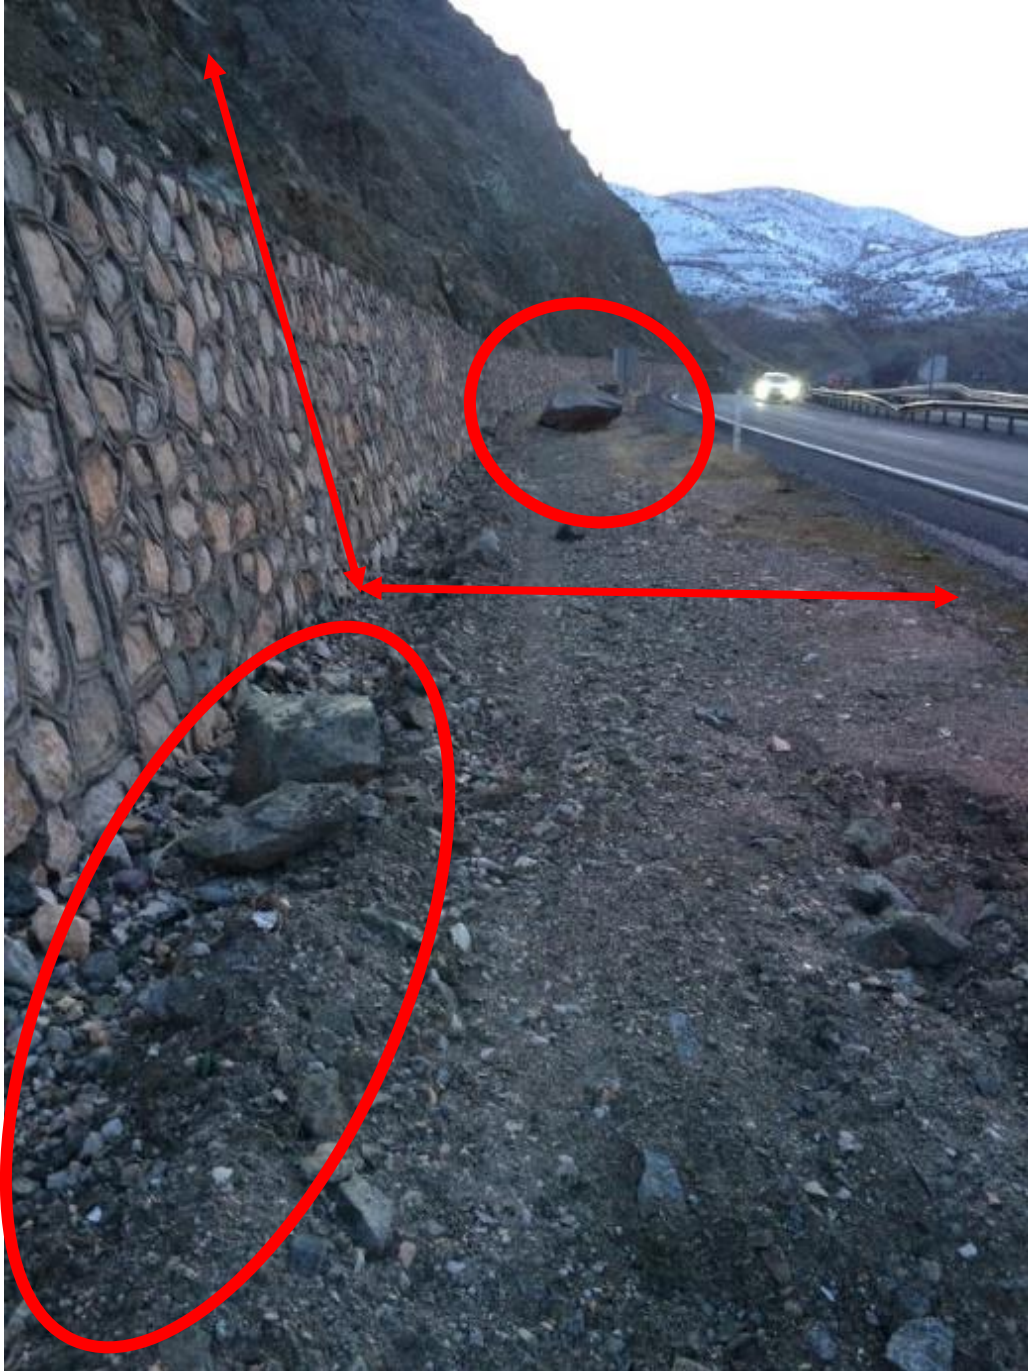
2-3 m diameter rocks were fallen freshly on the shoulders of the highway, as shown in Figure 4.59.

Figure 4.59. Fallen rocks on the highway
(38°26'19.8"N 38°49'38.8"E / 01.02.2020 / 7:23)

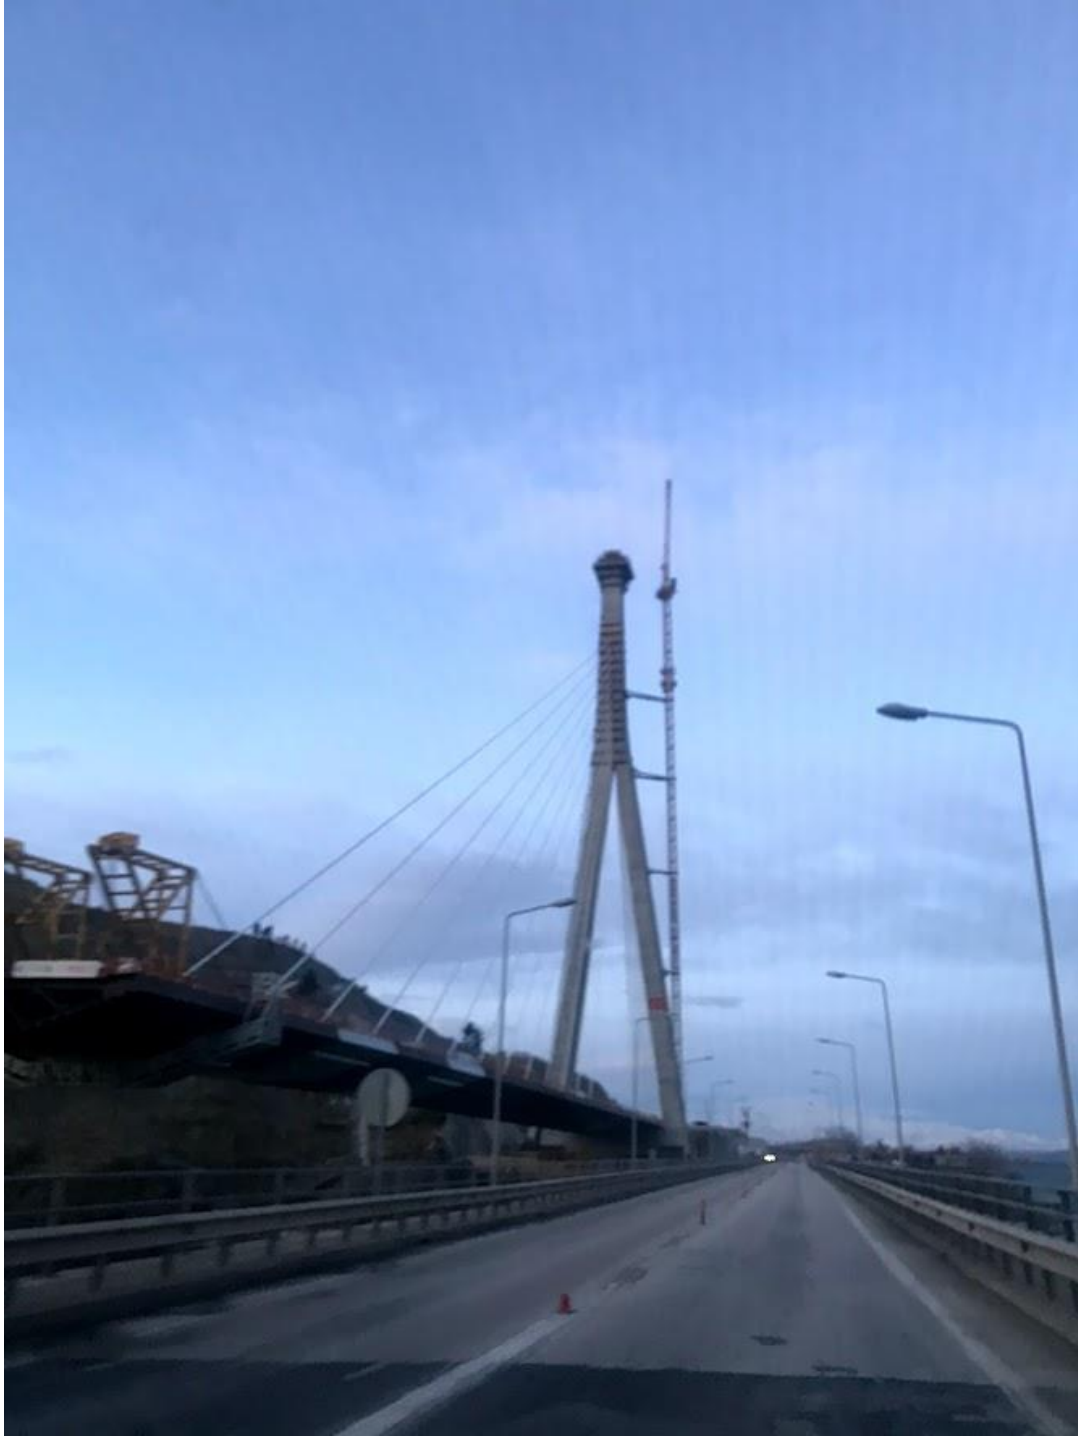
New Kömürhan Bridge under construction on Fırat River was visited, which experienced no damage as shown in Figure 4.60.

Figure 4.60. New Kömürhan Bridge under construction on Fırat River
(38°26'29.6"N 38°49'10.3"E / 01.02.2020 / 7:25)

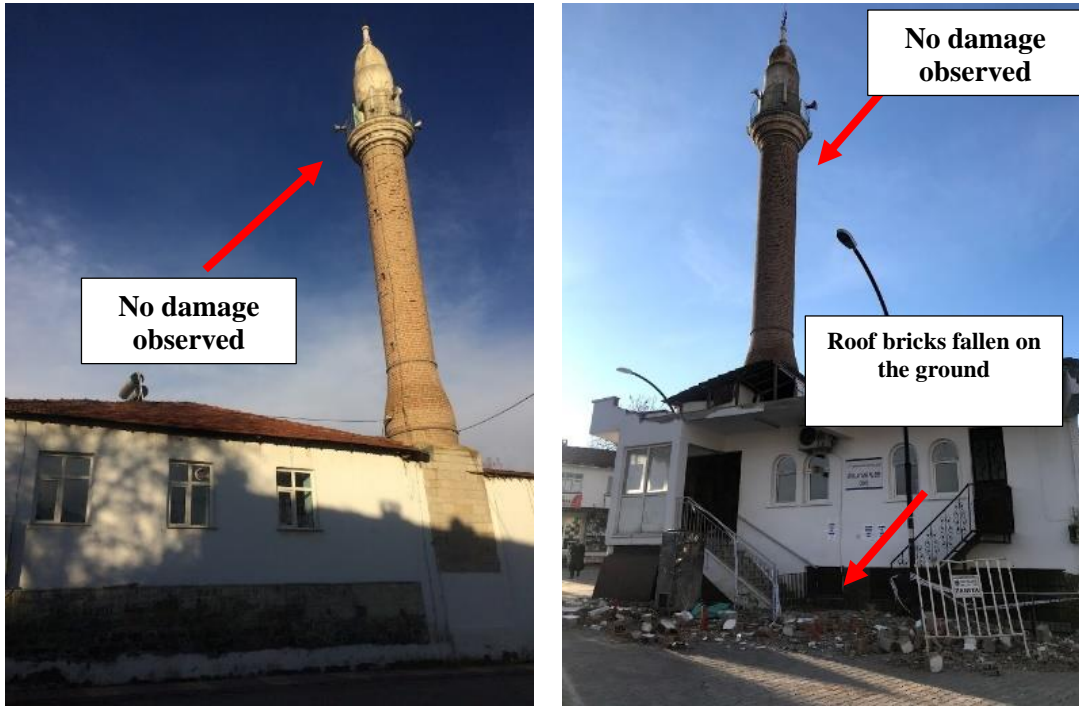
Damages on a number of non-engineered masonry, and reinforced concrete structures were observed in the Battalgazi village, as shown in Figures 4.62- 4.66. Some of these structures suffered from intensive cracking, partial collapse, whereas some others experienced no evident damage. The minarets of village Mosques were not damaged. Historical monument (Ulu Cami) was also documented to be not damaged. No signs of ground deformation-induced structural failures.

Figure 4.63. Minaret's of village Mosque
($38^{\circ}25'28.6''N$ $38^{\circ}21'55.5''E$ / 01.02.2020 / 8:41)

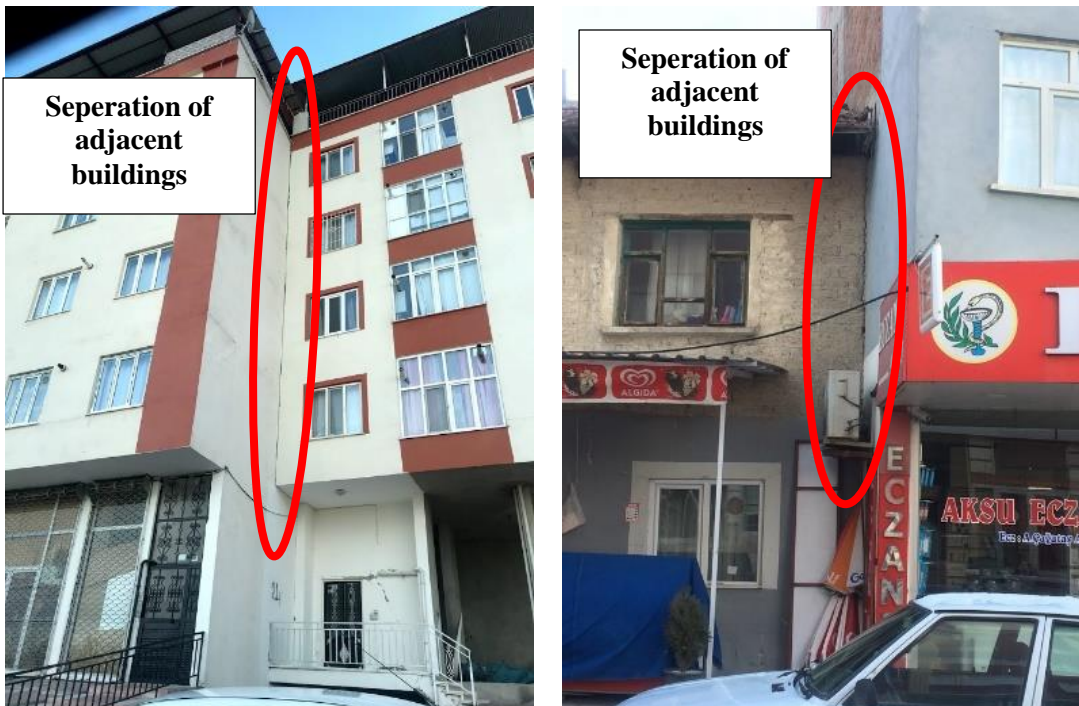
Figure 4.64. Separation of two adjacent buildings in Battalgazi Village
($38^{\circ}25'40.4''N$ $38^{\circ}22'02.8''E$ / 01.02.2020 / 8:44 & $38^{\circ}25'35.4''N$ $38^{\circ}22'00.4''E$ / 01.02.2020 / 8:43)

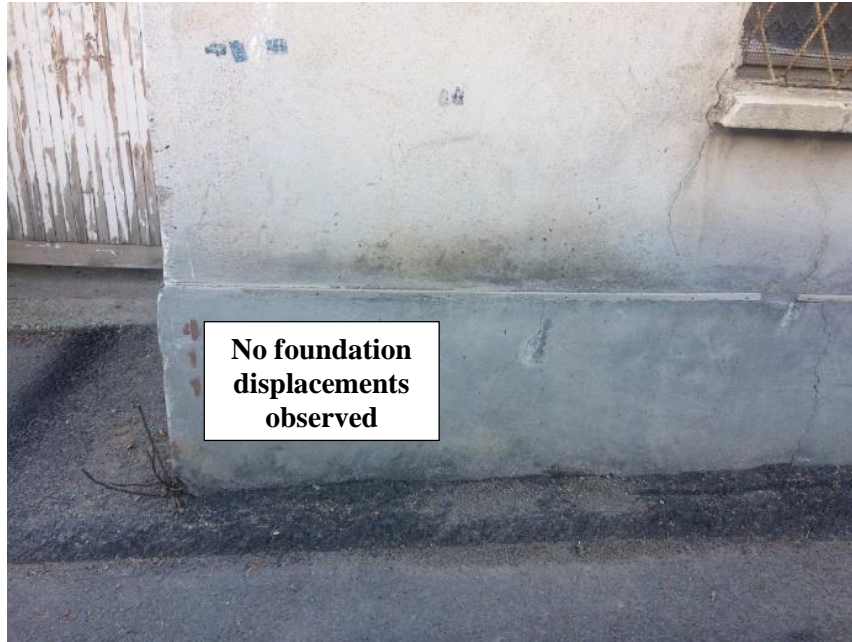
Figure 4.65. No foundation displacements observed at a residential building in Battalgazi Village
(38°25'20.7"N 38°21'59.3"E / 01.02.2020 / 8:31)

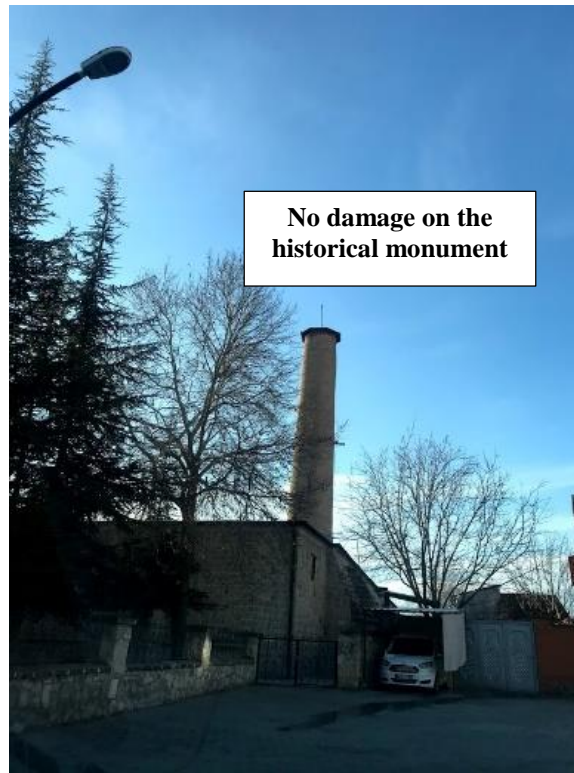
Figure 4.66. Historical monument in the Battalgazi Village
(38°25'15.5"N 38°21'59.7"E / 01.02.2020 / 8:32)

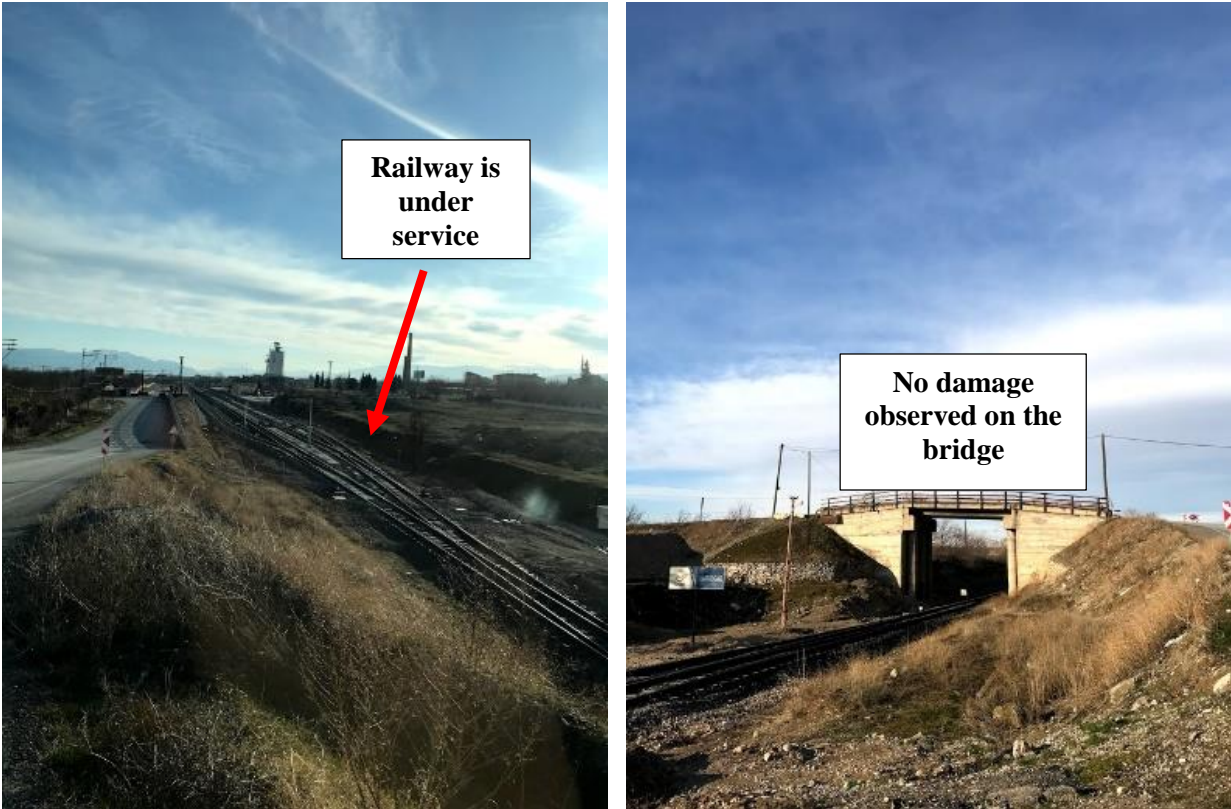
Railway tracks were observed to be not damaged at the 29th stop. The railway was under service as presented in Figure 4.67. In the same figure a small bridge is shown again with no signs of damage.

Figure 4.67. Railway and bridge at 20th stop
(38°26'00.1"N 38°21'59.1"E / 01.02.2020 / 8:49 & 38°26'00.2"N 38°22'01.3"E / 01.02.2020 / 8:50)

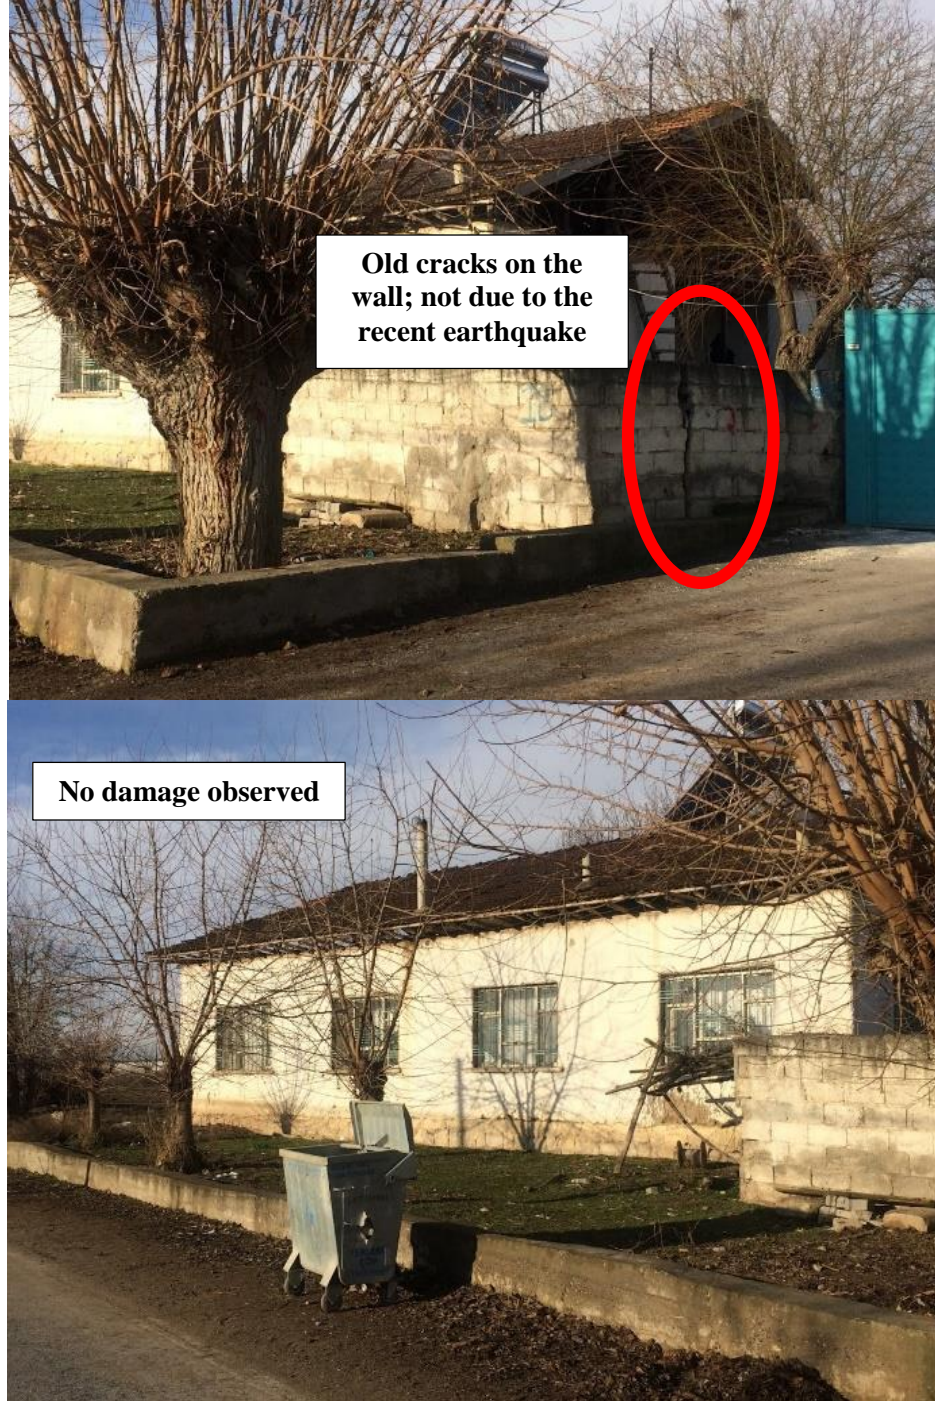
A number of structural damages were observed, mostly concentrating on masonry buildings in Bahçelievler district of Battalgazi village, as shown in Figure 4.68 and 4.69.

Figure 4.68. Residential buildings in the Bahçelievler district of Battalgazi Village
(38°26'51.2"N 38°22'19.2"E / 01.02.2020 / 8:52 & 38°26'51.1"N 38°22'19.2"E / 01.02.2020 / 8:53)

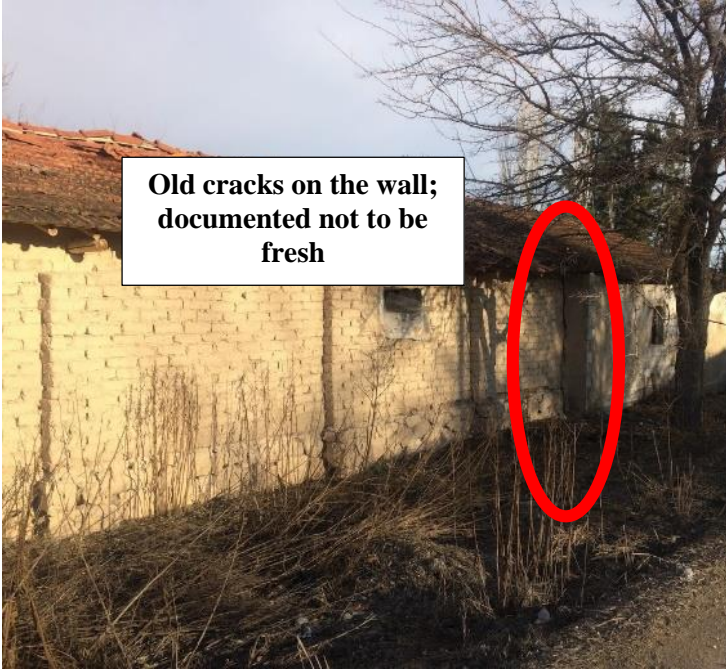
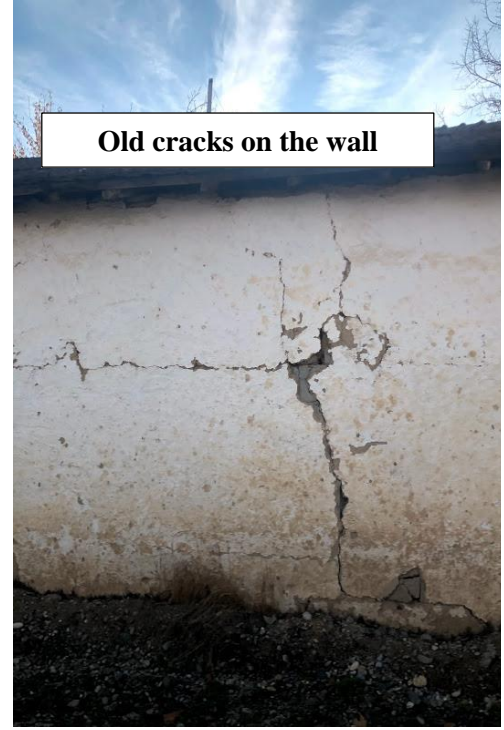
Figure 4.69. Cracks on the wall of a residential building in the Bahçelievler district of Battalgazi Village
(38°27'48.5"N 38°22'50.6"E / 01.02.2020 / 8:56 & 38°27'49.0"N 38°22'51.7"E / 01.02.2020 / 8:56)

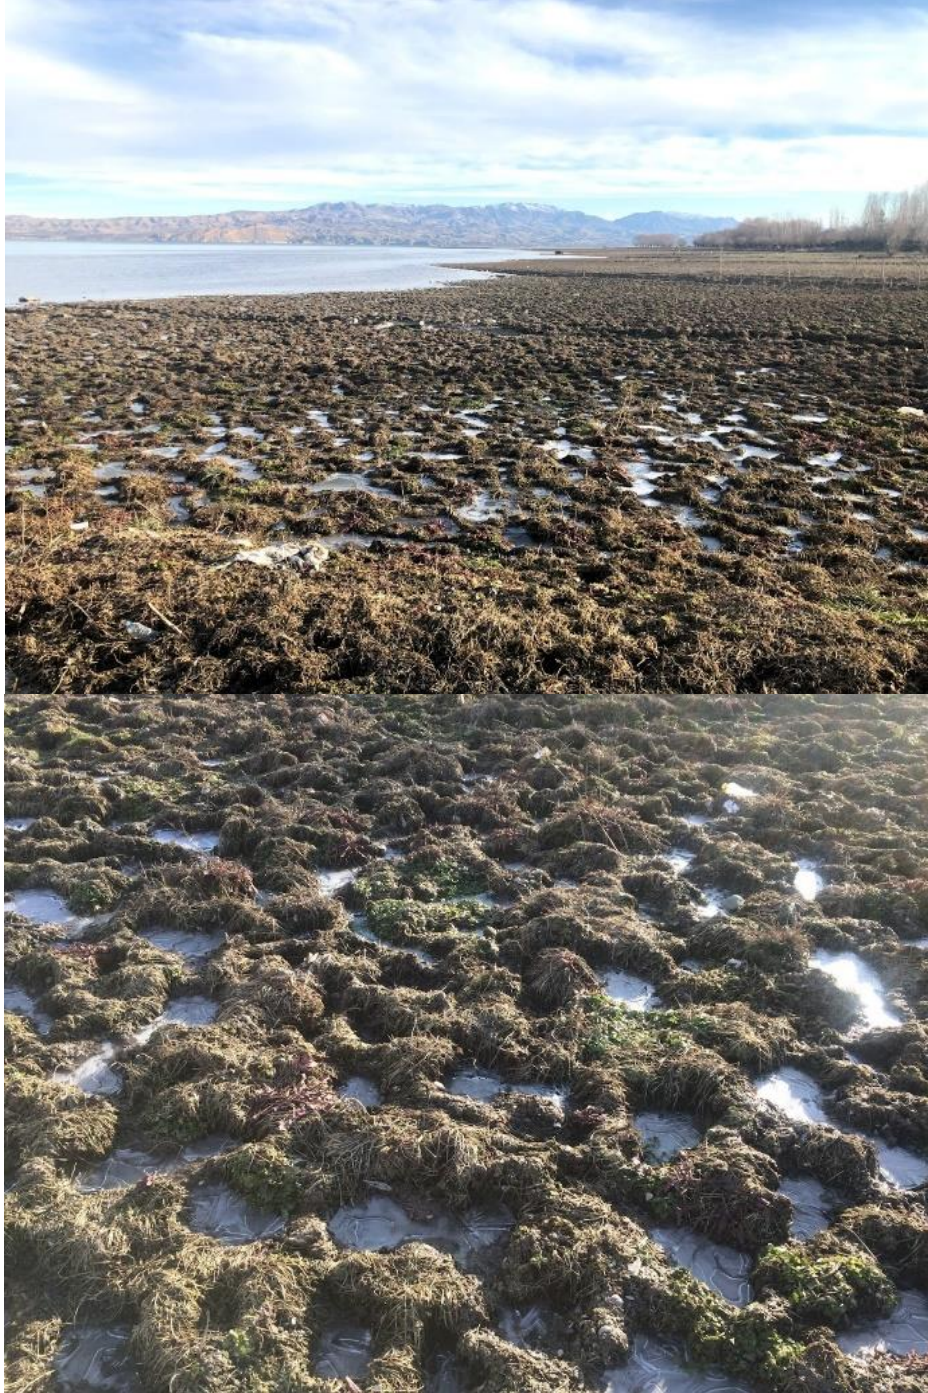
Although it is composed of alluvial deposits with potential for ground failure, no signs of it were observed. Surficial soils, observed to be of high plasticity clays, and frozen ground were listed as two factors, which might have impeded possible ground failure, as shown in Figures 4.70 and 4.71.

Figure 4.70. Views of frozen soil in Toygar district of Battalgazi Village
(38°28'38.6"N 38°23'26.4"E / 01.02.2020 / 9:02 & 38°28'38.6"N 38°23'27.1"E / 01.02.2020 / 9:03)

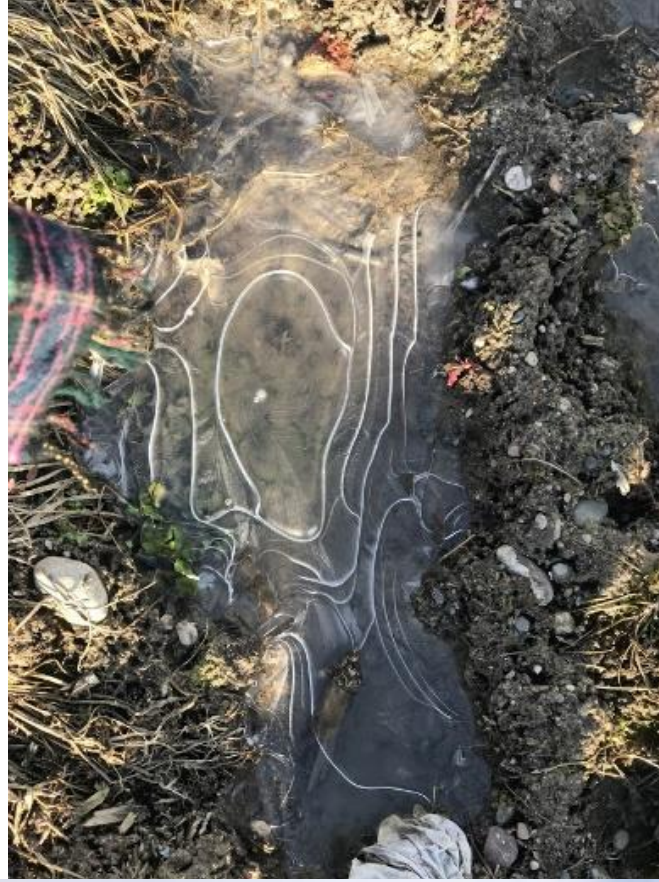
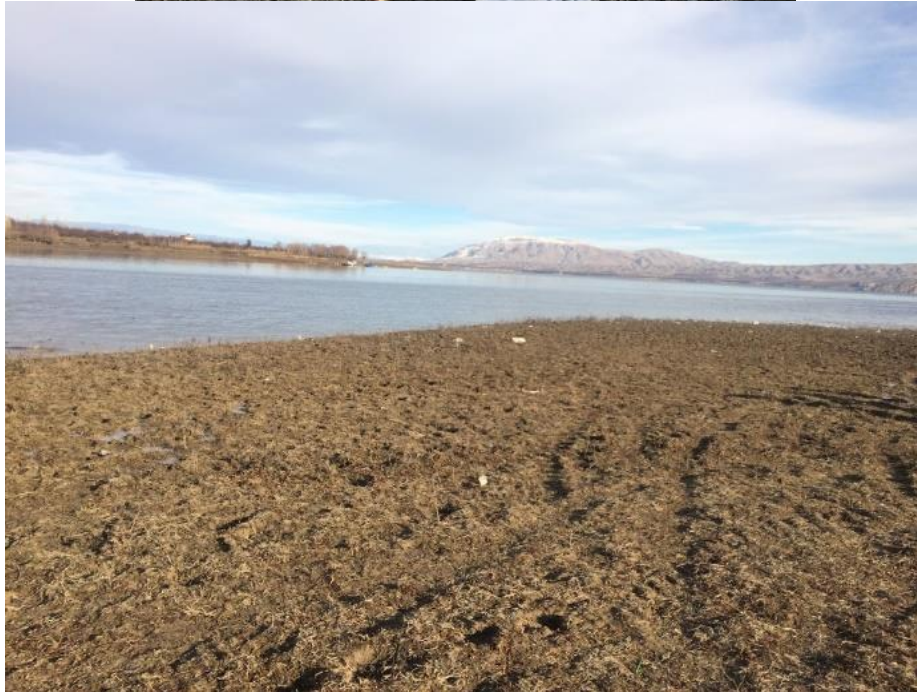
Figure 4.71. Views of frozen clayey soils in Toygar district of Battalgazi Village
($38^{\circ}28'38.9''N$ $38^{\circ}23'27.3''E$ / 01.02.2020 / 9:03 & $38^{\circ}28'39.8''N$ $38^{\circ}23'29.3''E$ / 01.02.2020 / 9:05)

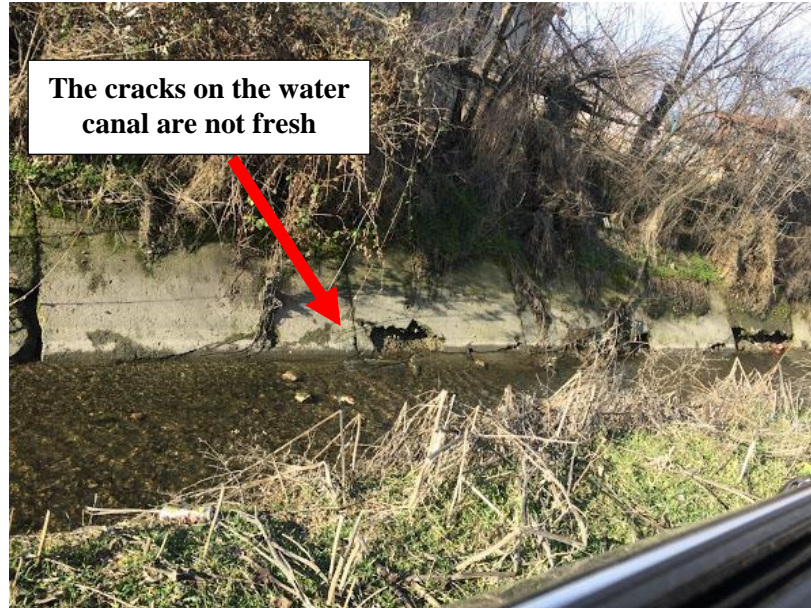
A water canal and the highway bridge were documented with no signs of damage, as shown in Figure 4.72 and Figure 4.73. Note that the observed cracks were dated older, and are not associated with the recent earthquake event.

Figure 4.72. Water trench in Dolamantepe district of Battalgazi Village
(38°26'00.4"N 38°21'44.1"E / 01.02.2020 / 9:25)

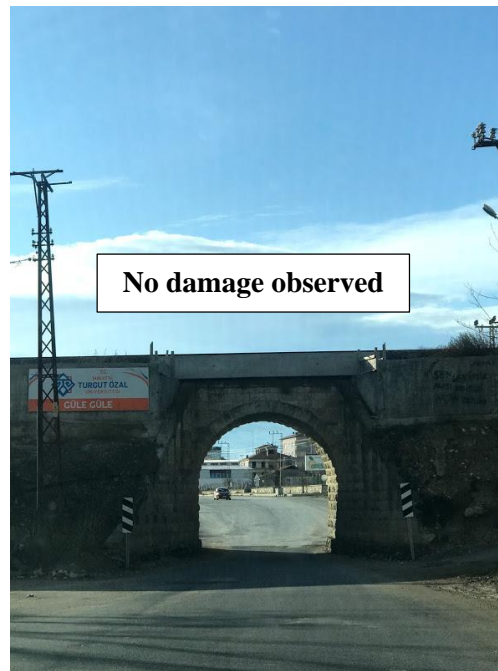
Figure 4.73. Dolamantepe district of Battalgazi Village
(38°25'59.9"N 38°21'41.5"E / 01.02.2020 / 9:26)

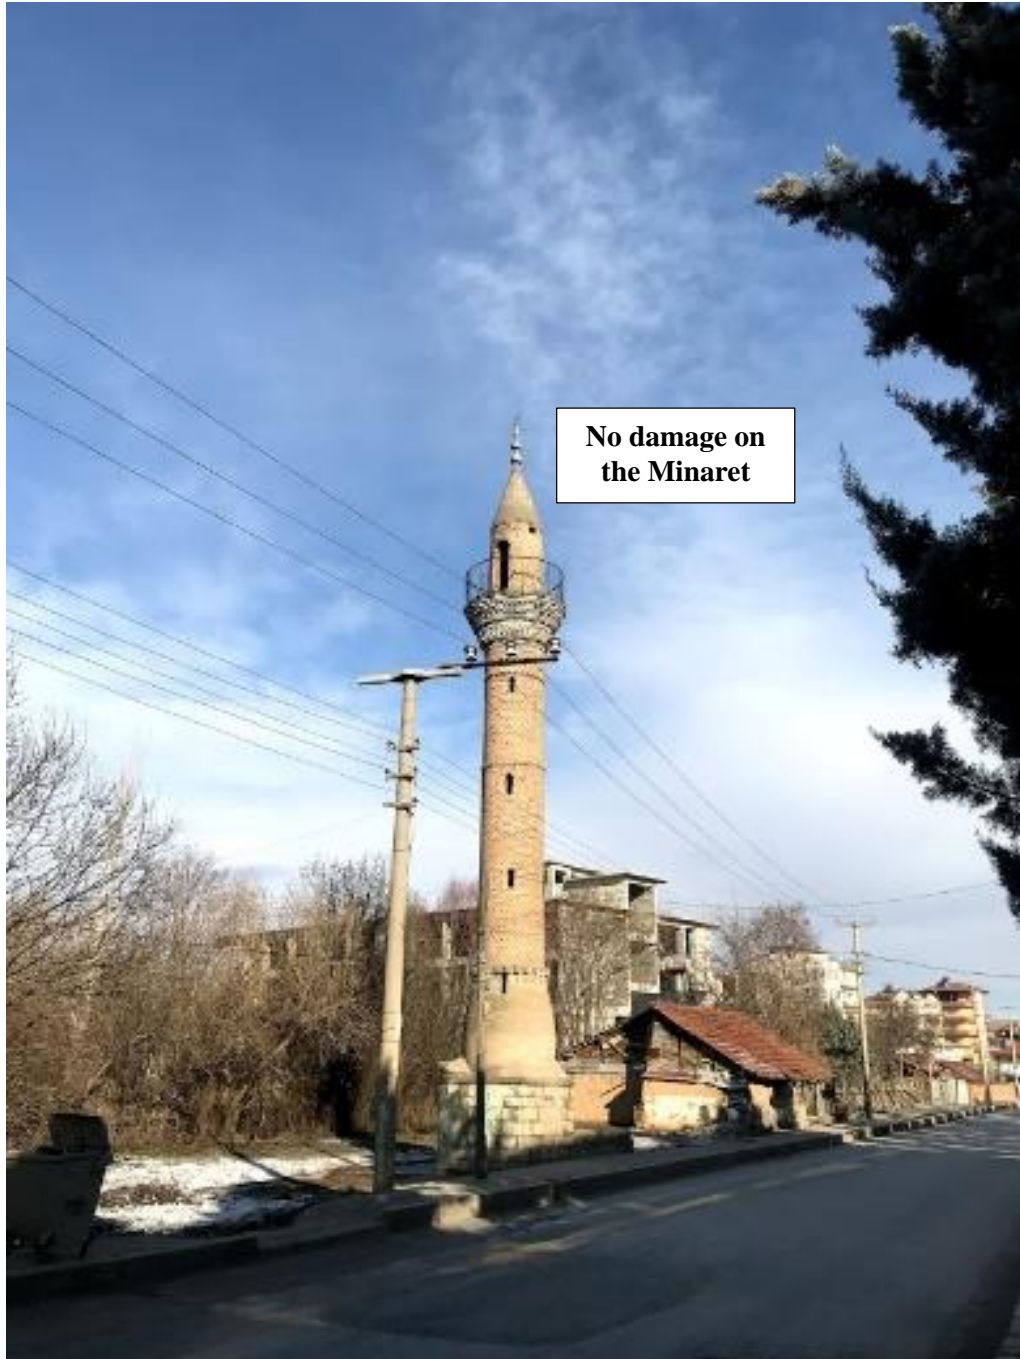
The minaret of village Mosque was not damaged, as shown in Figure 4.74.

Figure 4.74. Minaret's of a Mosque in the Hanımınçiftliği district of Battalgazi Village
(38°22'39.4"N 38°20'08.7"E / 01.02.2020 / 9:44)
