**January 24, 2020 Elazığ-Sivrice Earthquake ($M_w=6.8$)
Reconnaissance Study Report**

**MIDDLE EAST TECHNICAL UNIVERSITY
EARTHQUAKE ENGINEERING RESEARCH CENTER**

REPORT NO: METU/EERC 2020-01

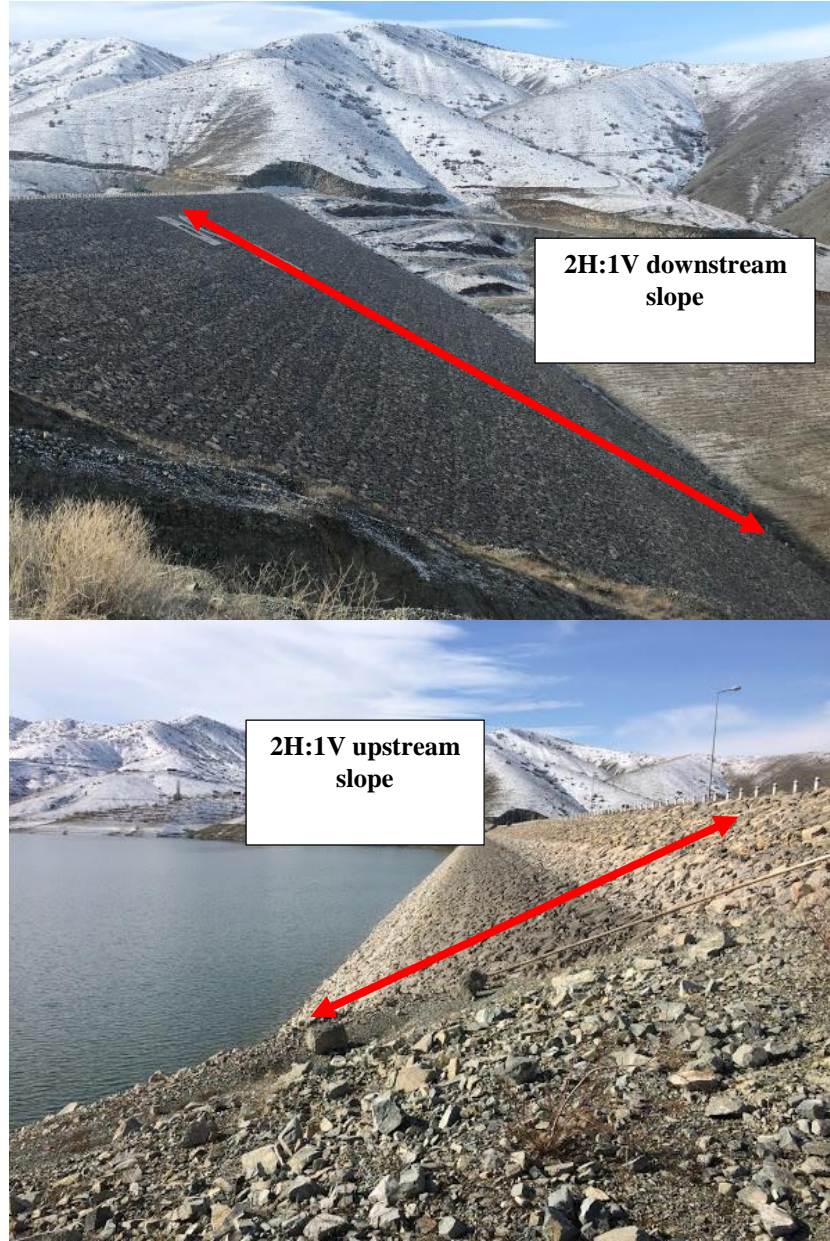
The dam was built on Memikhan River for irrigation purposes. It is an 89.5 m high clay core rockfill dam. The crest and normal water elevations were 868 m and 864.9, respectively. During our visit the water level was measured as 854.70 m. The right and left abutments along with the dam body itself were documented to be not affected from the shaking. Also, no damage to water in-take and spillways were observed. Pictures taken at the dam site can be seen in Figures 4.75 to 4.83.

Figure 4.75. Side views of Kapıkaya Dam
(38°21'19.1"N 38°36'33.9"E / 01.02.2020 / 10:21 & 38°21'16.3"N 38°36'35.0"E / 01.02.2020 / 10:38)

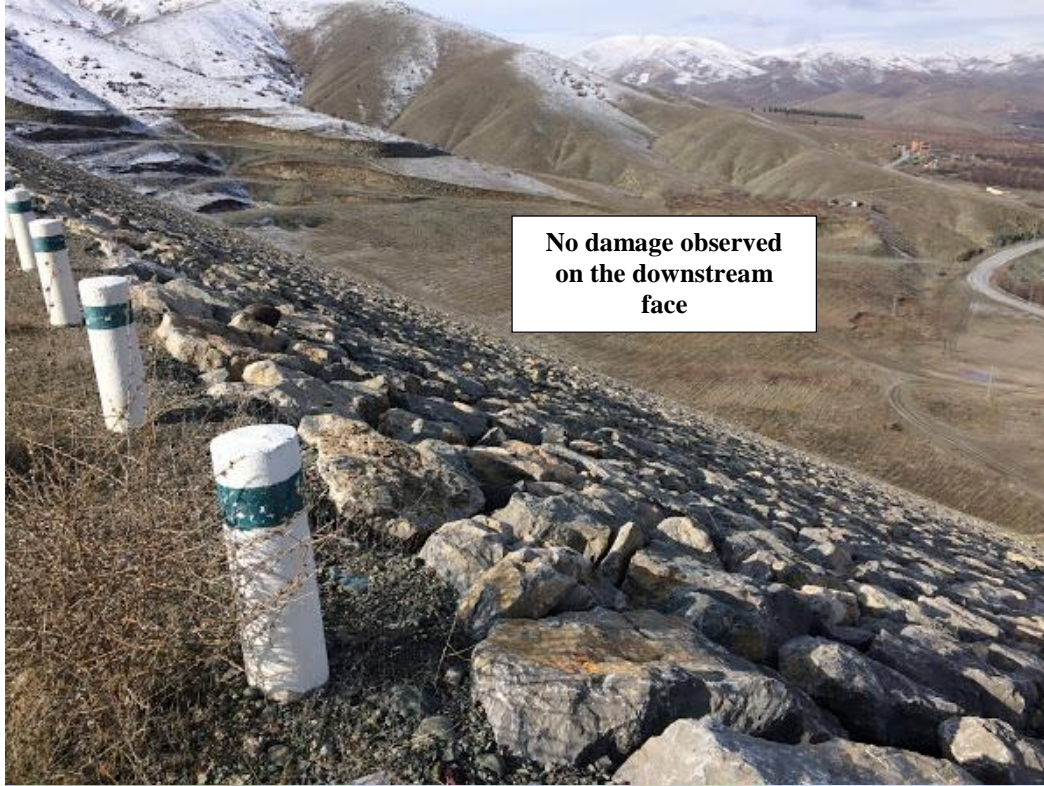
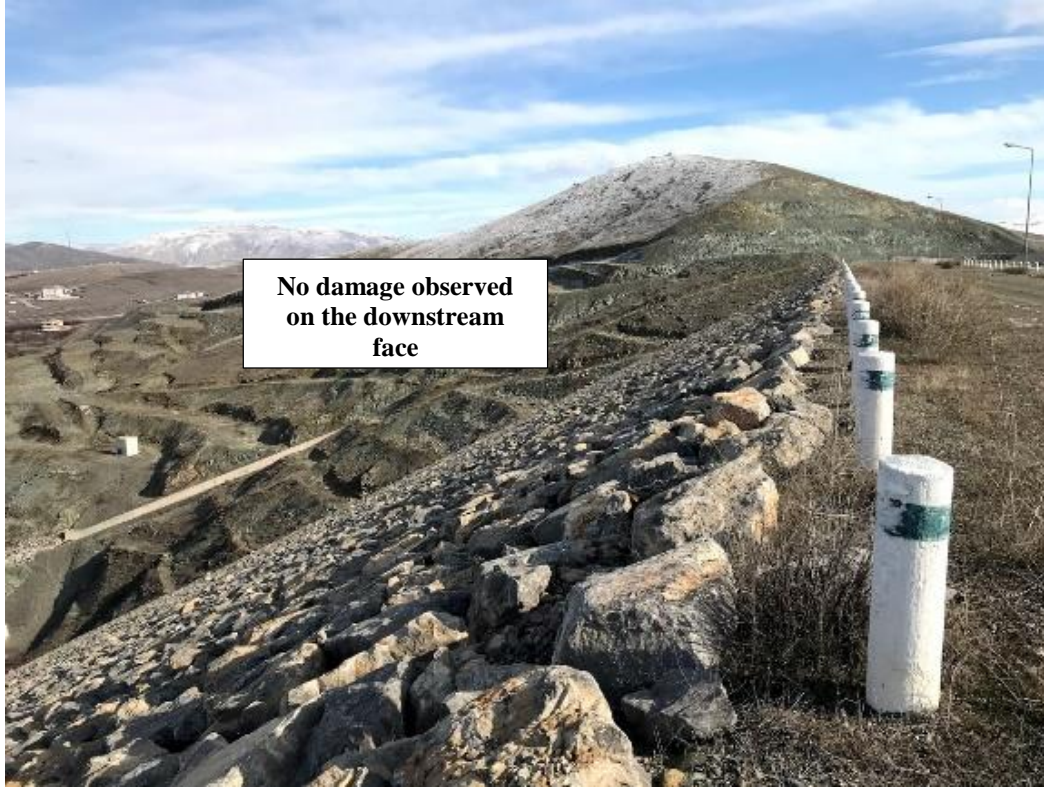
Figure 4.76. Side view of Kapıkaya Dam downstream face
($38^{\circ}21'16.3''N$ $38^{\circ}36'33.2''E$ / 01.02.2020 / 10:40 & $38^{\circ}21'13.1''N$ $38^{\circ}36'26.7''E$ / 01.02.2020 / 10:46)

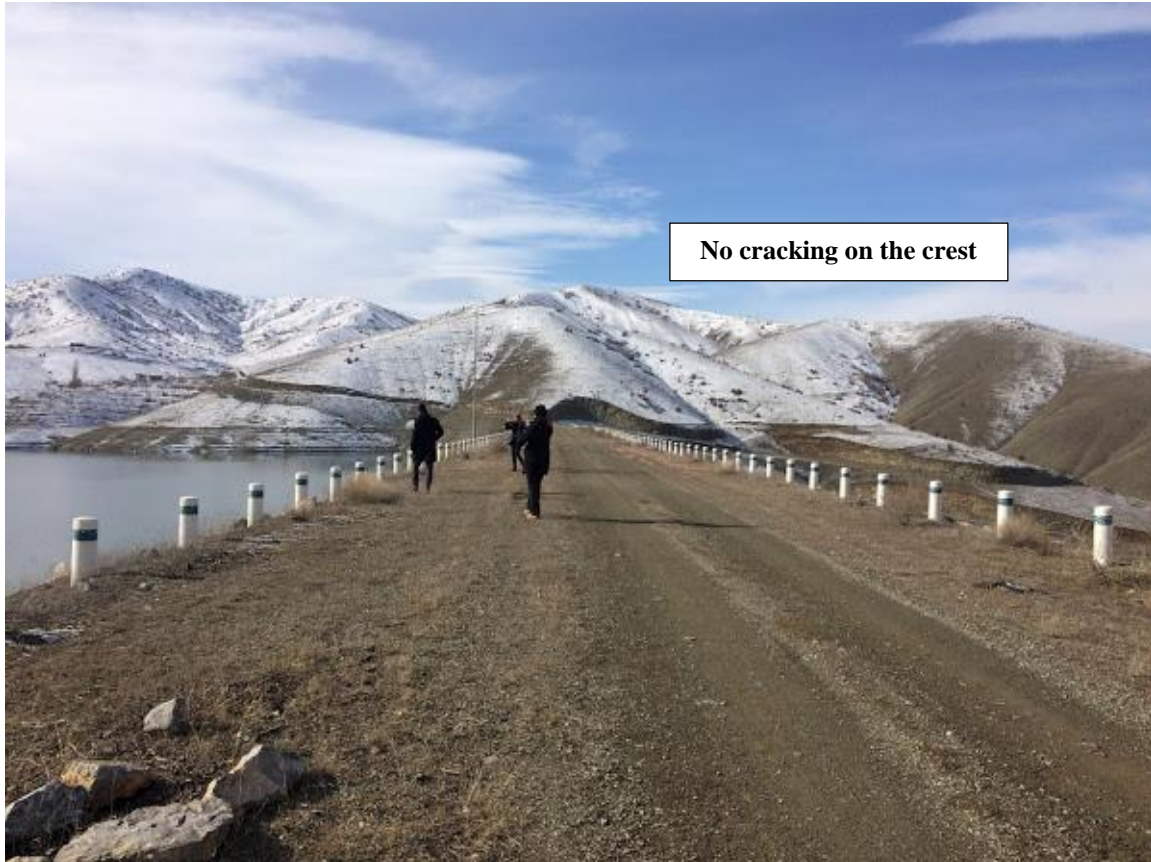
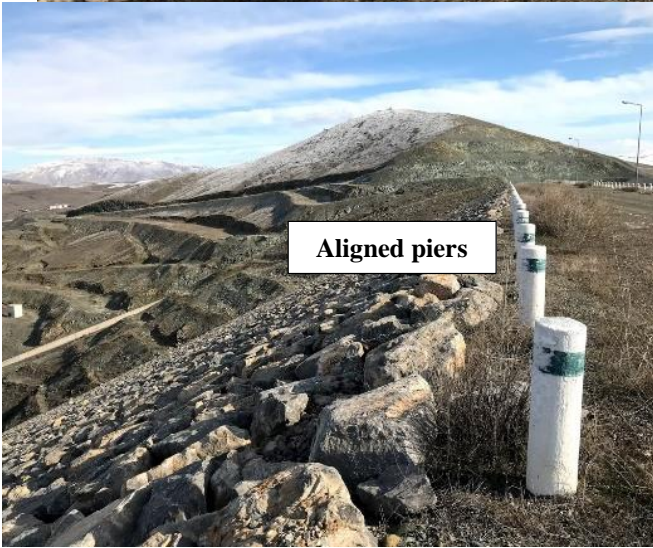
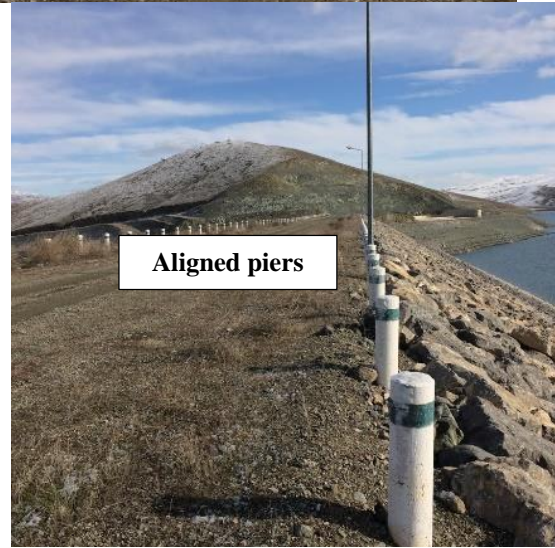
Figure 4.77. Crest view of Kapıkaya Dam
($38^{\circ}21'15.9''N$ $38^{\circ}36'32.8''E$ / 01.02.2020 / 10:40 & $38^{\circ}21'12.6''N$ $38^{\circ}36'26.9''E$ / 01.02.2020 / 10:46 &
 $38^{\circ}21'16.9''N$ $38^{\circ}36'36.0''E$ / 01.02.2020 / 11:13)

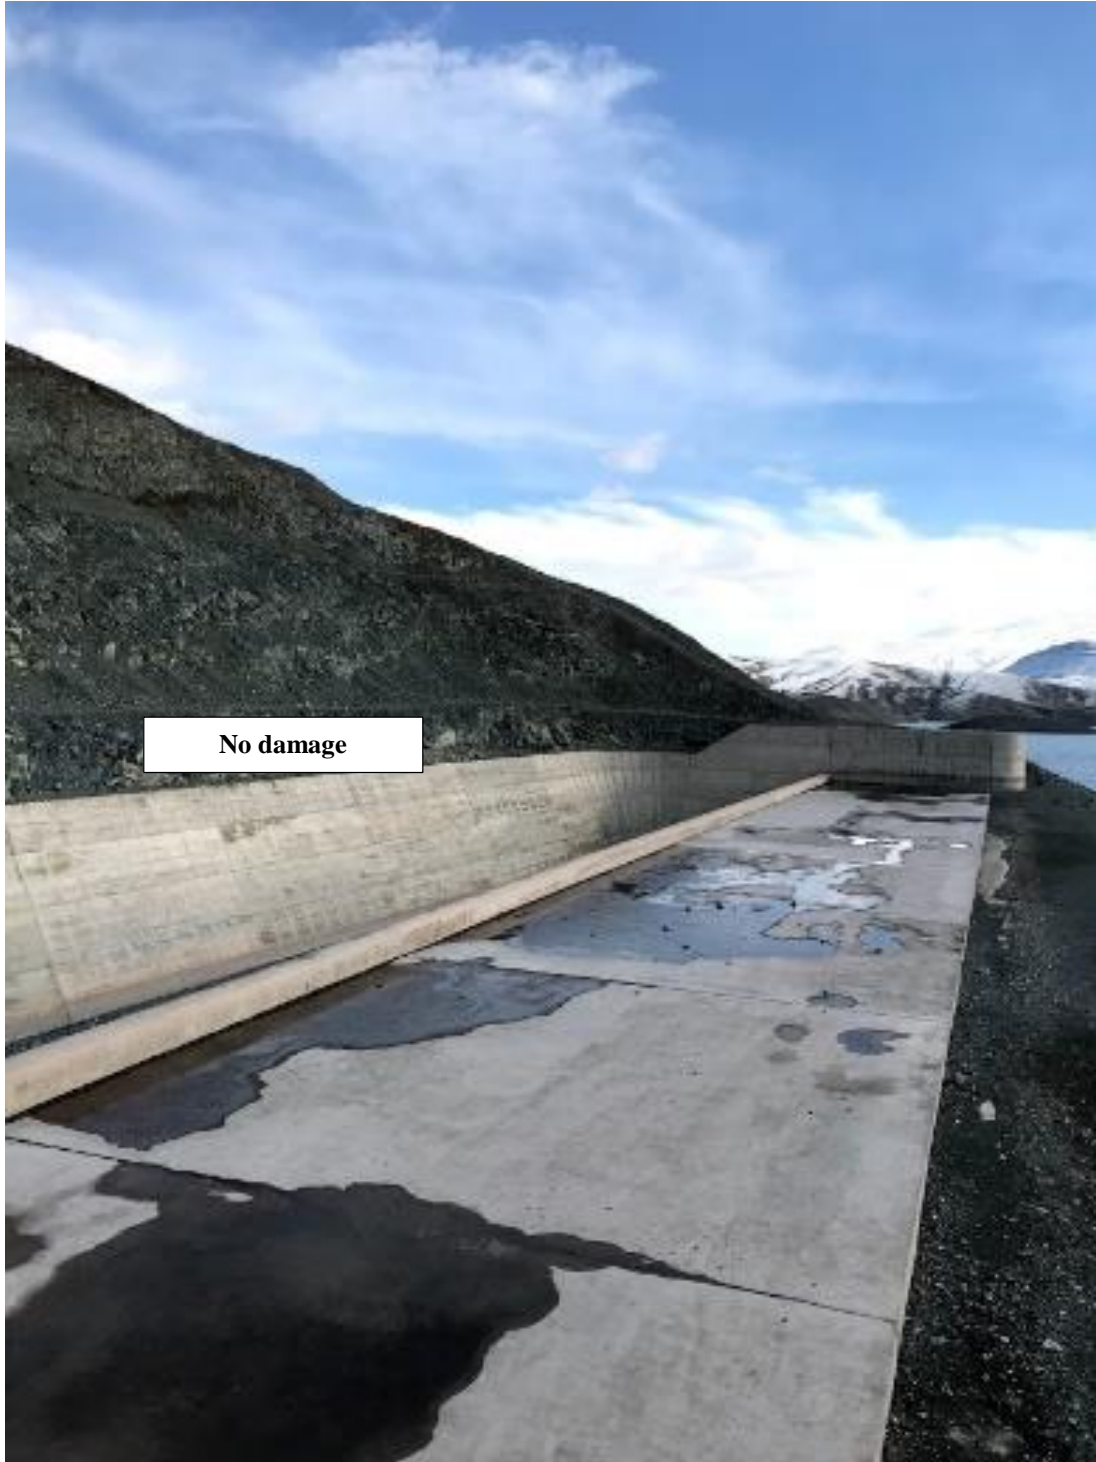
Figure 4.78. Water in-take structure of Kapıkaya Dam
(38°21'16.9"N 38°36'36.0"E / 01.02.2020 / 11:13)

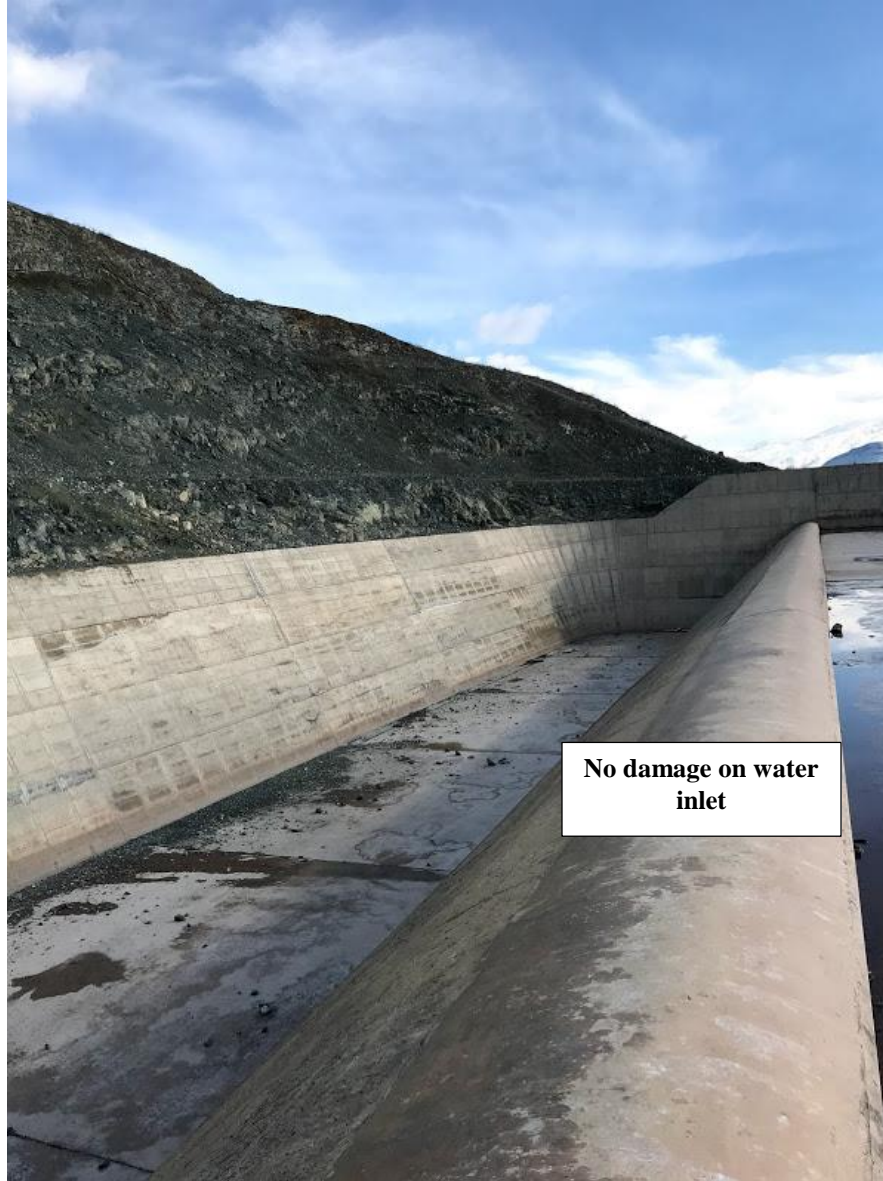
Figure 4.79. Spillway of Kapıkaya Dam
(38°21'17.2"N 38°36'36.7"E / 01.02.2020 / 11:14)

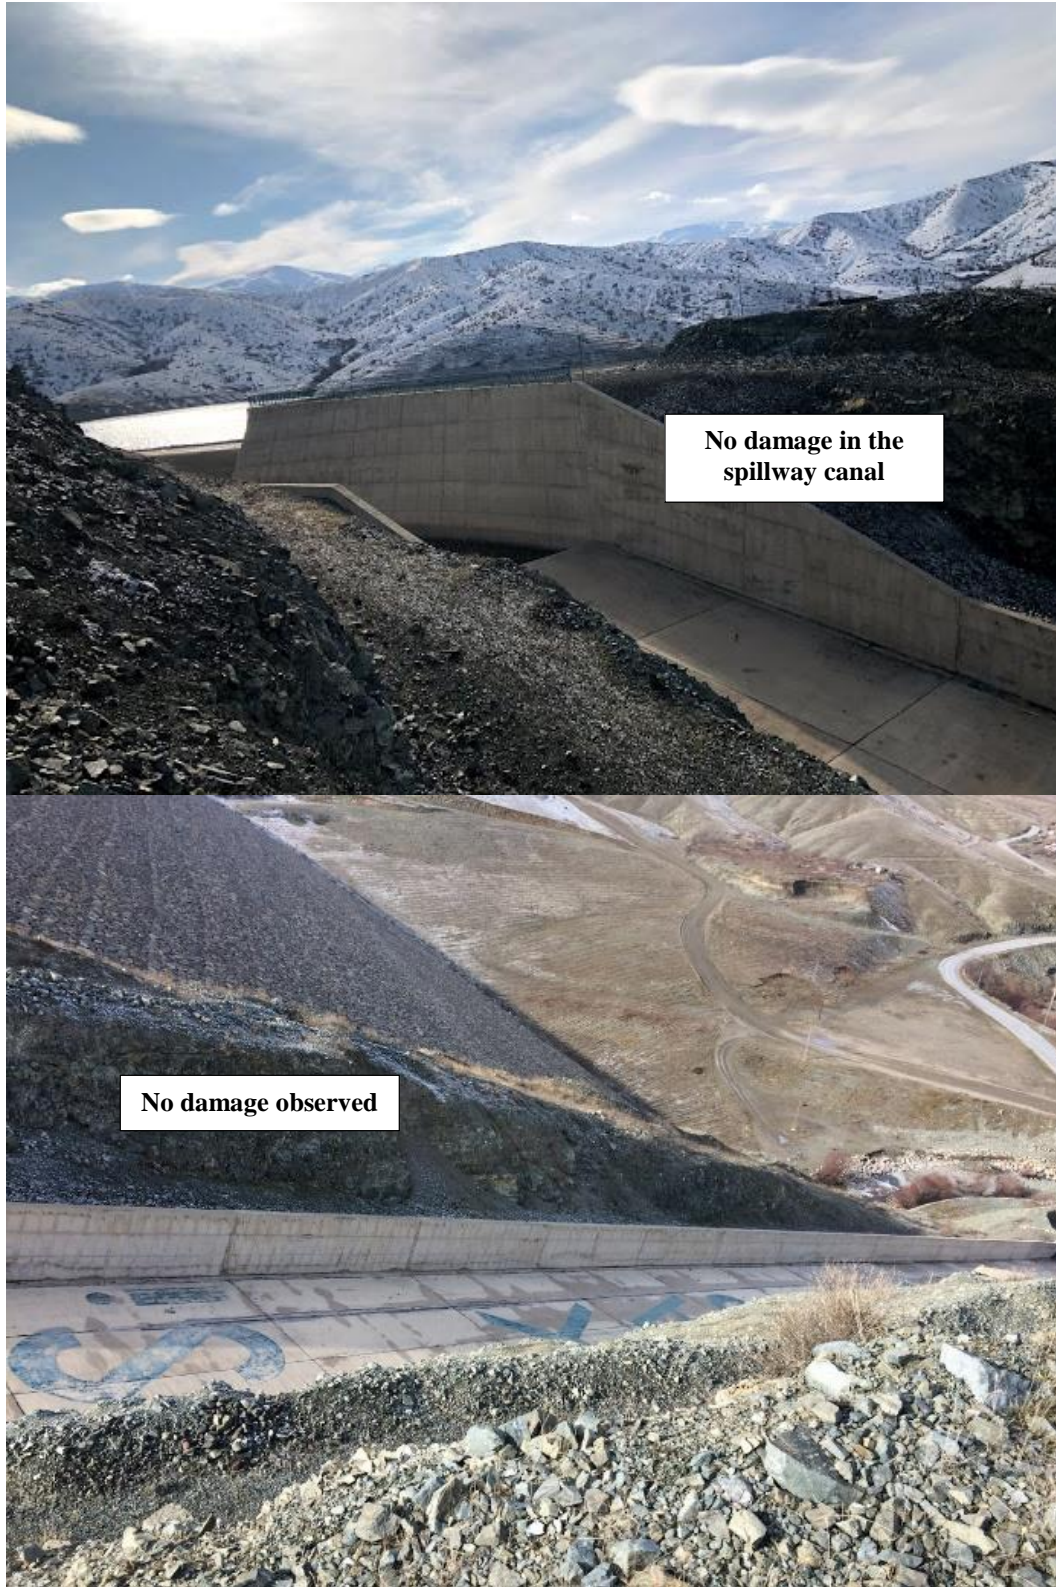
Figure 4.80. Spillway of Kapıkaya Dam
(38°21'19.1"N 38°36'33.9"E / 01.02.2020 / 10:22 & 38°21'19.2"N 38°36'34.1"E / 01.02.2020 / 10:22)

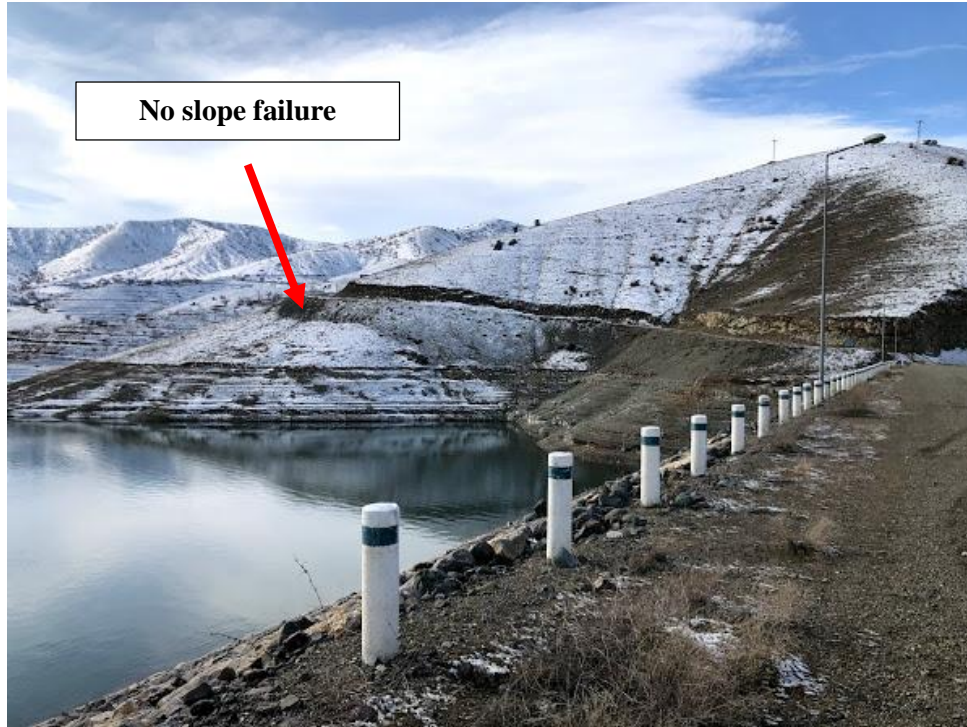
Figure 4.81. Abutment slopes of Kapıkaya Dam
($38^{\circ}21'07.1''N$ $38^{\circ}36'22.0''E$ / 01.02.2020 / 10:51)

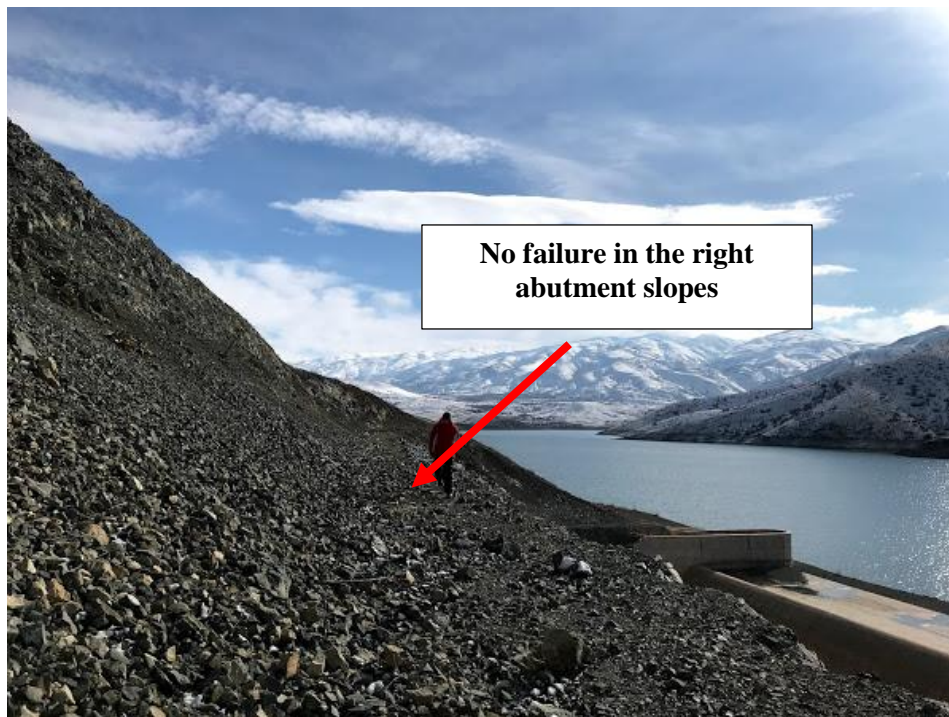
Figure 4.82. Right abutment natural slopes
($38^{\circ}21'18.7''N$ $38^{\circ}36'36.0''E$ / 01.02.2020 / 10:25)

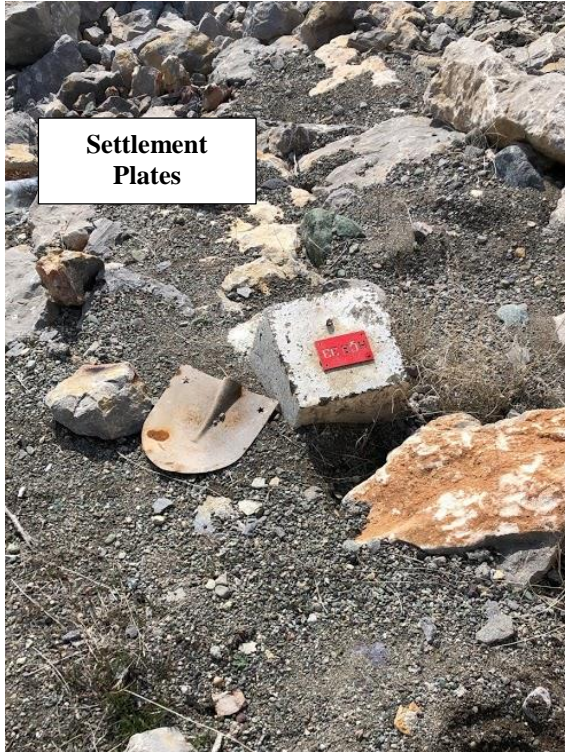
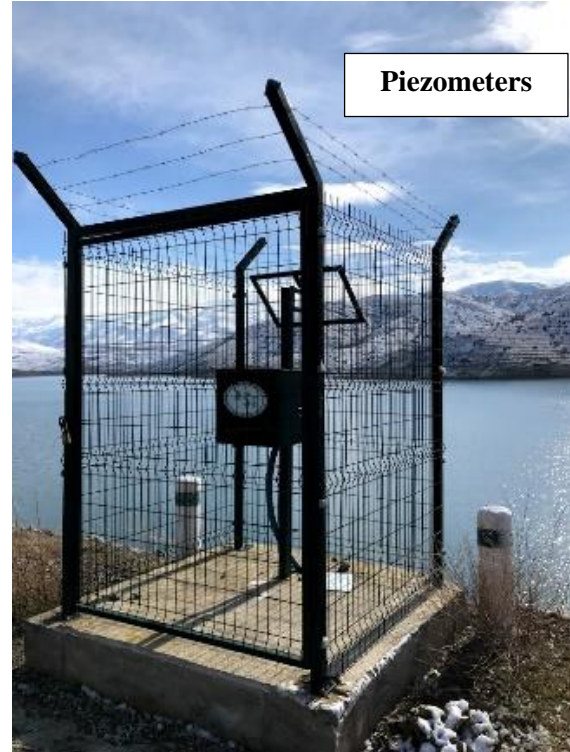
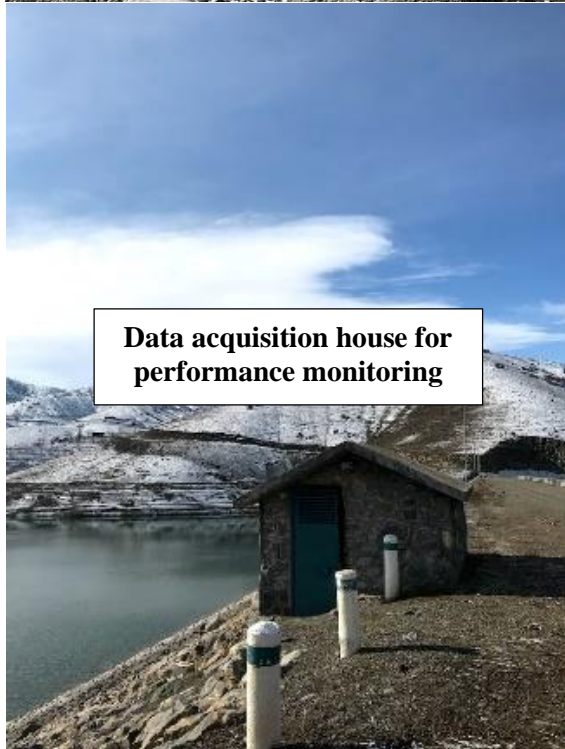
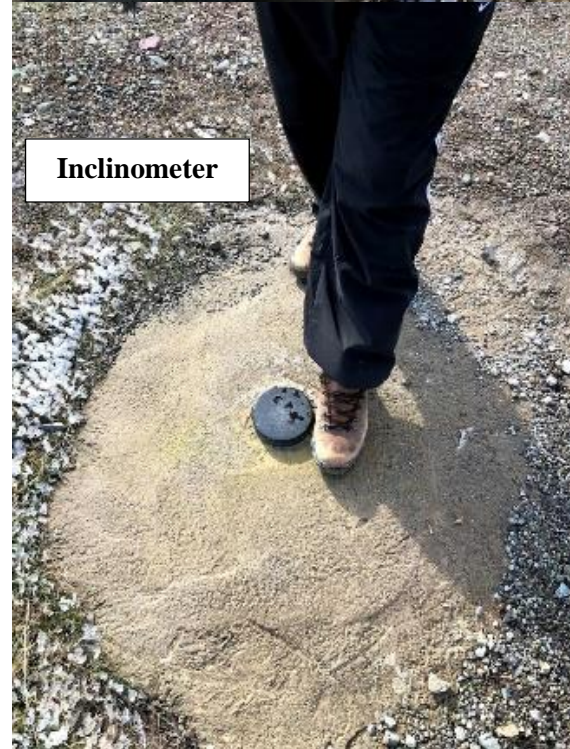
Figure 4.83. Settlement Plate, piezometer, data acquisition house and inclinometer borehole located at Kapıkaya Dam
(not available / 01.02.2020 / 10:50 & 38°21'11.7"N 38°36'23.5"E / 01.02.2020 / 10:48
38°21'11.1"N 38°36'23.7"E / 01.02.2020 / 10:48 & 38°21'10.2"N 38°36'23.0"E / 01.02.2020 / 11:06)

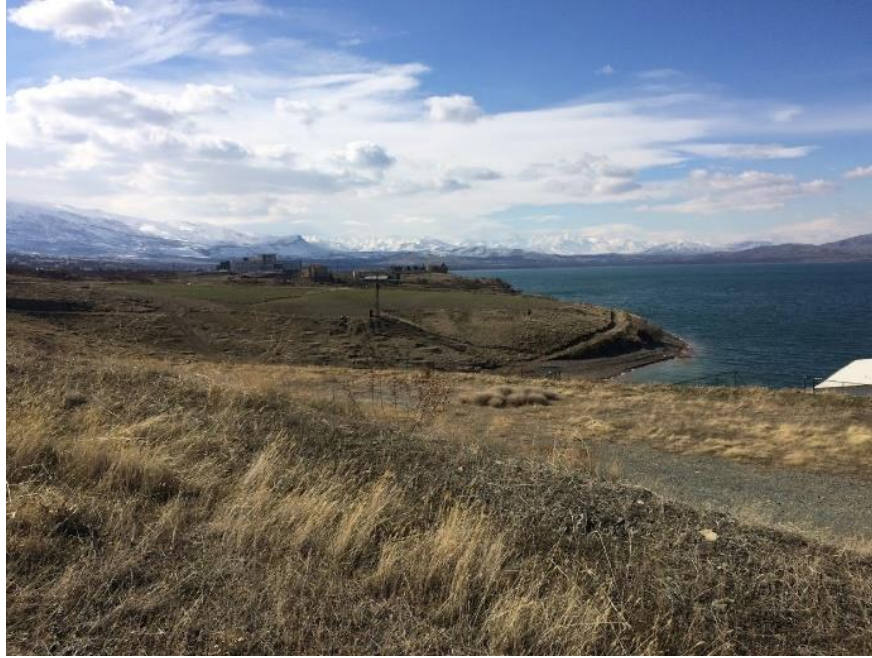
Seismically-induced liquefaction failure was observed in the Kale shores (Figure 4.84 and 4.85) in the form of sand boiling at 15th stop. A site view is shown in Figure 4.86. Pictures documenting sand boils are presented in Figures 4.87 to 4.91.

Figure 4.84. View of Kale shore
($38^{\circ}25'25.1''N$ $38^{\circ}45'46.1''E$ / 01.02.2020 / 12:12)

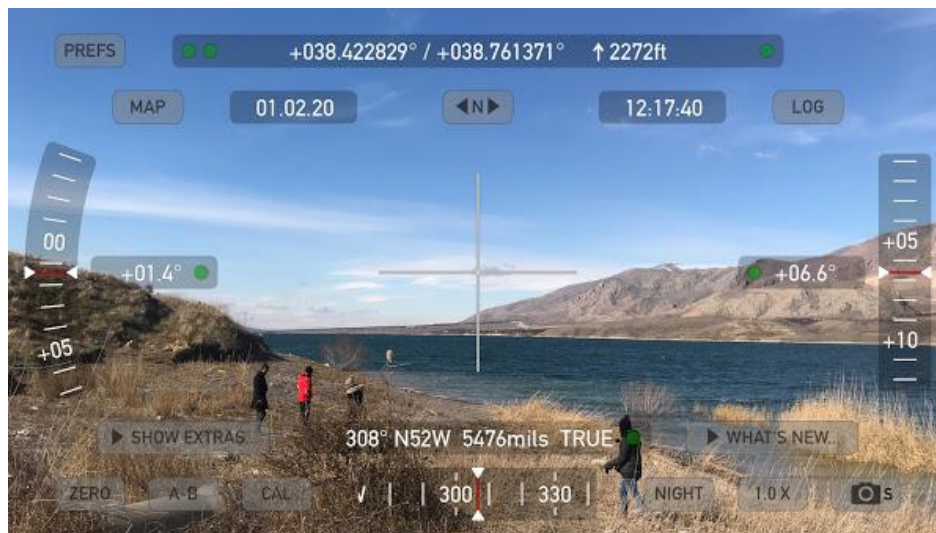
Figure 4.85. Another view of Kale shore
($38^{\circ}25'22.2''N$ $38^{\circ}45'40.9''E$ / 01.02.2020 / 12:17)

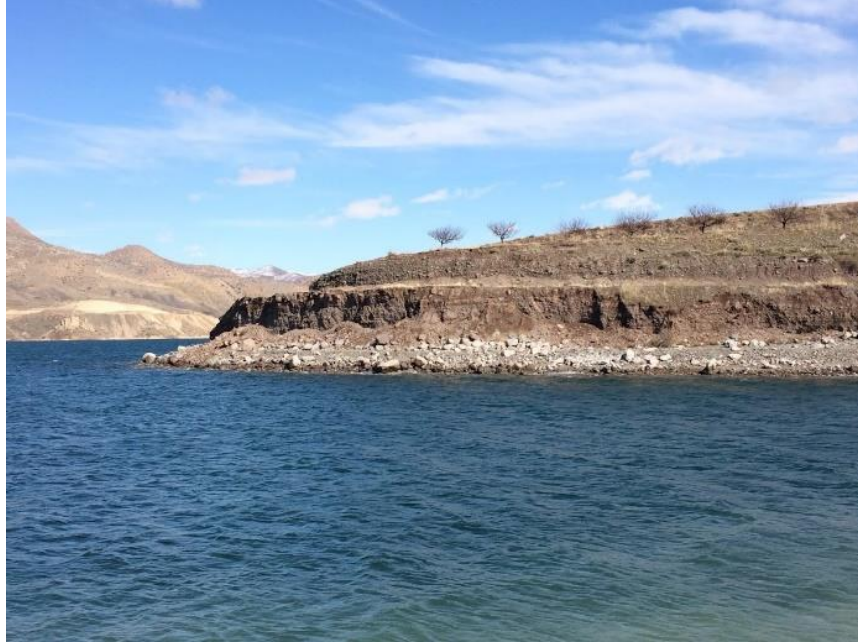
Figure 4.86. Kale shore
($38^{\circ}25'15.9''N$ $38^{\circ}45'28.8''E$ / 01.02.2020 / 12:39)

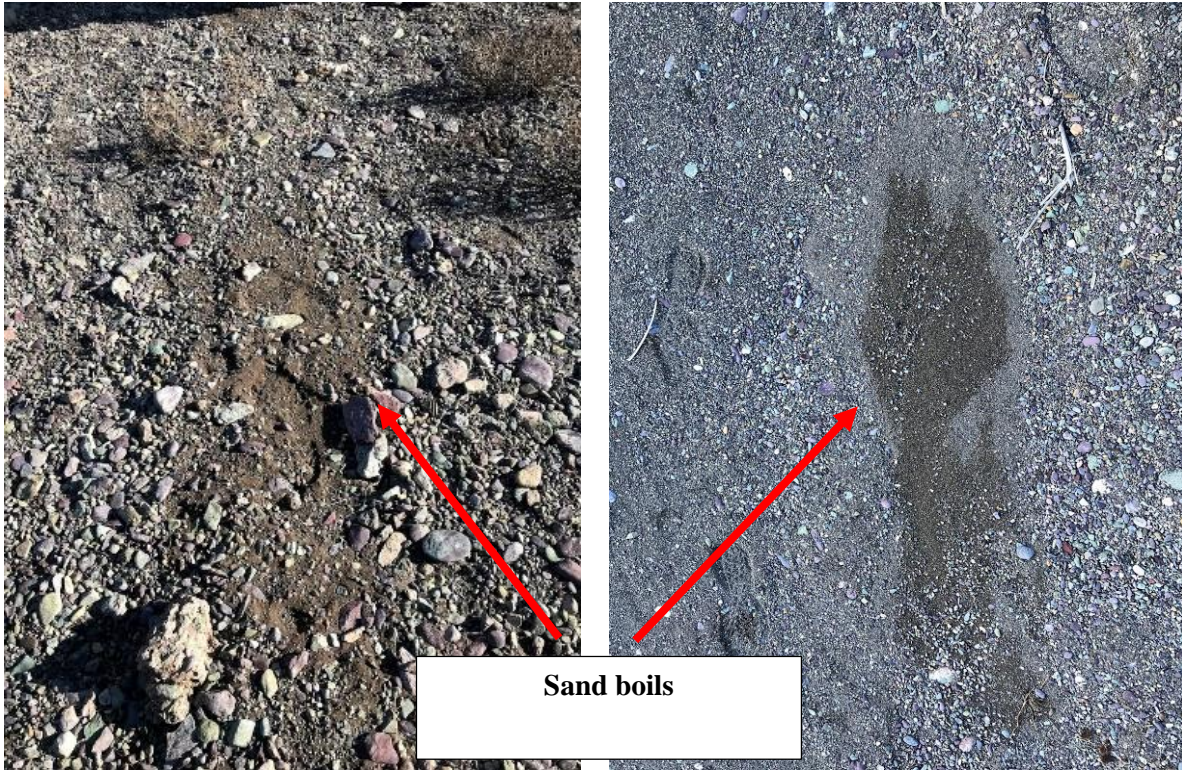
Figure 4.87. Seismic soil liquefaction-induced sand boils at Kale shore
($38^{\circ}25'19.9''N$ $38^{\circ}45'33.2''E$ / 01.02.2020 / 12:25 & $38^{\circ}25'14.6''N$ $38^{\circ}45'24.7''E$ / 01.02.2020 / 12:45)

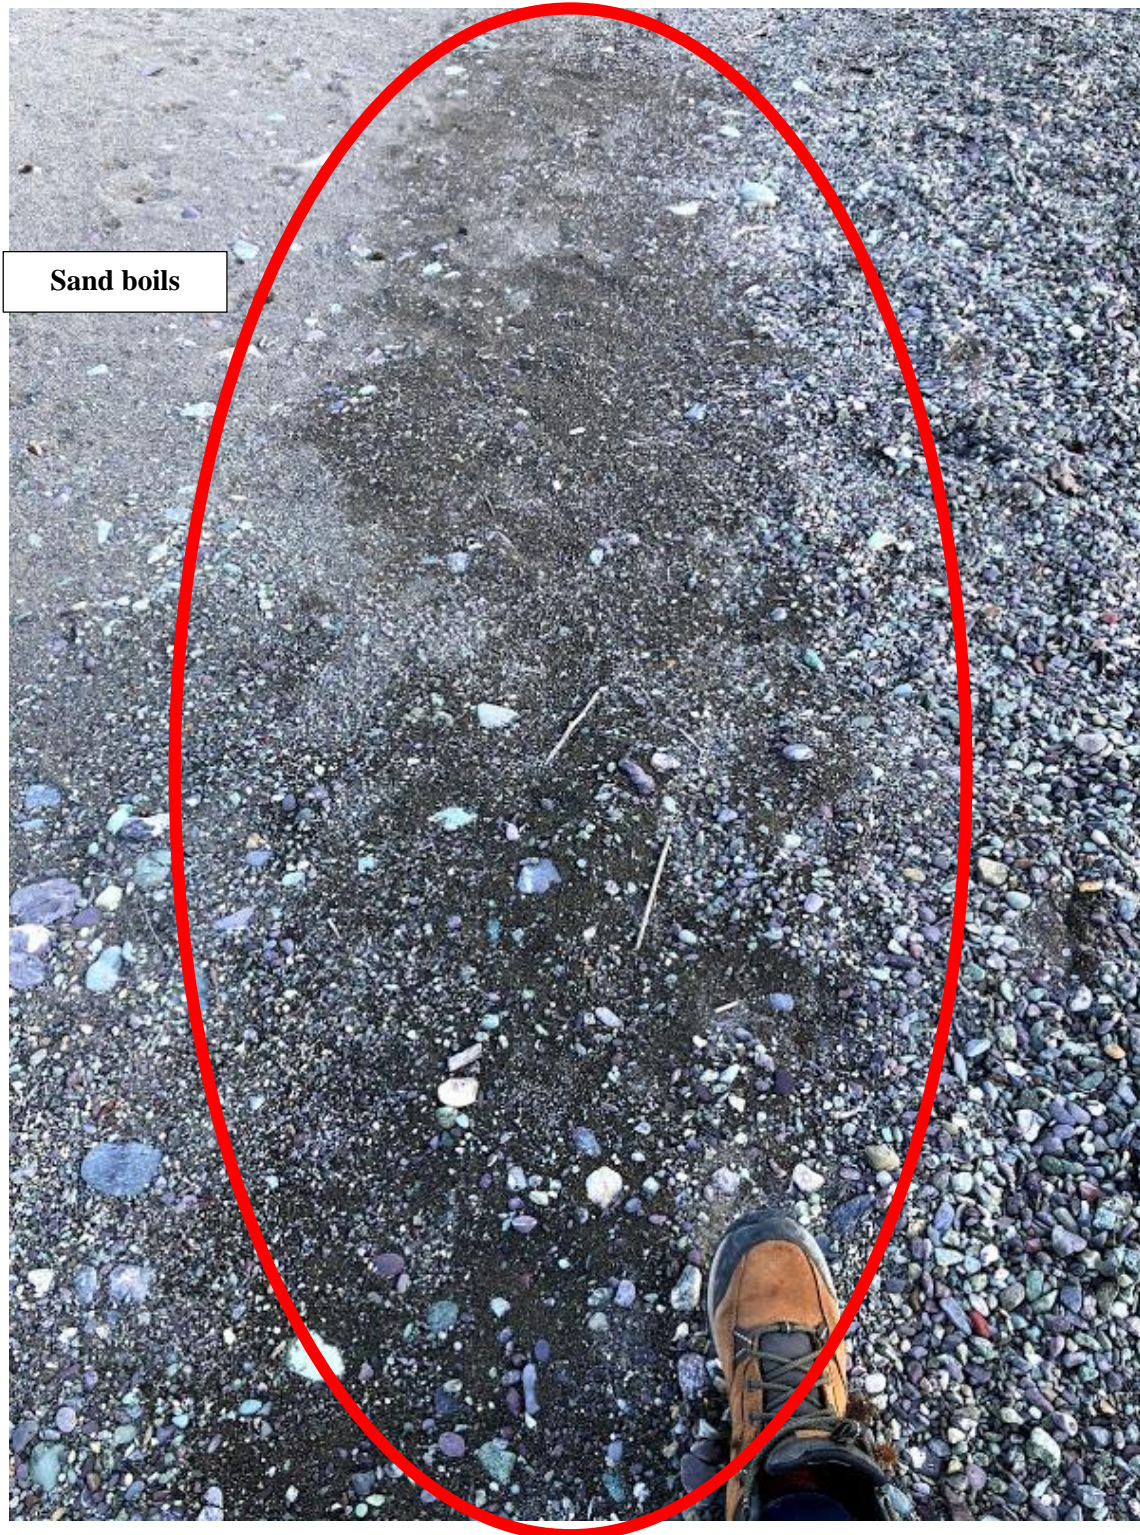
Figure 4.88. Seismic soil liquefaction-induced sand boils at Kale shore
(38°25'15.2"N 38°45'24.1"E / 01.02.2020 / 12:45)

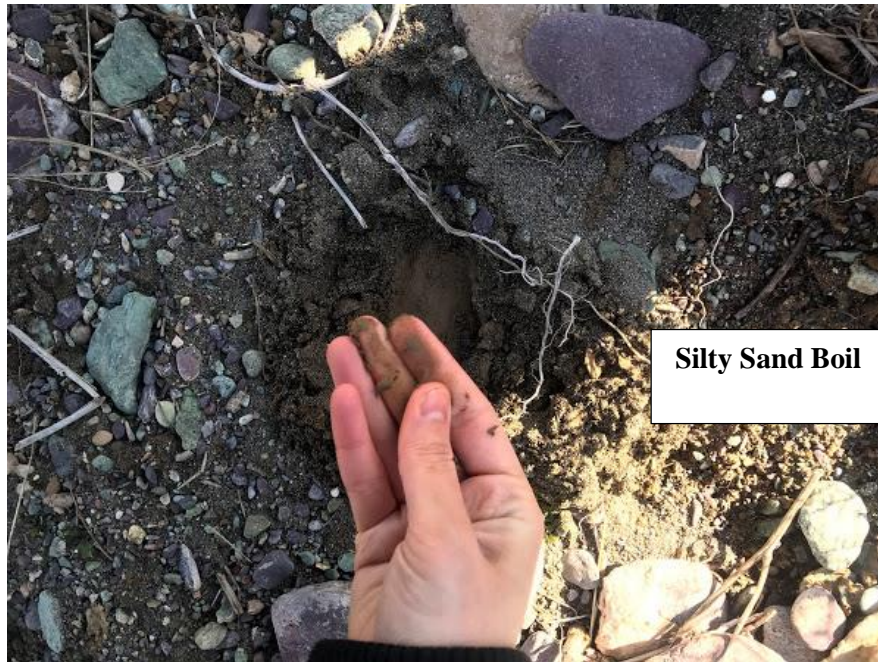
Figure 4.89. Seismic soil liquefaction-induced sand boils at Kale shore
($38^{\circ}25'22.8''N$ $38^{\circ}45'38.4''E$ / 01.02.2020 / 12:21)

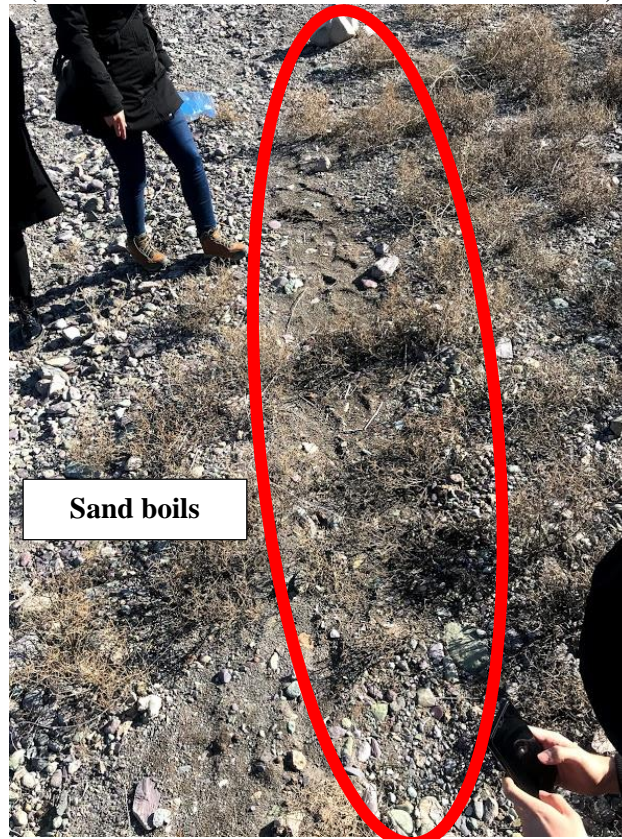
Figure 4.90. Seismic soil liquefaction-induced sand boils at Kale shore
($38^{\circ}25'19.9''N$ $38^{\circ}45'32.1''E$ / 01.02.2020 / 12:27)

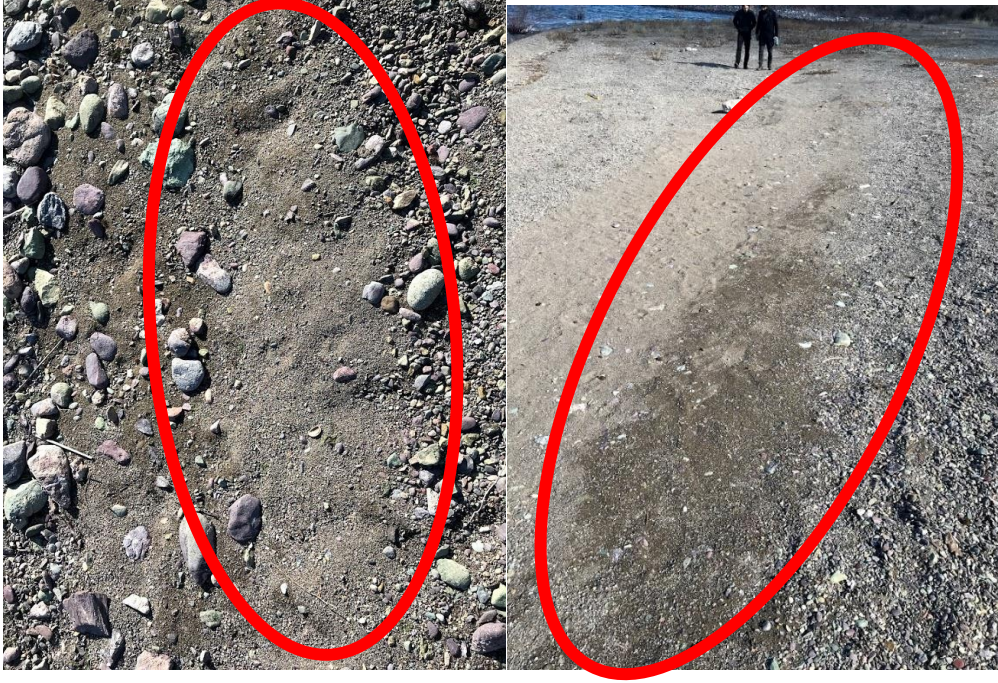
Figure 4.91. Seismic soil liquefaction-induced sand boils at Kale shore
($38^{\circ}25'15.2''N$ $38^{\circ}45'32.2''E$ / 01.02.2020 / 12:32 & $38^{\circ}25'15.2''N$ $38^{\circ}45'23.9''E$ / 01.02.2020 / 12:45)

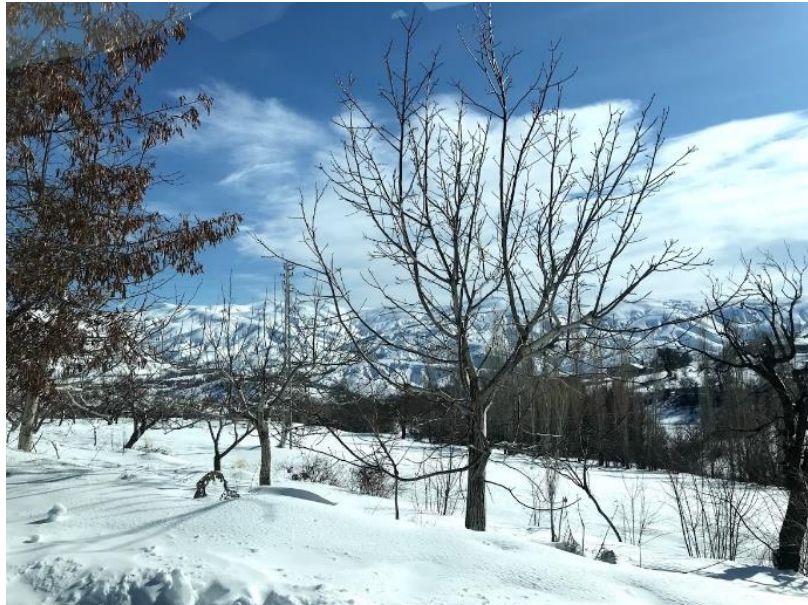
Our intent was to access to Çevrimtaş, the epicentral district. However, the road was closed to traffic due to heavy snow. (Figure 4.92). It was decided to spend the rest of the reconnaissance time in Elazığ downtown.

Figure 4.92. Snow-covered road on our way to Çevrimtaş
($38^{\circ}25'26.3''N$ $39^{\circ}03'01.3''E$ / 01.02.2020 / 13:52)

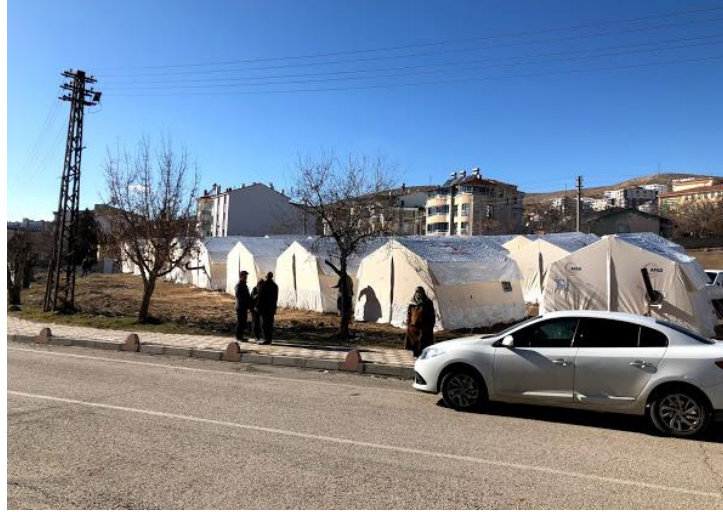
Figure 4.93. Tents for the people suffering from the earthquake
(38°39'30.0"N 39°08'59.5"E / 01.02.2020 / 14:28)

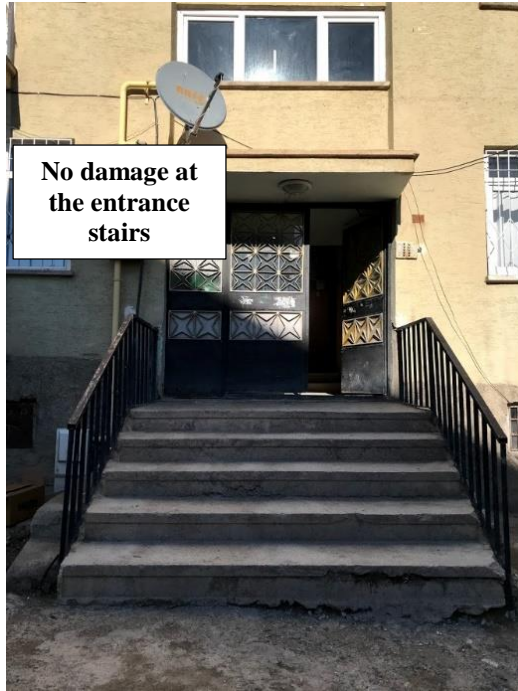
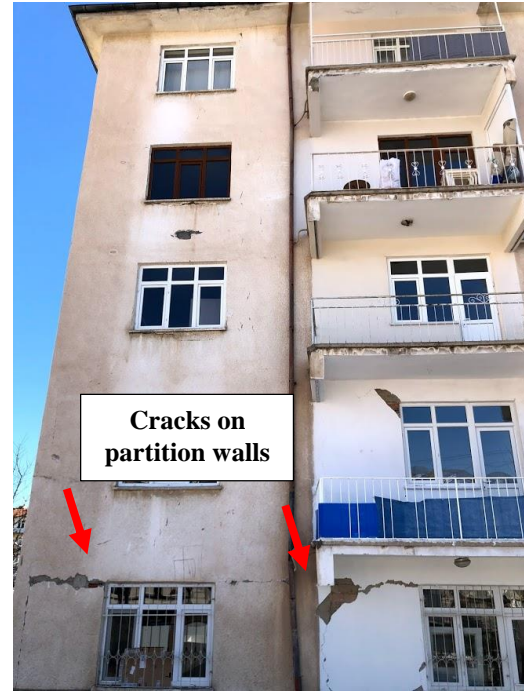
A number of structurally damaged residential buildings were documented in Abdullah Paşa district of Elazığ city center, as shown in Figures 4.93 to 4.100. The level of damage varies in a large scale, from no damage to heavy damage. No signs of foundation failures were observed except a few rare cases of volumetric settlements of foundation backfill soils.

Figure 4.95. Residential buildings located at the Abdullah Paşa district of Elazığ city center ($38^{\circ}39'29.3''N$ $39^{\circ}09'02.6''E$ / 01.02.2020 / 14:32 & $38^{\circ}39'29.6''N$ $39^{\circ}08'59.0''E$ / 01.02.2020 / 14:28)

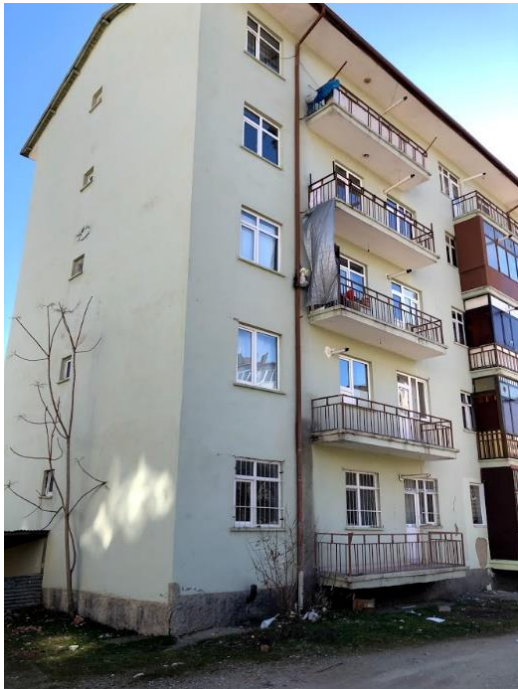
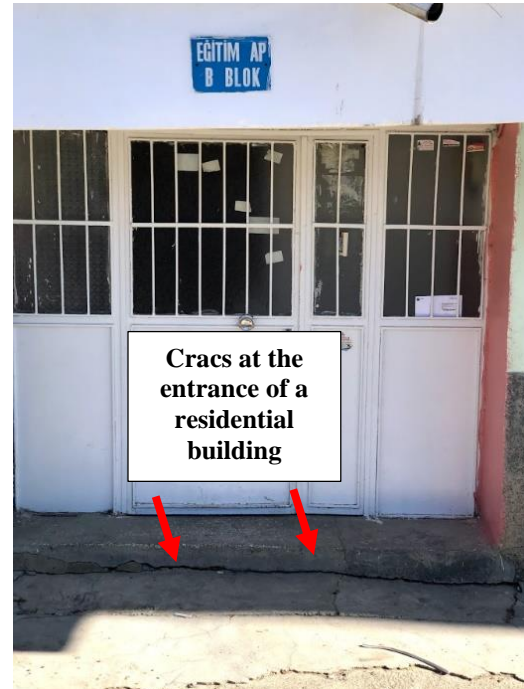
Figure 4.96. Cracks observed at the entrance of Eğitim Apartment. ($38^{\circ}39'29.2''N$ $39^{\circ}09'01.6''E$ / 01.02.2020 / 14:31 & $38^{\circ}39'32.0''N$ $39^{\circ}09'00.8''E$ / 01.02.2020 / 14:36)

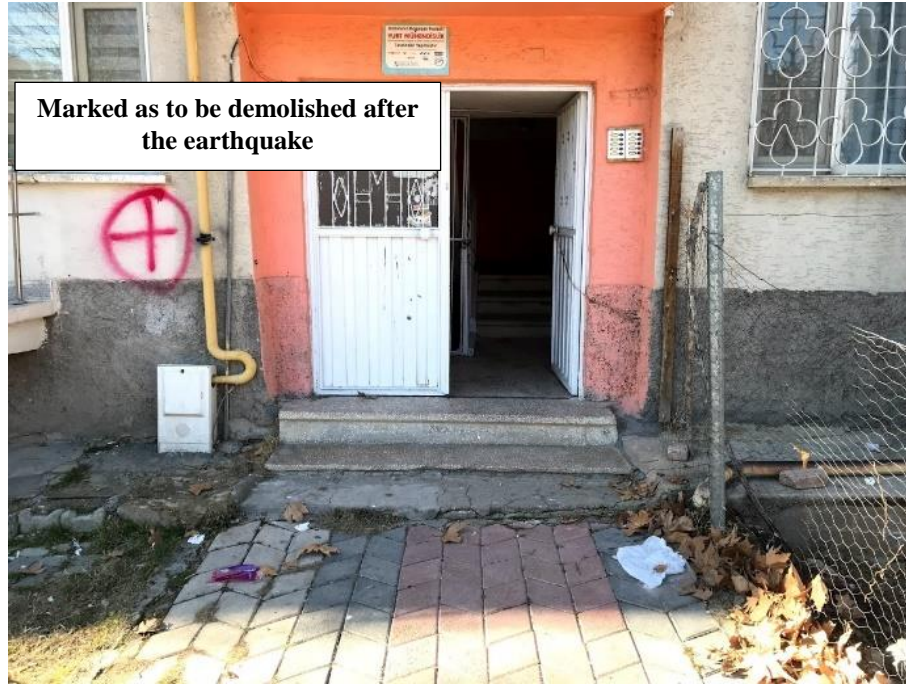
Figure 4.97. A residential building located in the Abdullah Paşa district of Elazığ city center ($38^{\circ}39'25.2''N$ $39^{\circ}09'10.3''E$ / 01.02.2020 / 14:45)

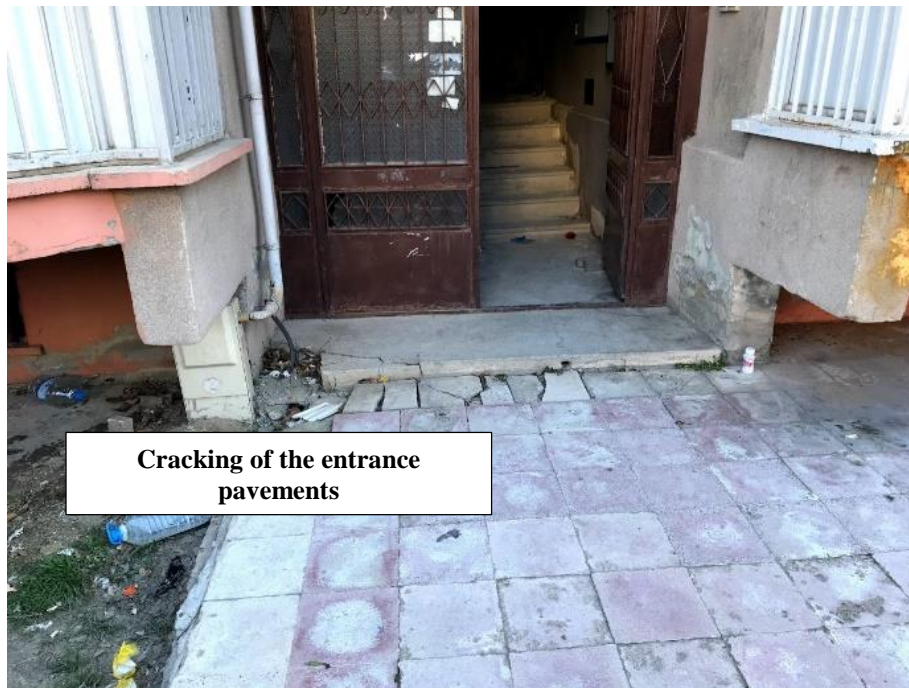
Figure 4.98. Cracking observed at the entrance of the of a residential building ($38^{\circ}39'21.9''N$ $39^{\circ}09'10.4''E$ / 01.02.2020 / 14:50)
