**January 24, 2020 Elazığ-Sivrice Earthquake ($M_w=6.8$)
Reconnaissance Study Report**

**MIDDLE EAST TECHNICAL UNIVERSITY
EARTHQUAKE ENGINEERING RESEARCH CENTER**

REPORT NO: METU/EERC 2020-01

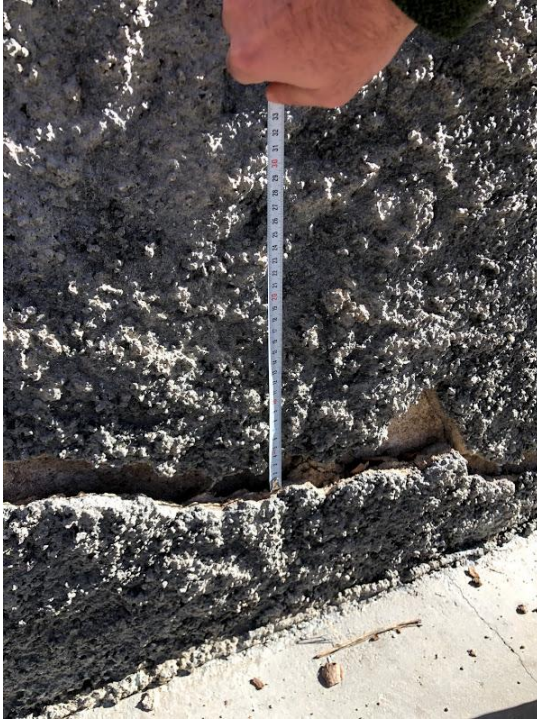
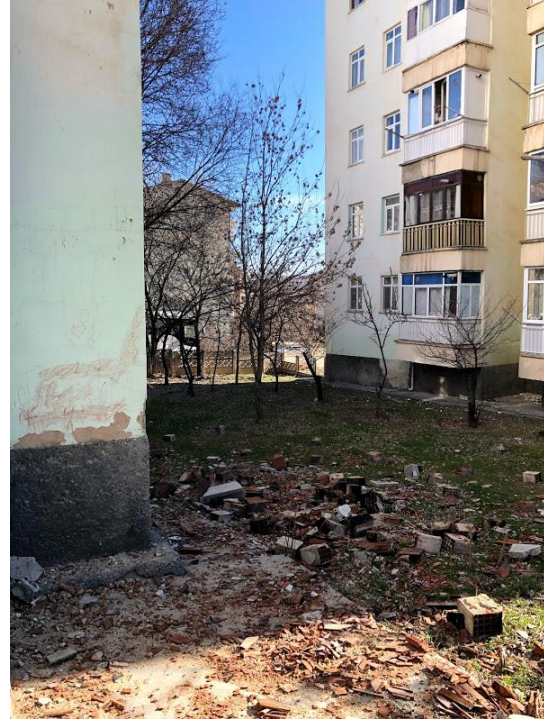
Figure 4.99. Cracks at the first floor, and fallen bricks
($38^{\circ}39'31.9''N$ $39^{\circ}08'57.9''E$ / 01.02.2020 / 14:38 & $38^{\circ}39'32.0''N$ $39^{\circ}09'01.3''E$ / 01.02.2020 / 14:39)

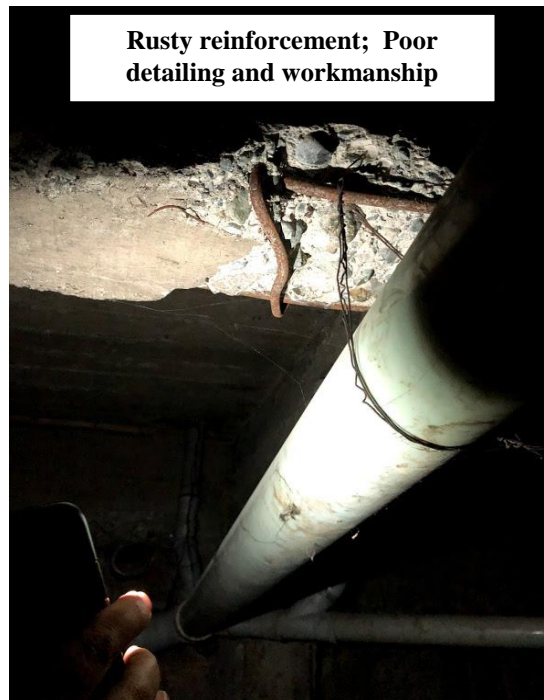
Figure 4.100. View of the basement of a residential building, rusty reinforcement bars, poor detailing and construction
($38^{\circ}39'24.8''N$ $39^{\circ}09'10.7''E$ / 01.02.2020 / 14:48)

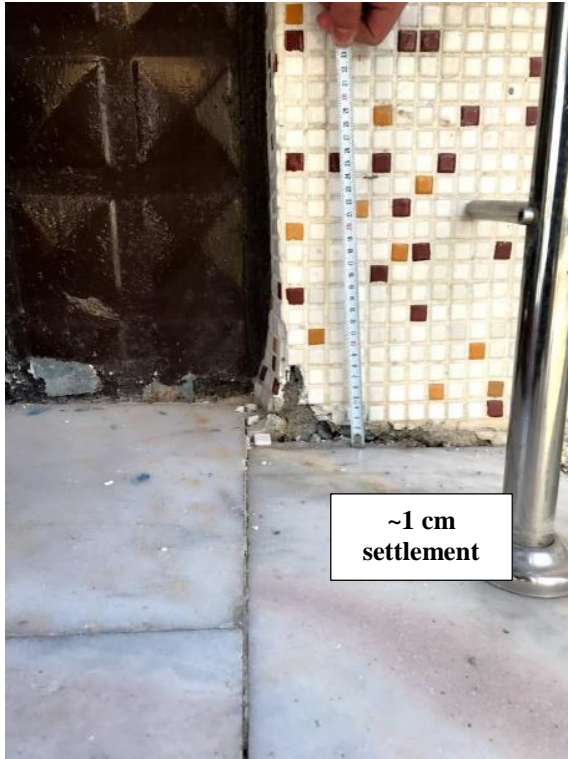
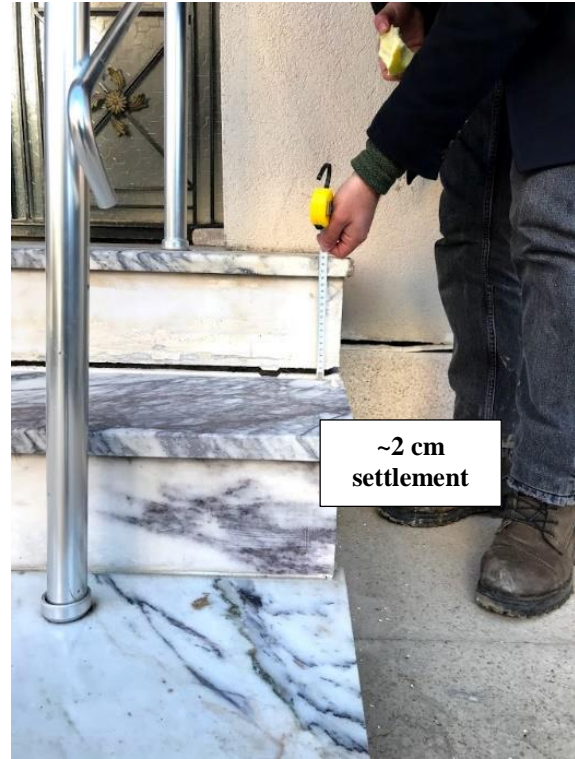
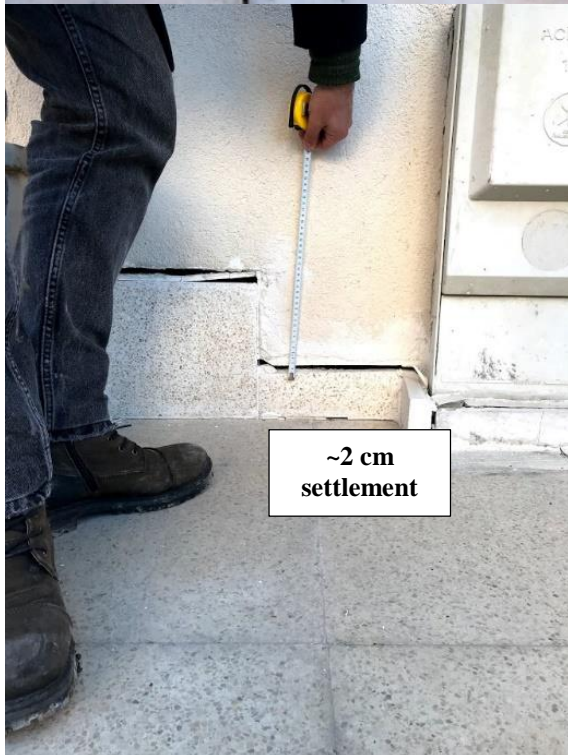
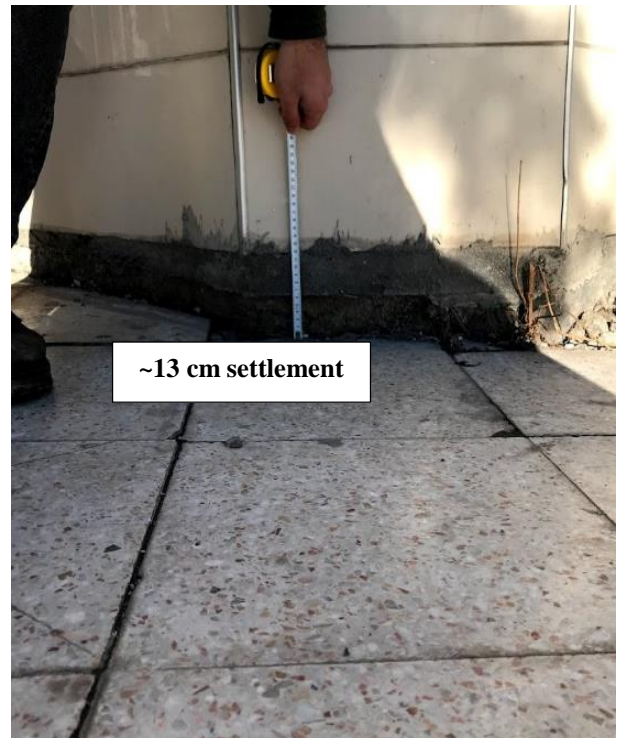
The most of the structural damage was concentrated in Elazığ-Sürsürü district. Several structurally damaged residential buildings were documented, as shown in Figures 4.102 to 4.106. The level of damage varies in a large scale, from no damage to heavy damage. Cracks at the pavements, walls and foundations, due to cyclic and residual lateral and volumetric deformations were observed.

Figure 4.103. Settlement mapped at the entrance of some buildings
($38^{\circ}40'04.7''N$ $39^{\circ}11'12.4''E$ / 01.02.2020 / 15:31 & $38^{\circ}40'05.9''N$ $39^{\circ}11'08.2''E$ / 01.02.2020 / 15:41
 $38^{\circ}40'05.9''N$ $39^{\circ}11'08.1''E$ / 01.02.2020 / 15:41 & $38^{\circ}40'04.7''N$ $39^{\circ}11'09.7''E$ / 01.02.2020 / 15:40)

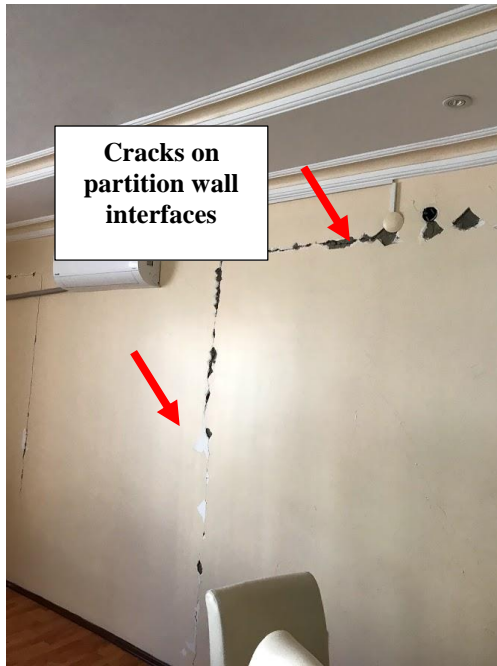
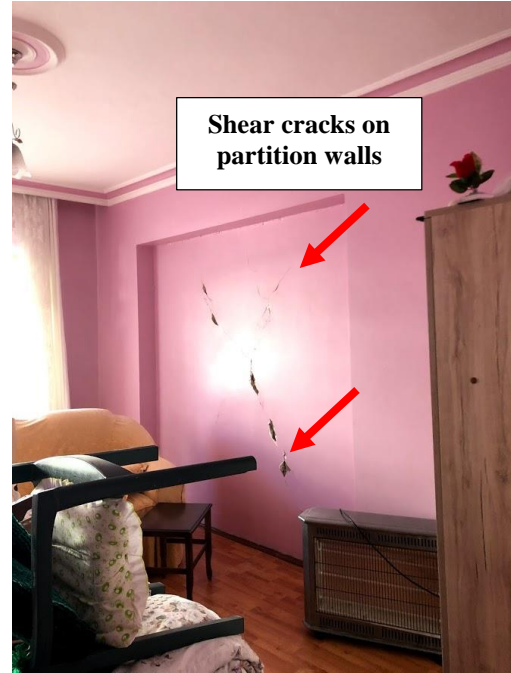
Figure 4.106. Cracks on partition walls

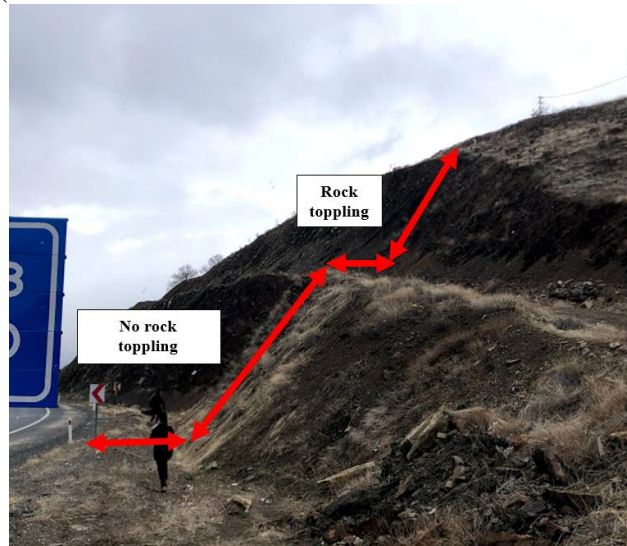
At the first rockfall site, the surface geology reveals phyllyites with schistosity texture. The cross section is 15 m high with a slope of 50° . The dimensions of the fallen rocks and the distance from the edge of the benches are mapped in the field. No fallen rocks were observed on the lower, second bench of the highway cut. Slope angle, length and height of different sections of the upper and lower benches, and possible height that rock falls were initiated were also mapped in the field. RocFall 2019 software program is used to guesstimate the initial velocity of the rock.

Figure 4.112. Cross section of the rockfall at 13th stop
($38^\circ 31' 40.3''\text{N}$ $39^\circ 28' 02.9''\text{E}$ / 31.01.2020 / 16:20)

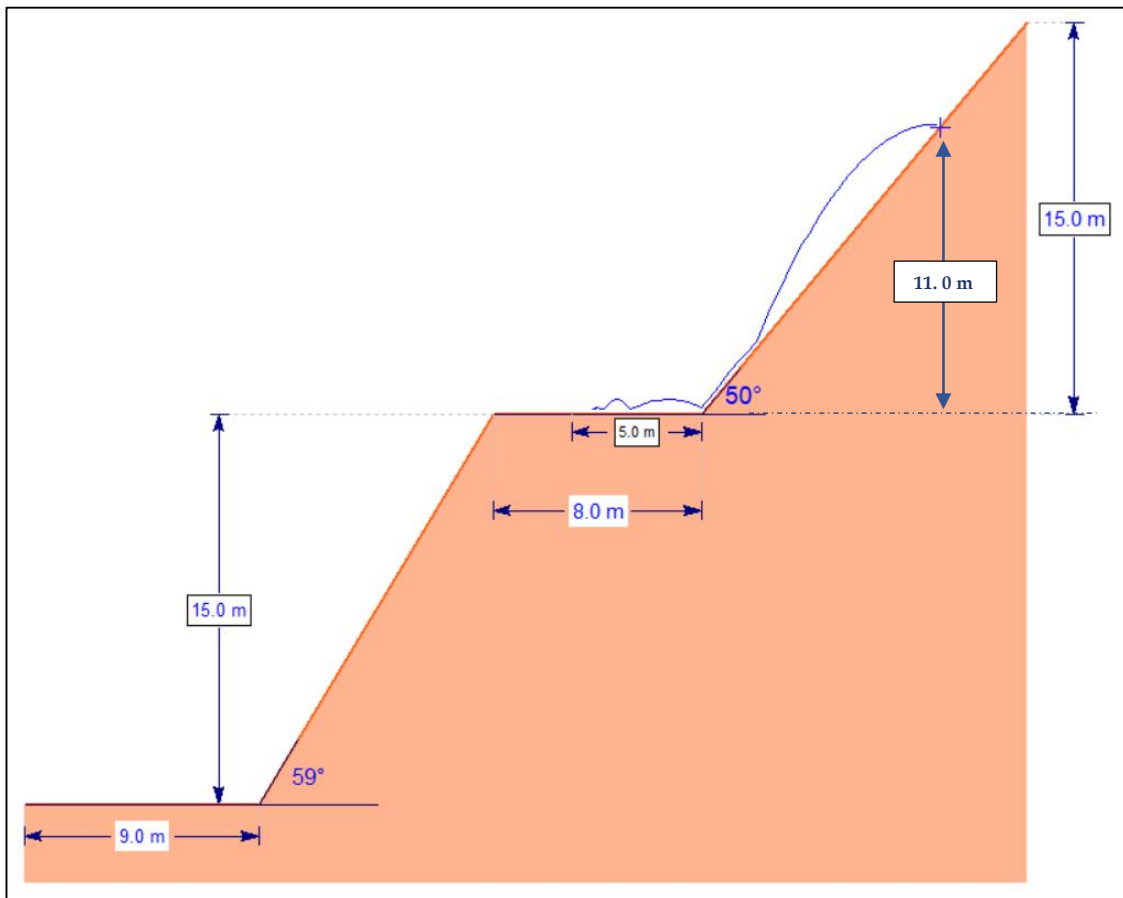
As seen in Figure 4.113, back analysis is performed to guess the initial velocity of the rock blocks to reach their final positions observed in the field. RocFall 2019 by RocScience is used for the purpose. Based on these very preliminary assessments, velocity range to trigger the fall and match with observed travel distances is calculated as 4 to 6 m/s.

Figure 4.113. Back analysis of rockfall with RocFall 2019

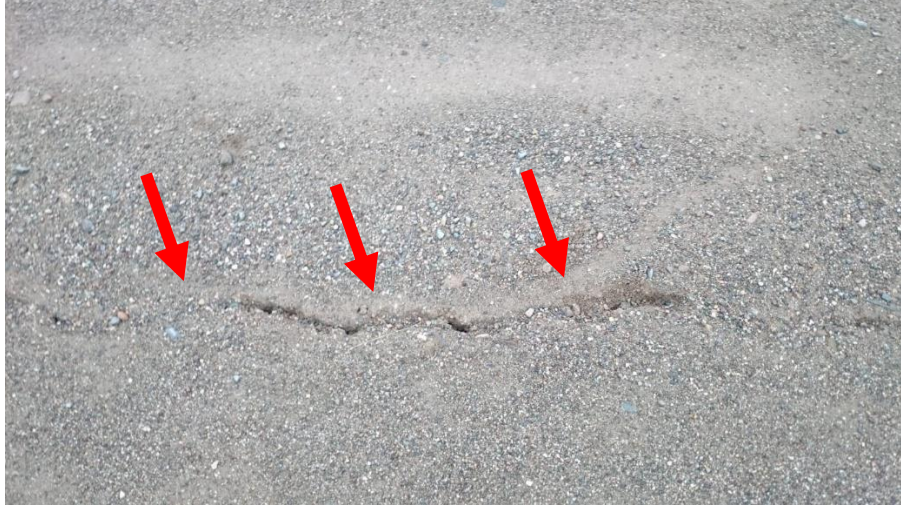
On the basis of reconnaissance studies performed by Dam Agency, no significant damage was reported to be observed at these dams after Sivrice Earthquake, except a limited extent longitudinal < 8 mm crack, as shown in Figure 4.119, observed on the crest of Dedeyolu Dam.

Figure 4.119. Longitudinal cracks on Dedeyolu Dam crest (DSİ)

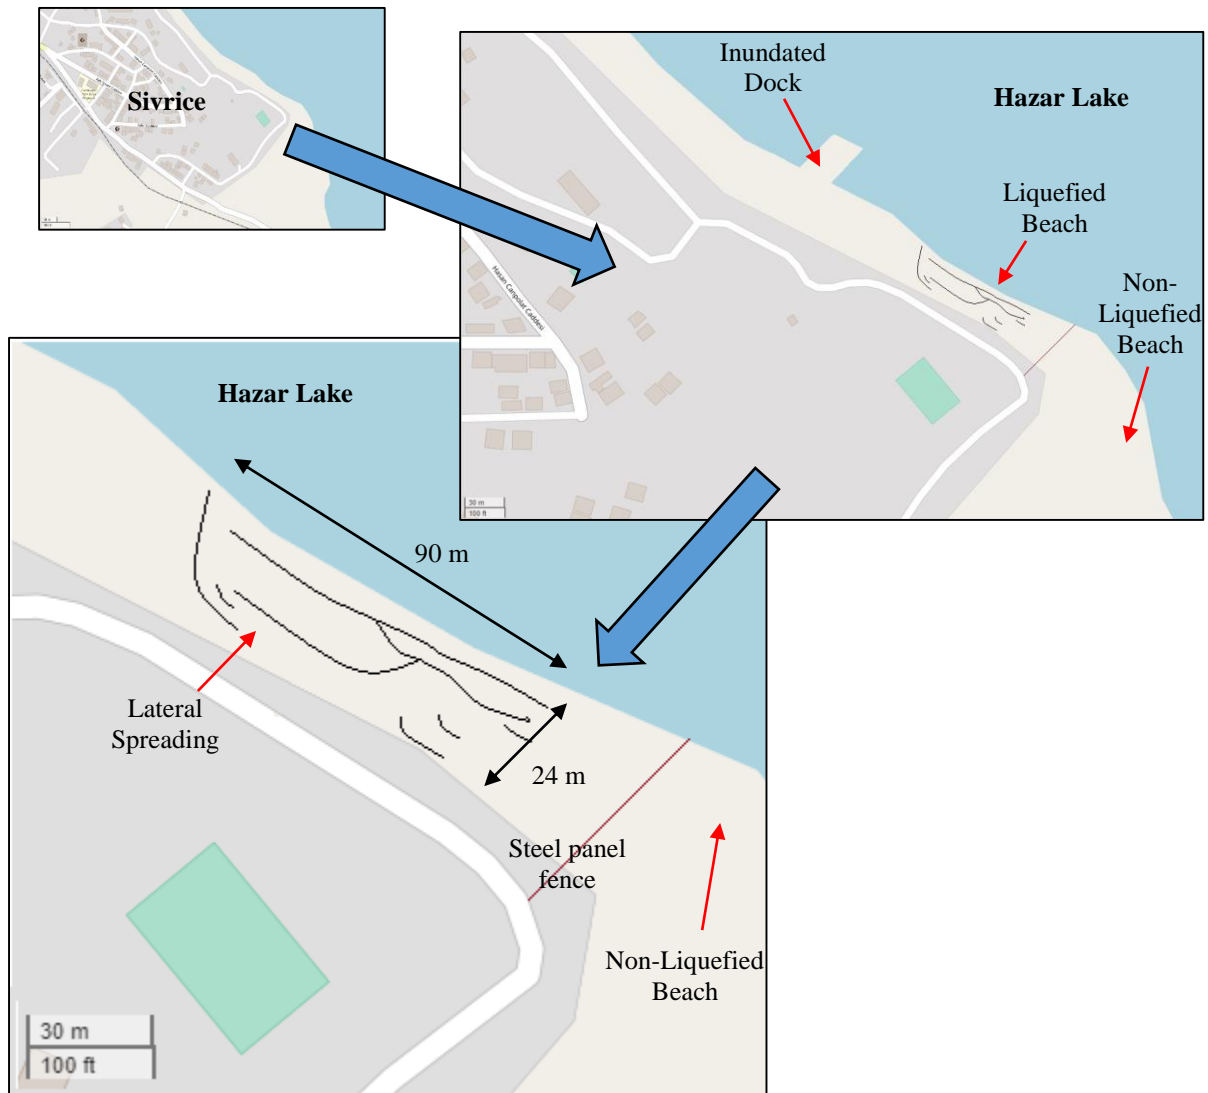
In day 1, surface manifestation of soil liquefaction in the form of sand boils and lateral spreading were mapped. The extent of lateral deformations was mapped as 3-5 cm along a 90 m long and 23 m wide zone at the second stop in the vicinity of Sivrice Dock, as shown in Figure 4.123. Figures 4.124 and 4.125 present the photos of lateral spreading site taken during field investigations.

Figure 4.123. A sketch of lateral spread deformations at 2nd stop
(Sivrice Dock-38°28'10.0"N 39°17'03.6"E / 31.01.2020 / 12:11)

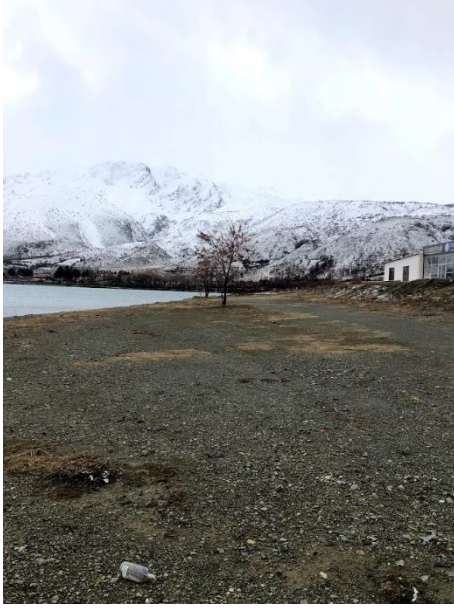
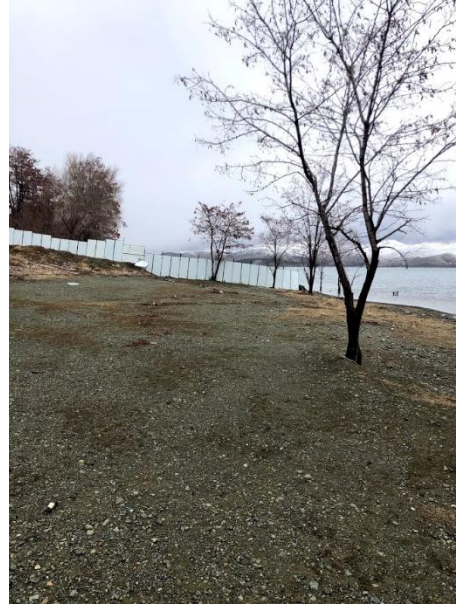
No signs of liquefaction were observed at a natural beach neighboring the lateral spreading site as shown in Figure 4.126. This beach was observed to have a milder slope when compared to the lateral spreading site shown in Figures 4.123-4.125.

Figure 4.126. No ground failure at the natural beach neighboring the lateral spreading
(2nd stop)
(338°26'48.9"N 39°18'59.4"E / 31.01.2020 / 13:08 & 38°27'58.0"N 39°20'42.4"E / 31.01.2020 / 13:08)

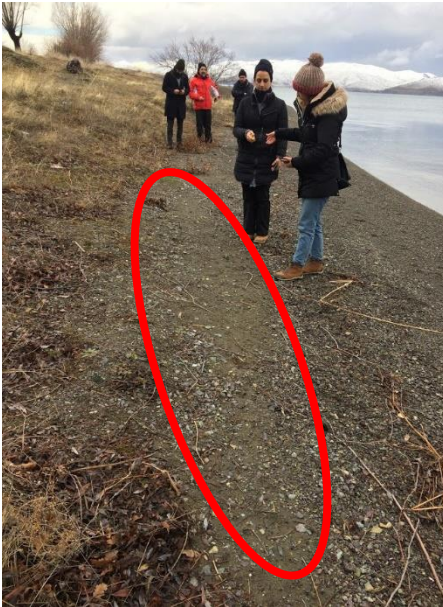
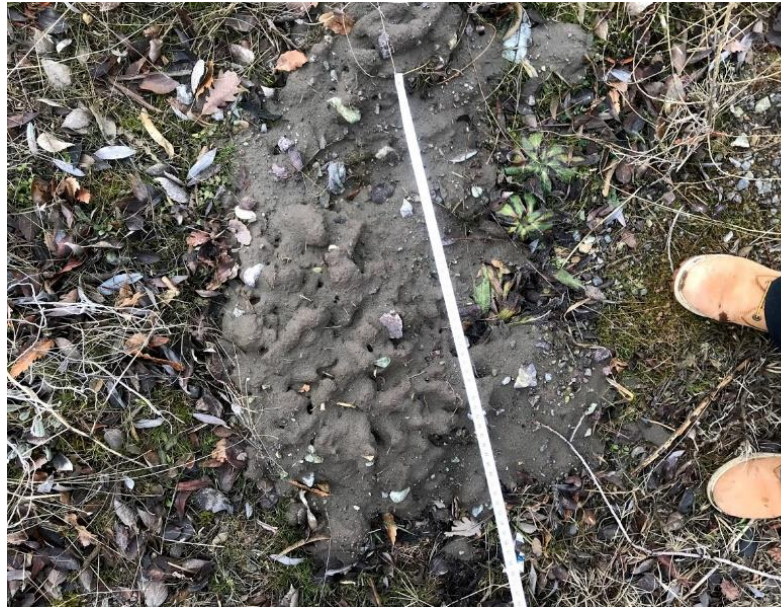
Ground deformations were observed due to liquefaction at 8th and 15th stops along Hazar Lake as shown in Figures 4.127 and 4.128. Sand boils were mapped and soil samples were retrieved from these locations. A series of sieve analysis tests has been performed at METU Soil Mechanics Laboratory. Based on the results of these tests, samples were reported to be potentially liquefiable as also will be discussed in the next section.

Figure 4.127. Surface manifestations of soil liquefaction in Hazar Lake (8th stop)
(38°27'49.7"N 39°24'03.3"E / 31.01.2020 / 14:16 & 38°27'50.0"N 39°24'02.5"E / 31.01.2020 / 14:20)

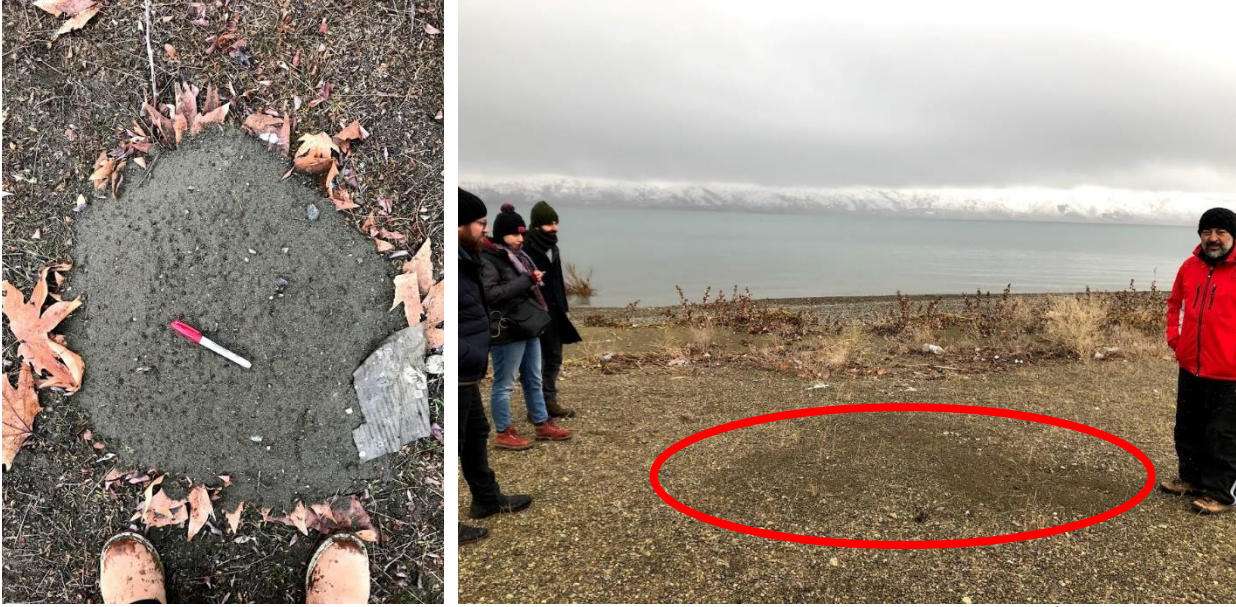
Figure 4.128. Surface manifestations of soil liquefaction in Hazar Lake (15th stop)
(38°29'34.6"N 39°21'03.7"E / 31.01.2020 / 17:11 & 38°29'30.6"N 39°20'57.7"E / 31.01.2020 / 17:01)

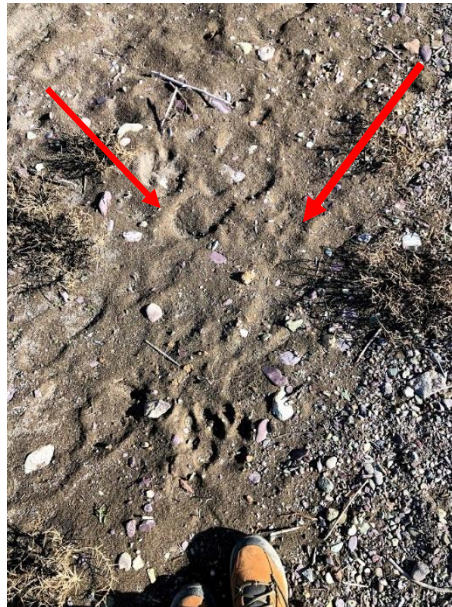
In day 2, surface manifestation of soil liquefaction in the form of sand boils were mapped along Kale shores. Figures 4.129 and 4.130 present the photos of the sand boils taken at the shores of Kale Village.

Figure 4.129. Surface manifestation of soil liquefaction at Kale Village shores (26th stop)
(38°25'23.6"N 38°45'39.0"E / 01.02.2020 / 12:18)

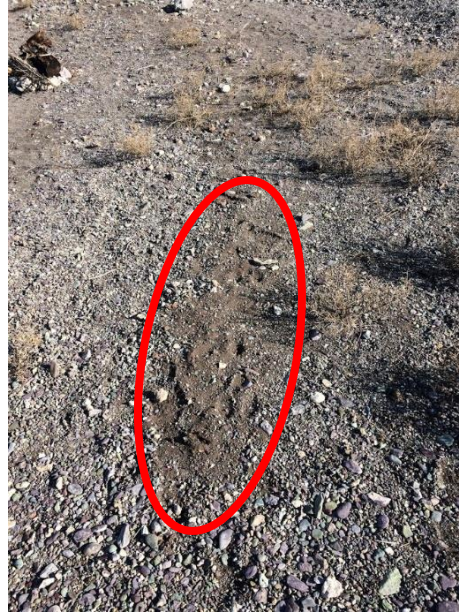
Figure 4.130. Surface manifestation of soil liquefaction at Kale Village shores
(26th stop)
(38°25'20.2"N 38°45'33.2"E / 01.02.2020 / 12:25)

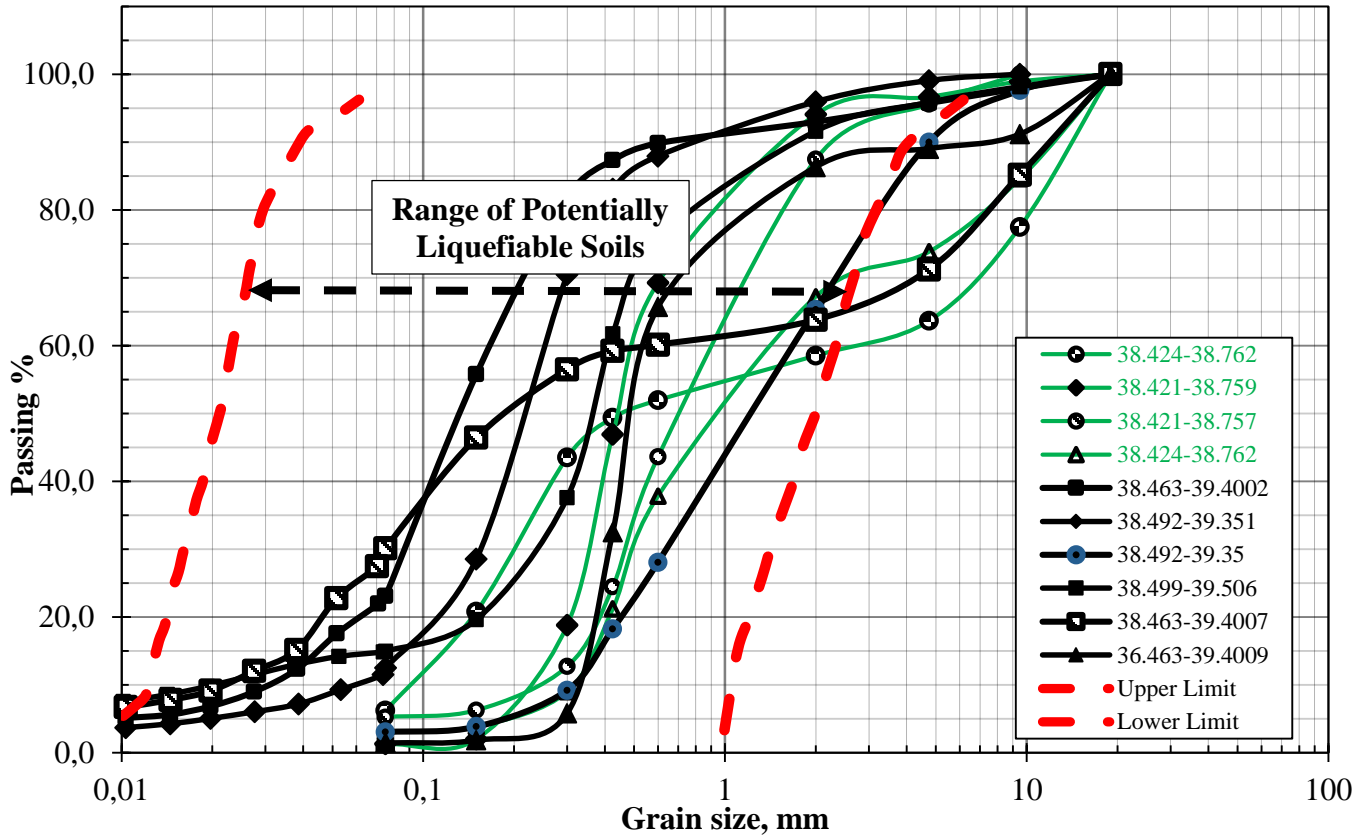
Disturbed samples were taken from the surface of the liquefied areas. The locations of sites from where 6 samples (Hazar Lake) and 4 samples (Kale Village) were taken, are shown in Figure 4.131 and 4.132. A map showing these locations are also presented in Figure 4.133. These samples were tested at METU Soil Mechanics Laboratory to determine the soil-type, grain size and consistency characteristics. The results are comparatively presented with the particle size distribution ranges common for potentially liquefiable soils (Tsuchida, 1970), as given in Figure 4.134. Sieve analysis test results are summarized in Table 4-3. Based on USCS, most of the samples retrieved from sand boils were classified as SP (poorly graded sand) and SM (silty sand).

Figure 4.134. Particles size distribution curves of the sand ejecta taken from liquefied sites. (Black lines are obtained from Hazar Lake region and green lines from Kale Village side, respectively)
