Significance of Fault Zones

Geotechnical Relevant Characterization of Brittle Faults

Gruppe
Geotechnik
Graz ZT GMBH

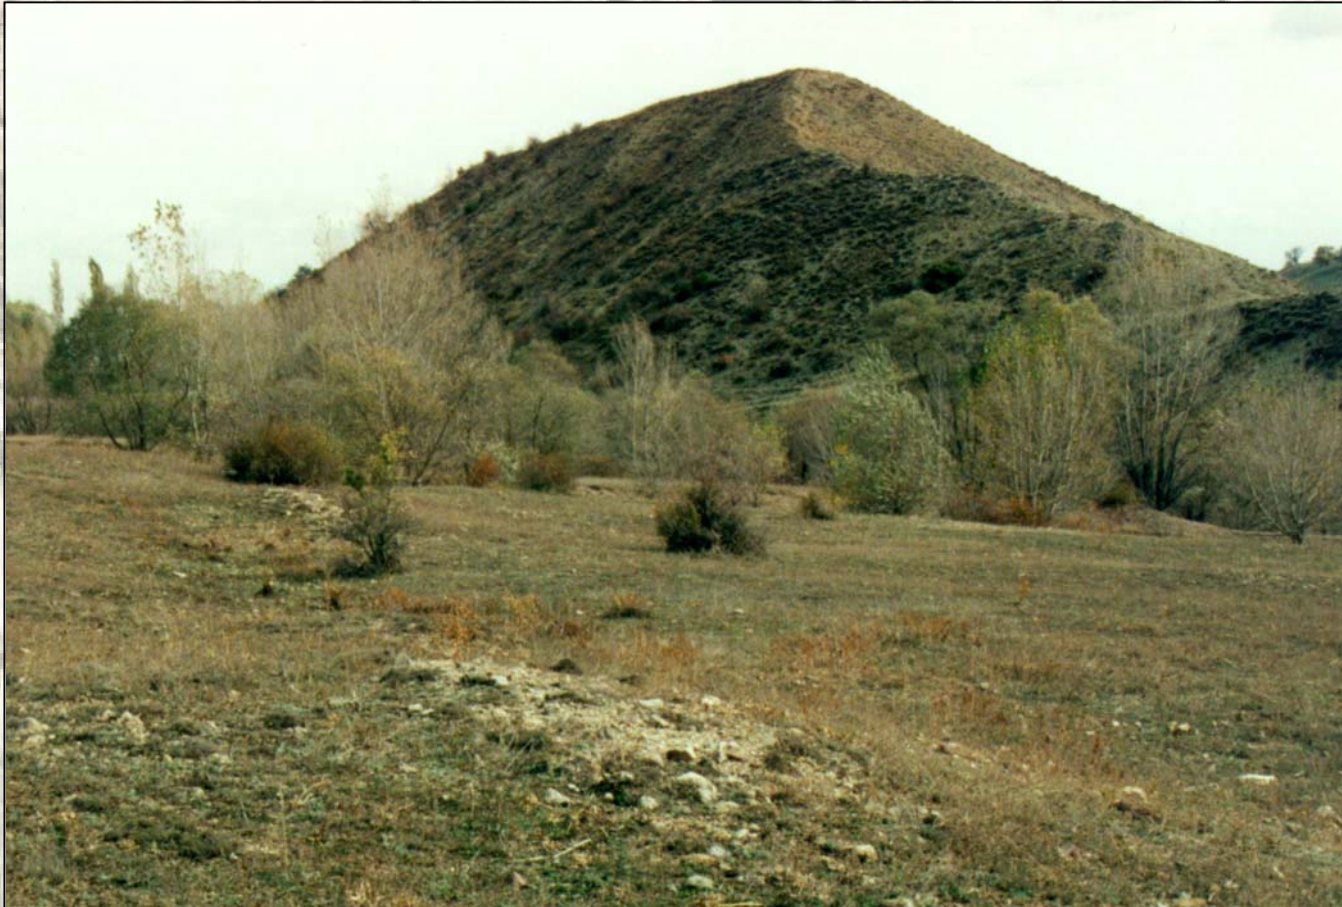
North Anatolian Fault Zone, Turkey
Fault Escarpment of Active Segment, near Bolu Tunnel

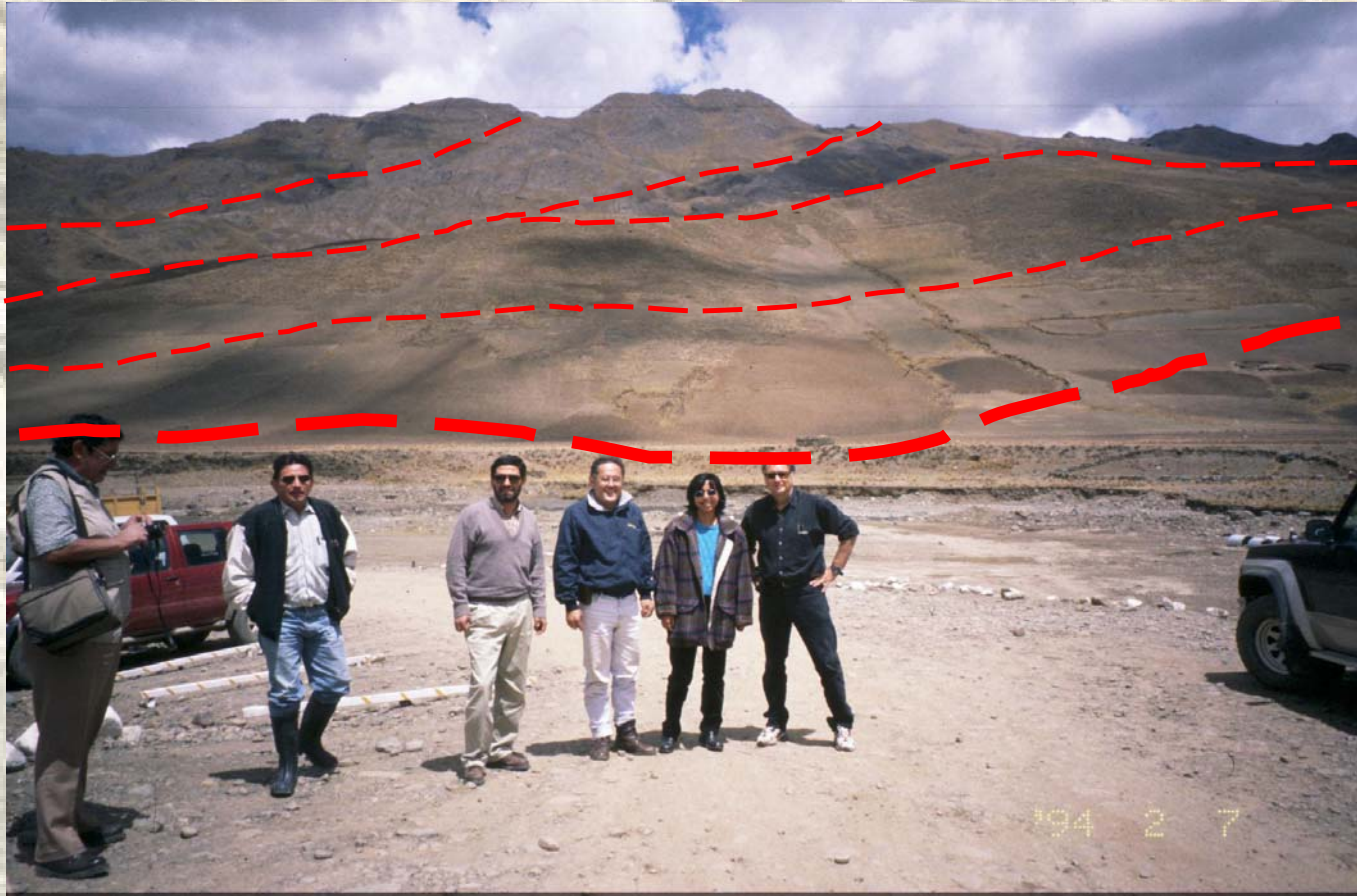
*Strike – Slip Fault, Misicuni Tunnel, Bolivia
Bocatoma Portal, Intermediate Shaft*

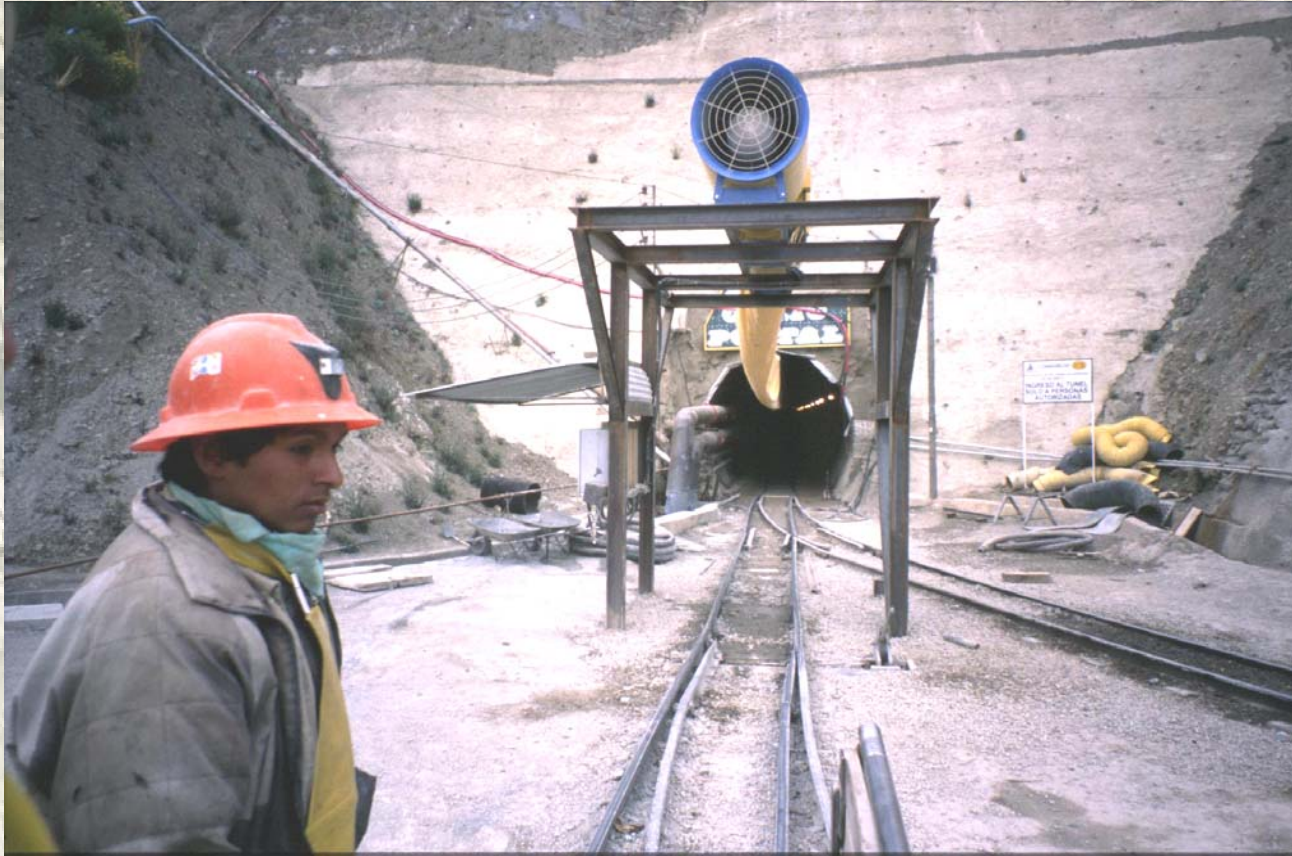
HPP Misicuni, Headrace Tunnel, Calio - Portal

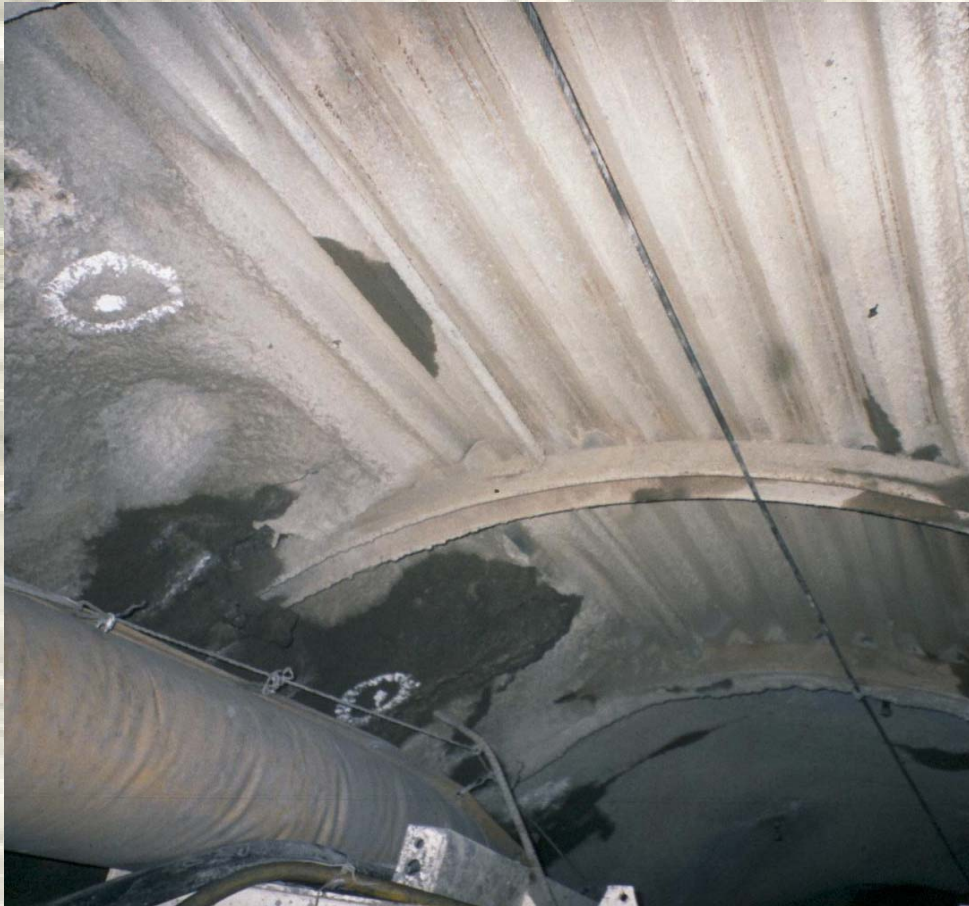
*Excavation Ahead of the TBM Using Marciavantis,
Steel Ribs and Shotcrete*

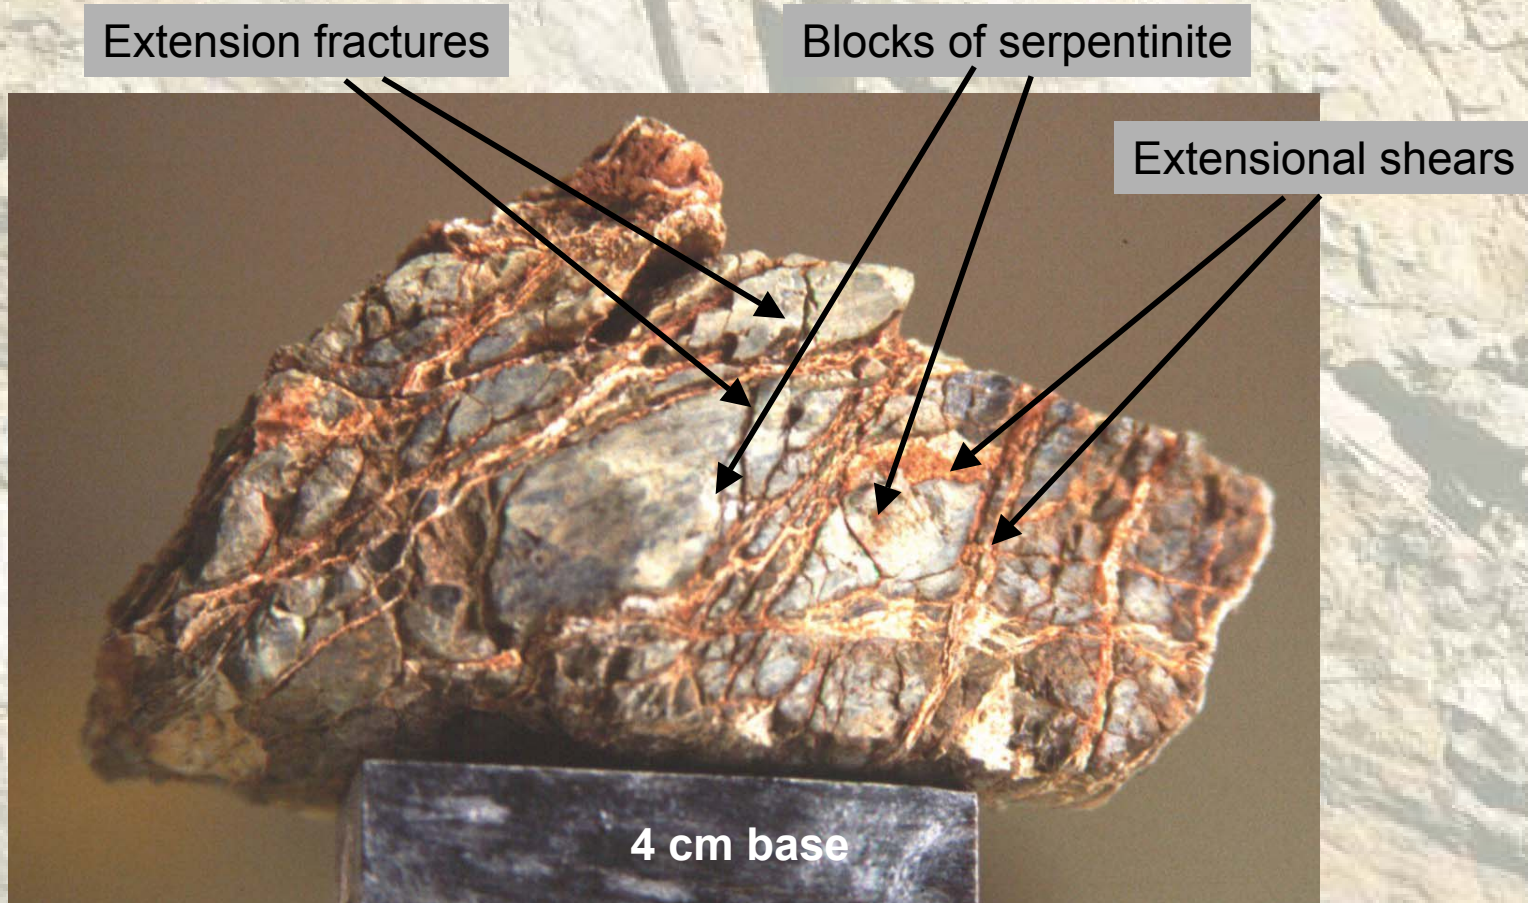
Typical Structure of Ophiolitic Melange in Mesoscale
Egnatia Motorway, N-Greece
